HYDROGEOLOGICAL ASSESSMENT
Doty-Dryad Area
Lewis County, Washington
Prepared for: Lewis County Department of Public Works

Project No. 080192-001-03 • December 1, 2008

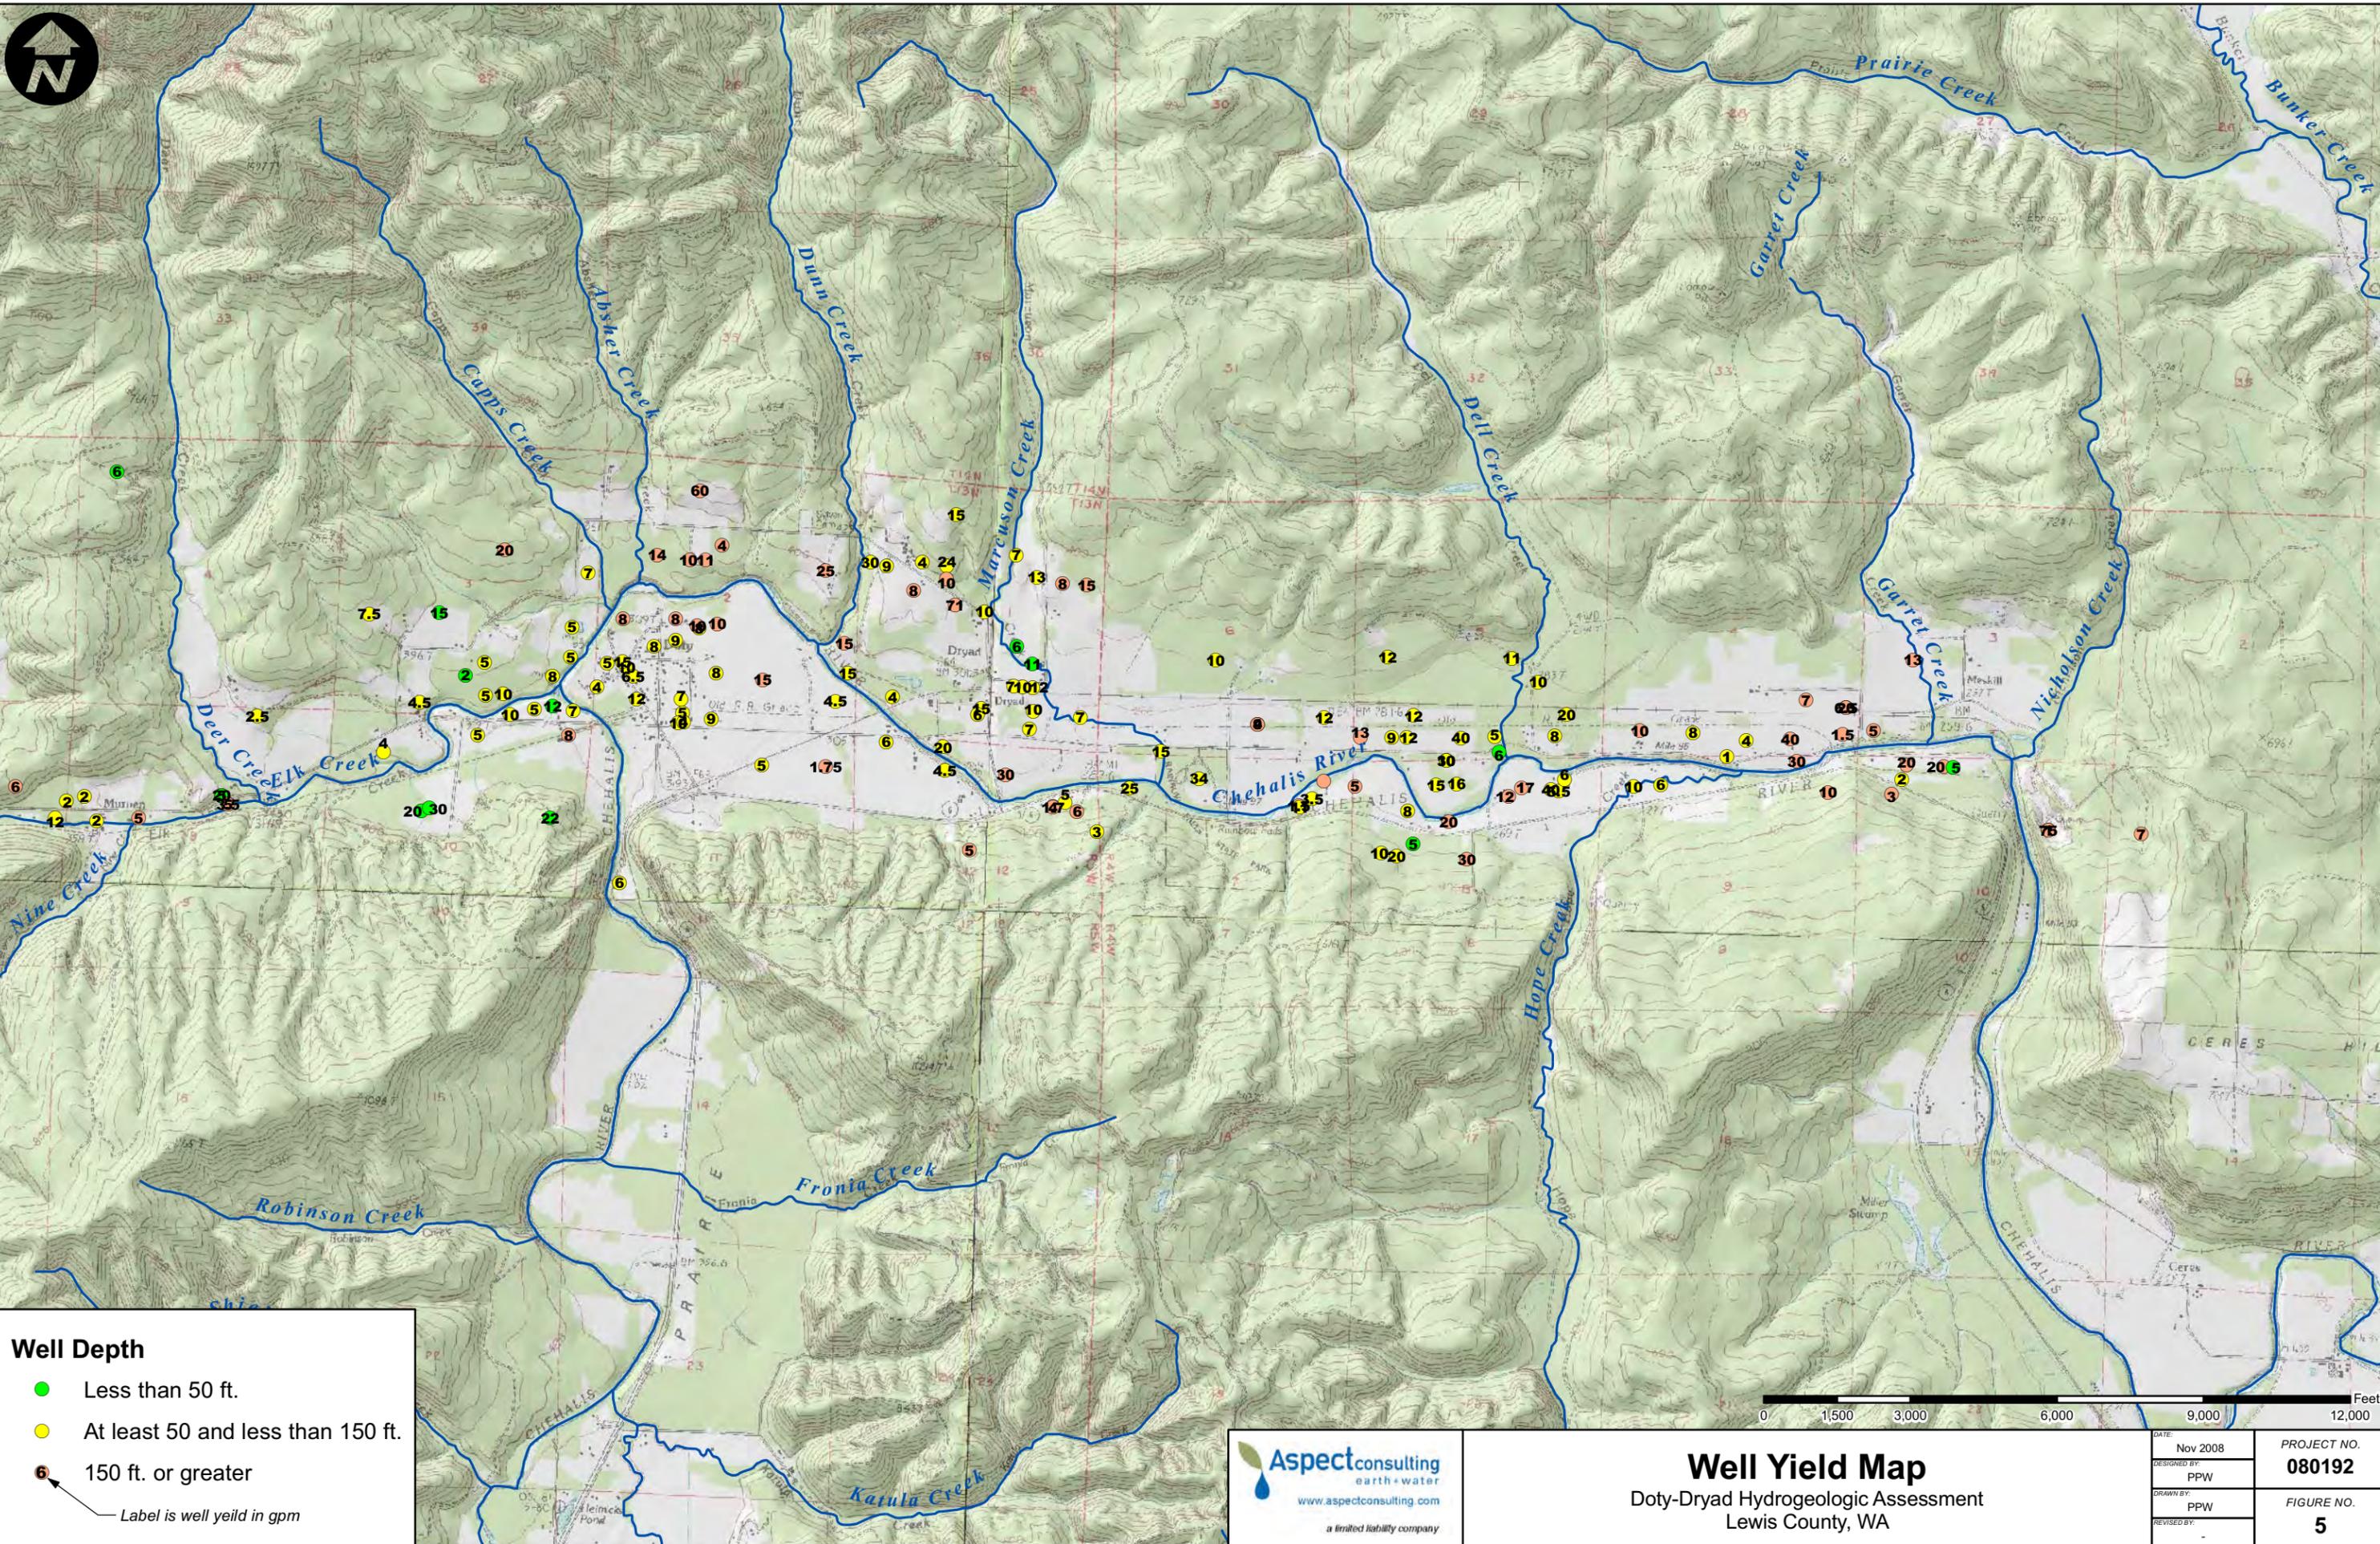
Air lift or bailer test data indicating approximate well yield is listed on 161 of the well logs. Wells for which well yield data are available are summarized on Table 1 and shown on Figure 5. Well location symbols also indicate the range of completion depths for the wells. Well yields from the sedimentary bedrock ranging from about 1 to 70 gallons per minute (gpm), with an average yield of about 10 gpm. Average yield for each of the depth intervals on Figure 5 does not vary significantly, ranging from about 10 to 13 gpm. Based on these data, there does not appear to be a pattern relating well yield to either total depth or horizontal location. Variations in well yield are likely due to a combination of differences in well construction and local variations in the number and continuity of fractures in the bedrock.

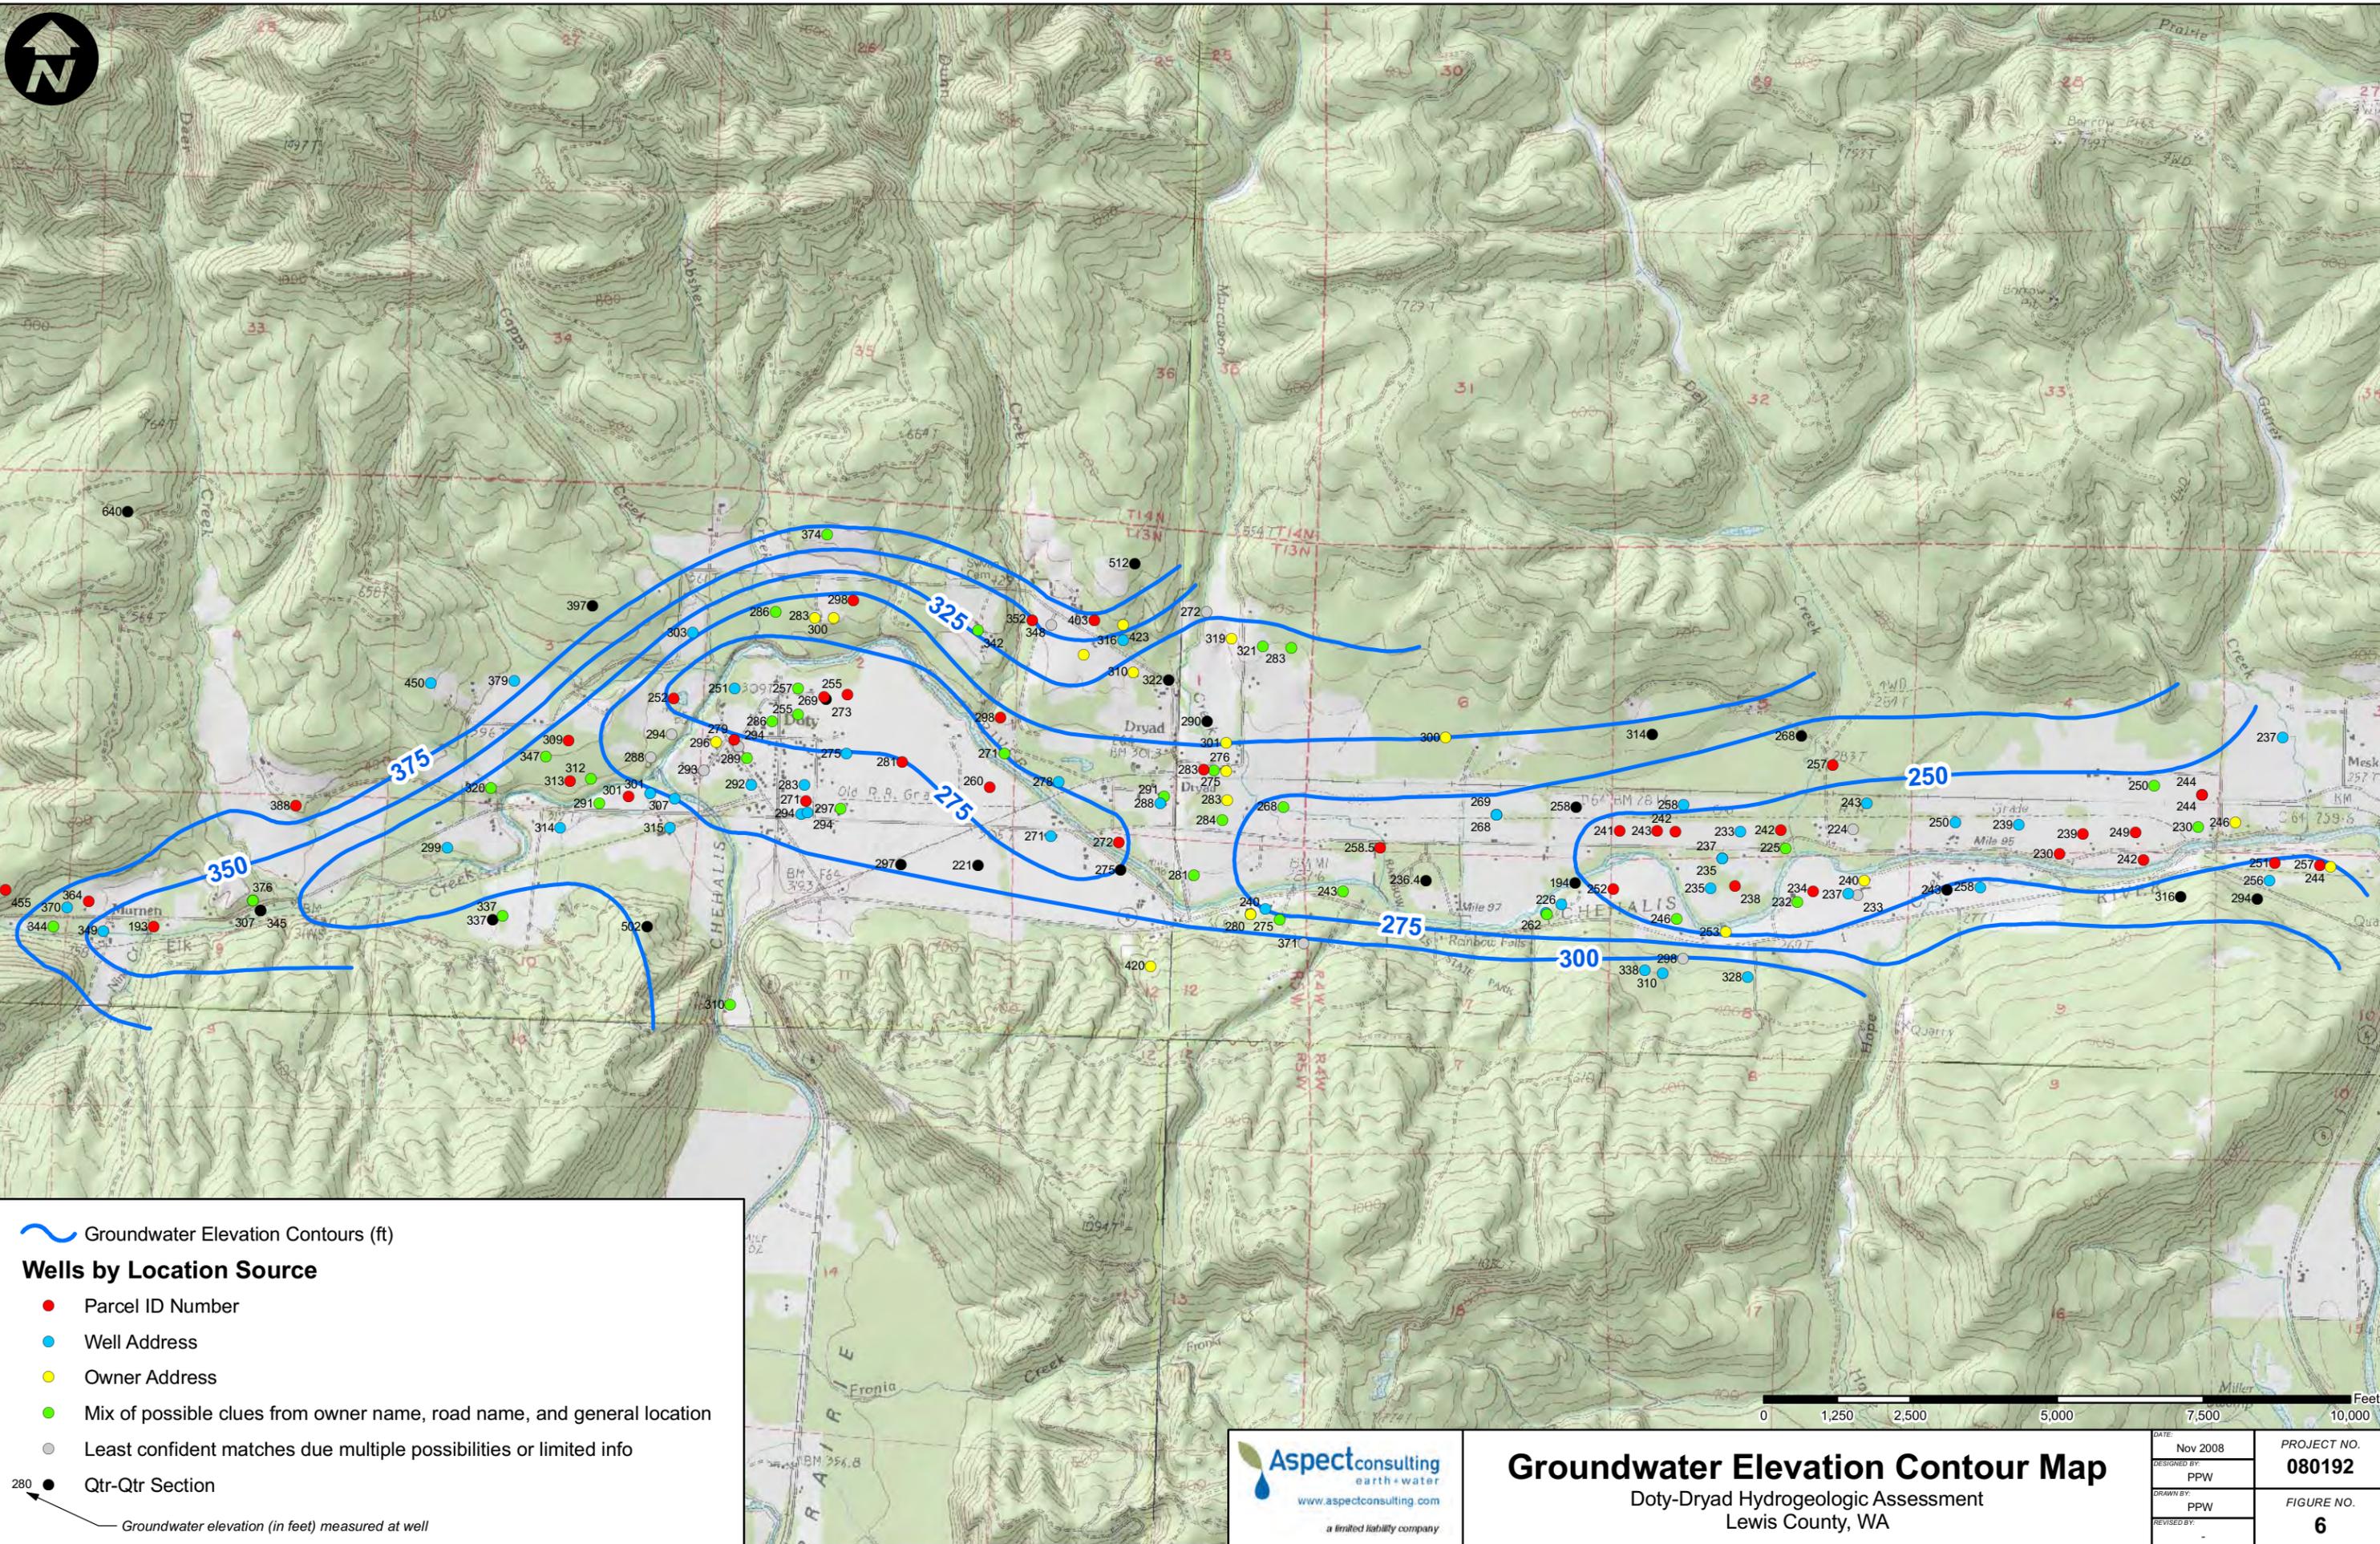
Groundwater elevations were estimated based on approximate ground surface elevations and depth to water measurements listed on the well logs. Due to uncertainties in well locations and ground elevations and the different dates of the depth to water measurements in the wells, accuracy of the estimated water level data is expected to be plus or minus 20 feet. There does not appear to be significant differences in groundwater elevations for wells completed at different depths, therefore all the groundwater elevation data were used to develop the groundwater elevation contour map shown on Figure 6.

Based on the groundwater elevation contours, groundwater flow appears to follow ground surface topography, with flow from the higher elevations toward the valley bottom. Groundwater in the valley bottom generally parallels the direction of river flow (i.e., eastward in the study area), and likely ultimately discharges to the Chehalis River. In Doty, groundwater elevations show an apparent depression, indicated by the closed 275-foot elevation contour. This area of lower groundwater levels may be an artifact of elevation errors or could be the result of pumping drawdown from the relatively large number of domestic wells in this area.

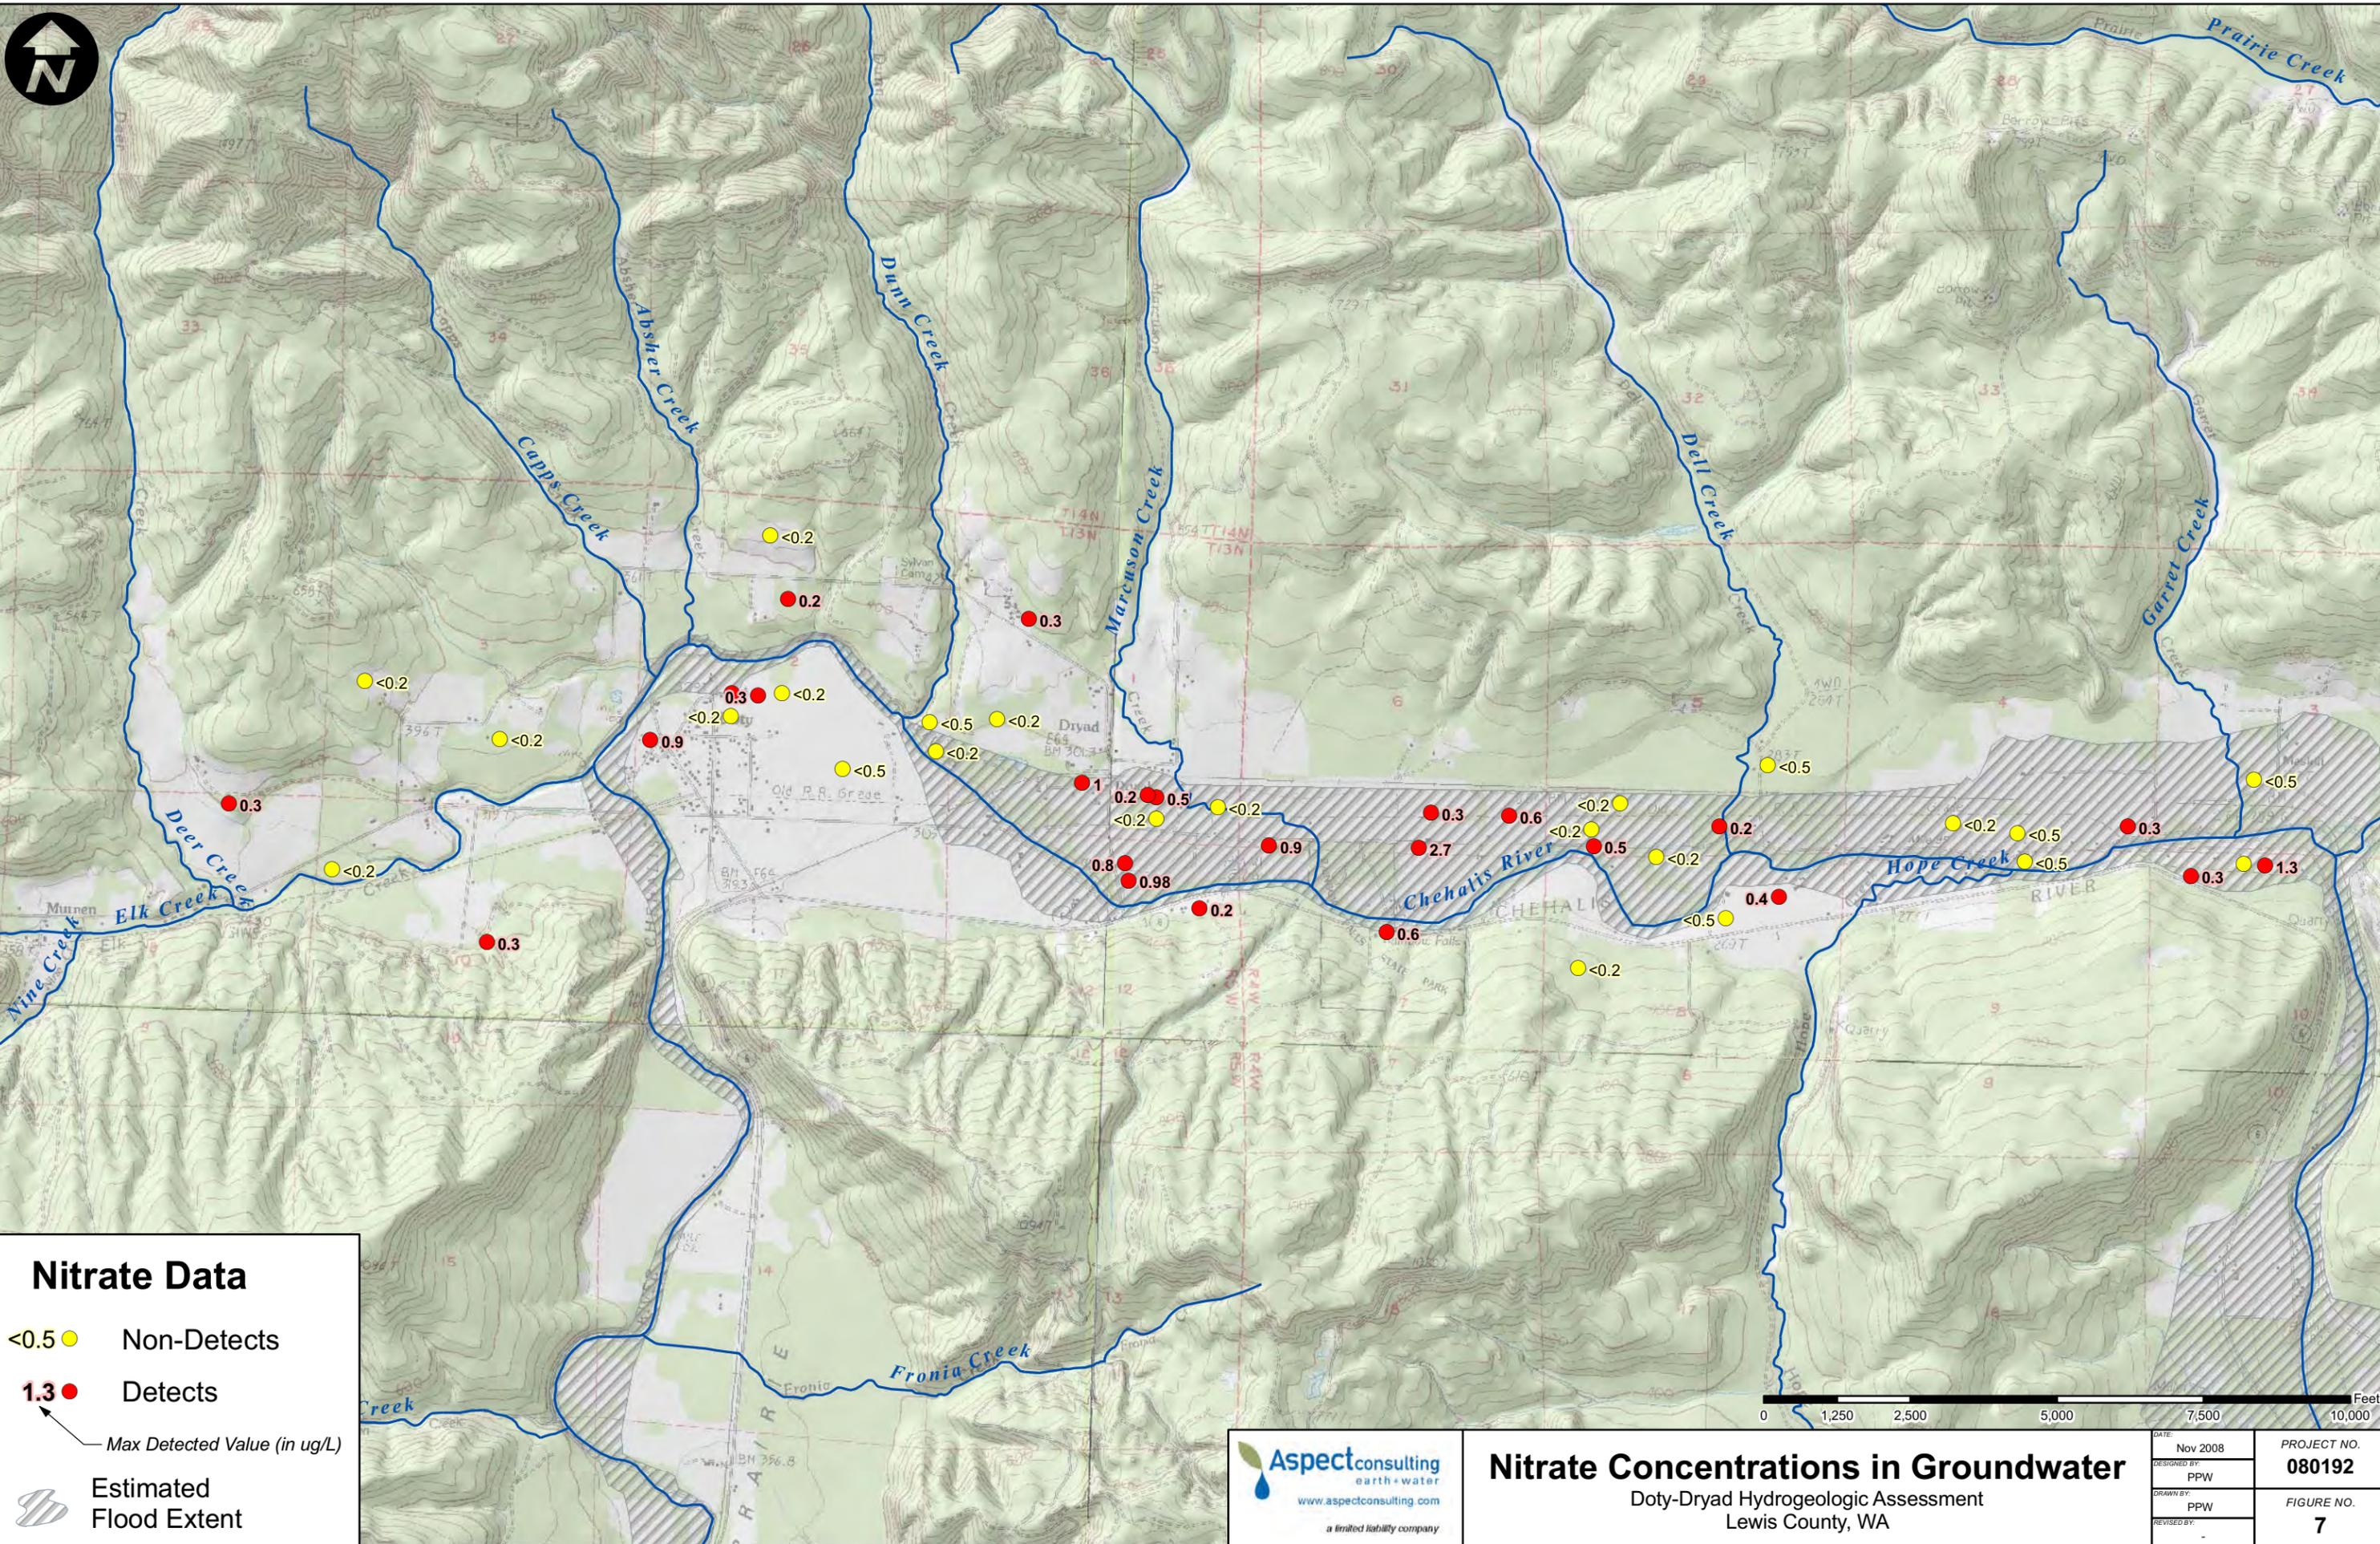
Elevated nitrate concentrations in groundwater can be an indication of infiltration of septic system leachate, in turn indicating the potential for coliform from septic systems to contaminate groundwater. As shown on Figure 7 and Table 2, nitrate concentrations are uniformly low in the study area. Only three wells had nitrate concentrations greater than or equal to 1 milligram per liter (mg/L), with a maximum detected concentration of 2.7 mg/L. These three wells are not located near each other and two of the wells are located outside the relatively densely developed towns of Doty and Dryad, where impacts to groundwater from septic systems would be most likely to occur. Based on the uniformly low concentrations and the large separation between locations with concentrations greater than or equal to 1 mg/L, it appears that infiltration of leachate from septic systems has not resulted in a widespread nitrate impacts to groundwater tapped by domestic supply wells in the area.

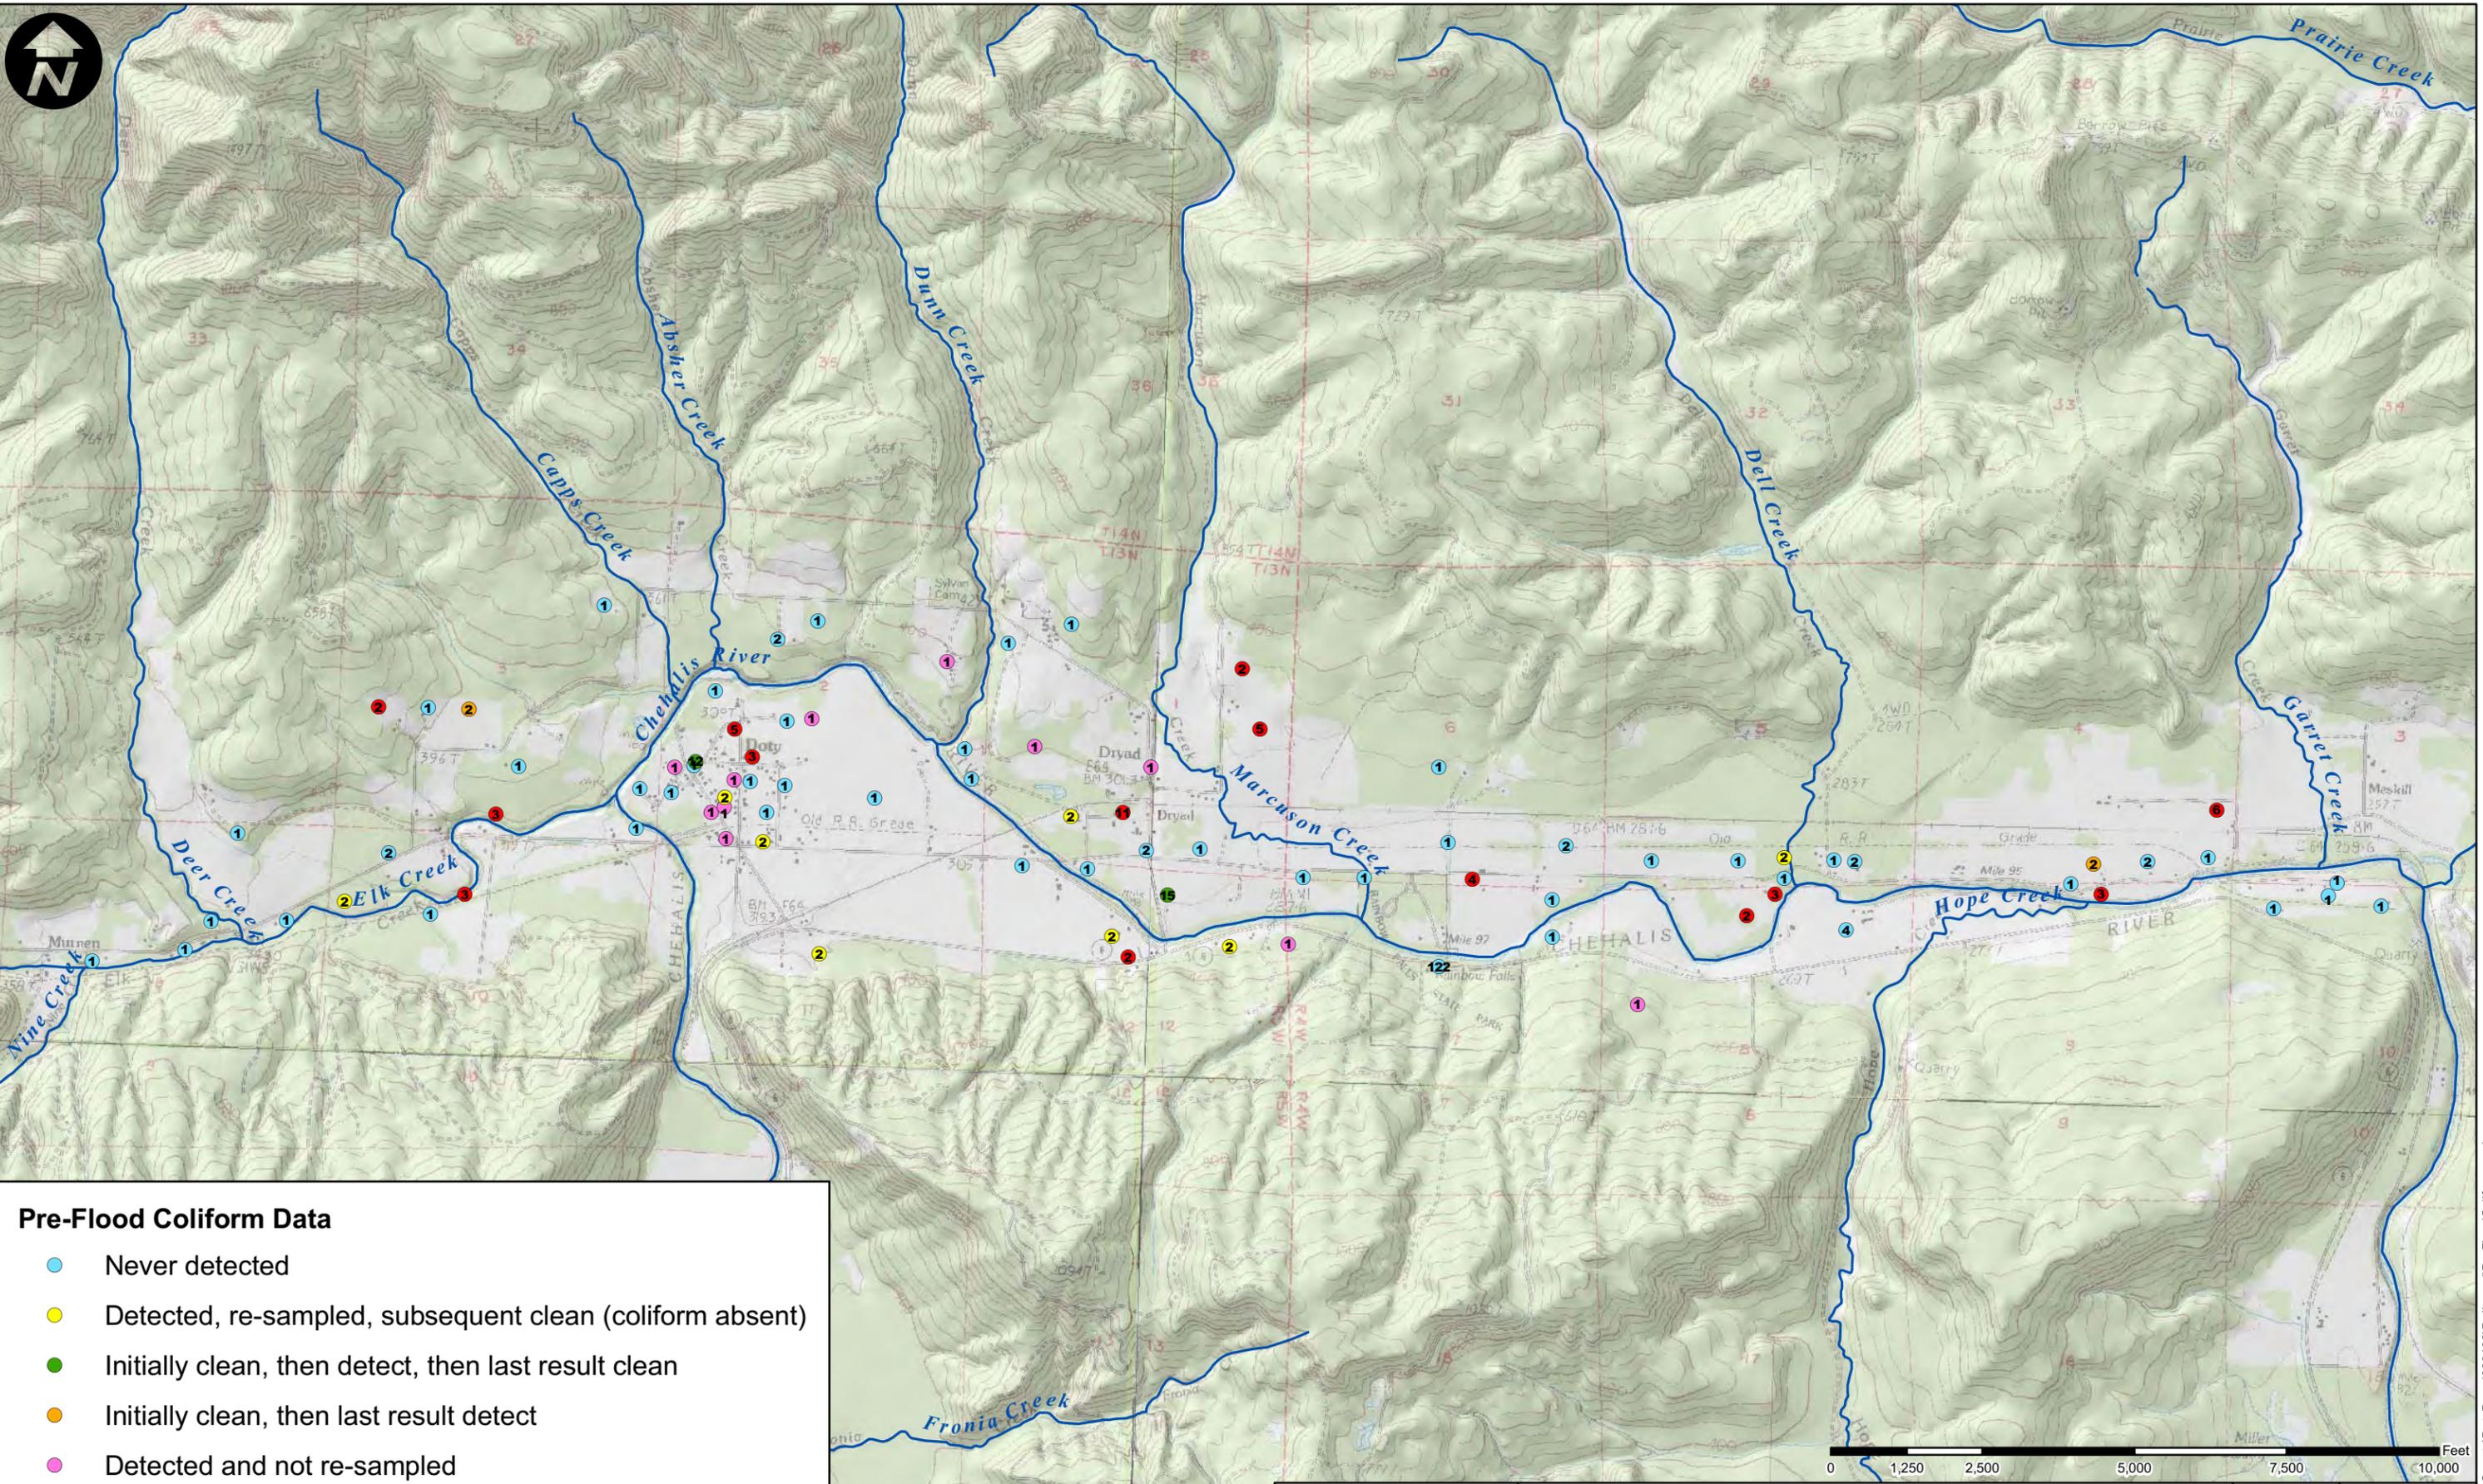
Coliform data collected prior to the December 2007 flood are presented on Figure 8 and in Table 3. Table 5 presents a statistics summary for coliform detections pre- and post-flood. About 180 coliform samples were collected from 88 domestic wells in the study area prior to the flood. Well logs were identified for approximately half the sample locations. These coliform sample totals do not include the large number of samples collected from the Rainbow Falls State Park Group A Water System, all of which were non-detect for coliform. Total coliform was detected in 37 of the 88 domestic wells sampled, with *E. coli* detected at 8 locations. Coliform was not detected at ten of these 37 locations in subsequent sampling, indicating the previous detections were probably due to localized contamination of the well or distribution system, rather than coliform contamination of the aquifer.

As shown on Table 3, coliform detections occur over a broad range of well depths. There appears to be some correlation of coliform occurrence with well depth. Coliform was detected in 8 of 14 wells completed at depths less than 100 feet, and only 6 of 29 wells completed at depths greater than 100 feet (Table 5).

The locations of coliform detections are scattered throughout the study area, although a cluster of nine detections (without subsequent nondetect samples) are located in the more densely developed town of Doty. Well logs were identified for three of the locations with detected coliform. These wells with detected coliform are completed at depths of 80 to 155 feet. Other pre-flood samples from Doty collected from wells completed nearby at similar depths (80 to 160 feet) did not show detections of coliform.

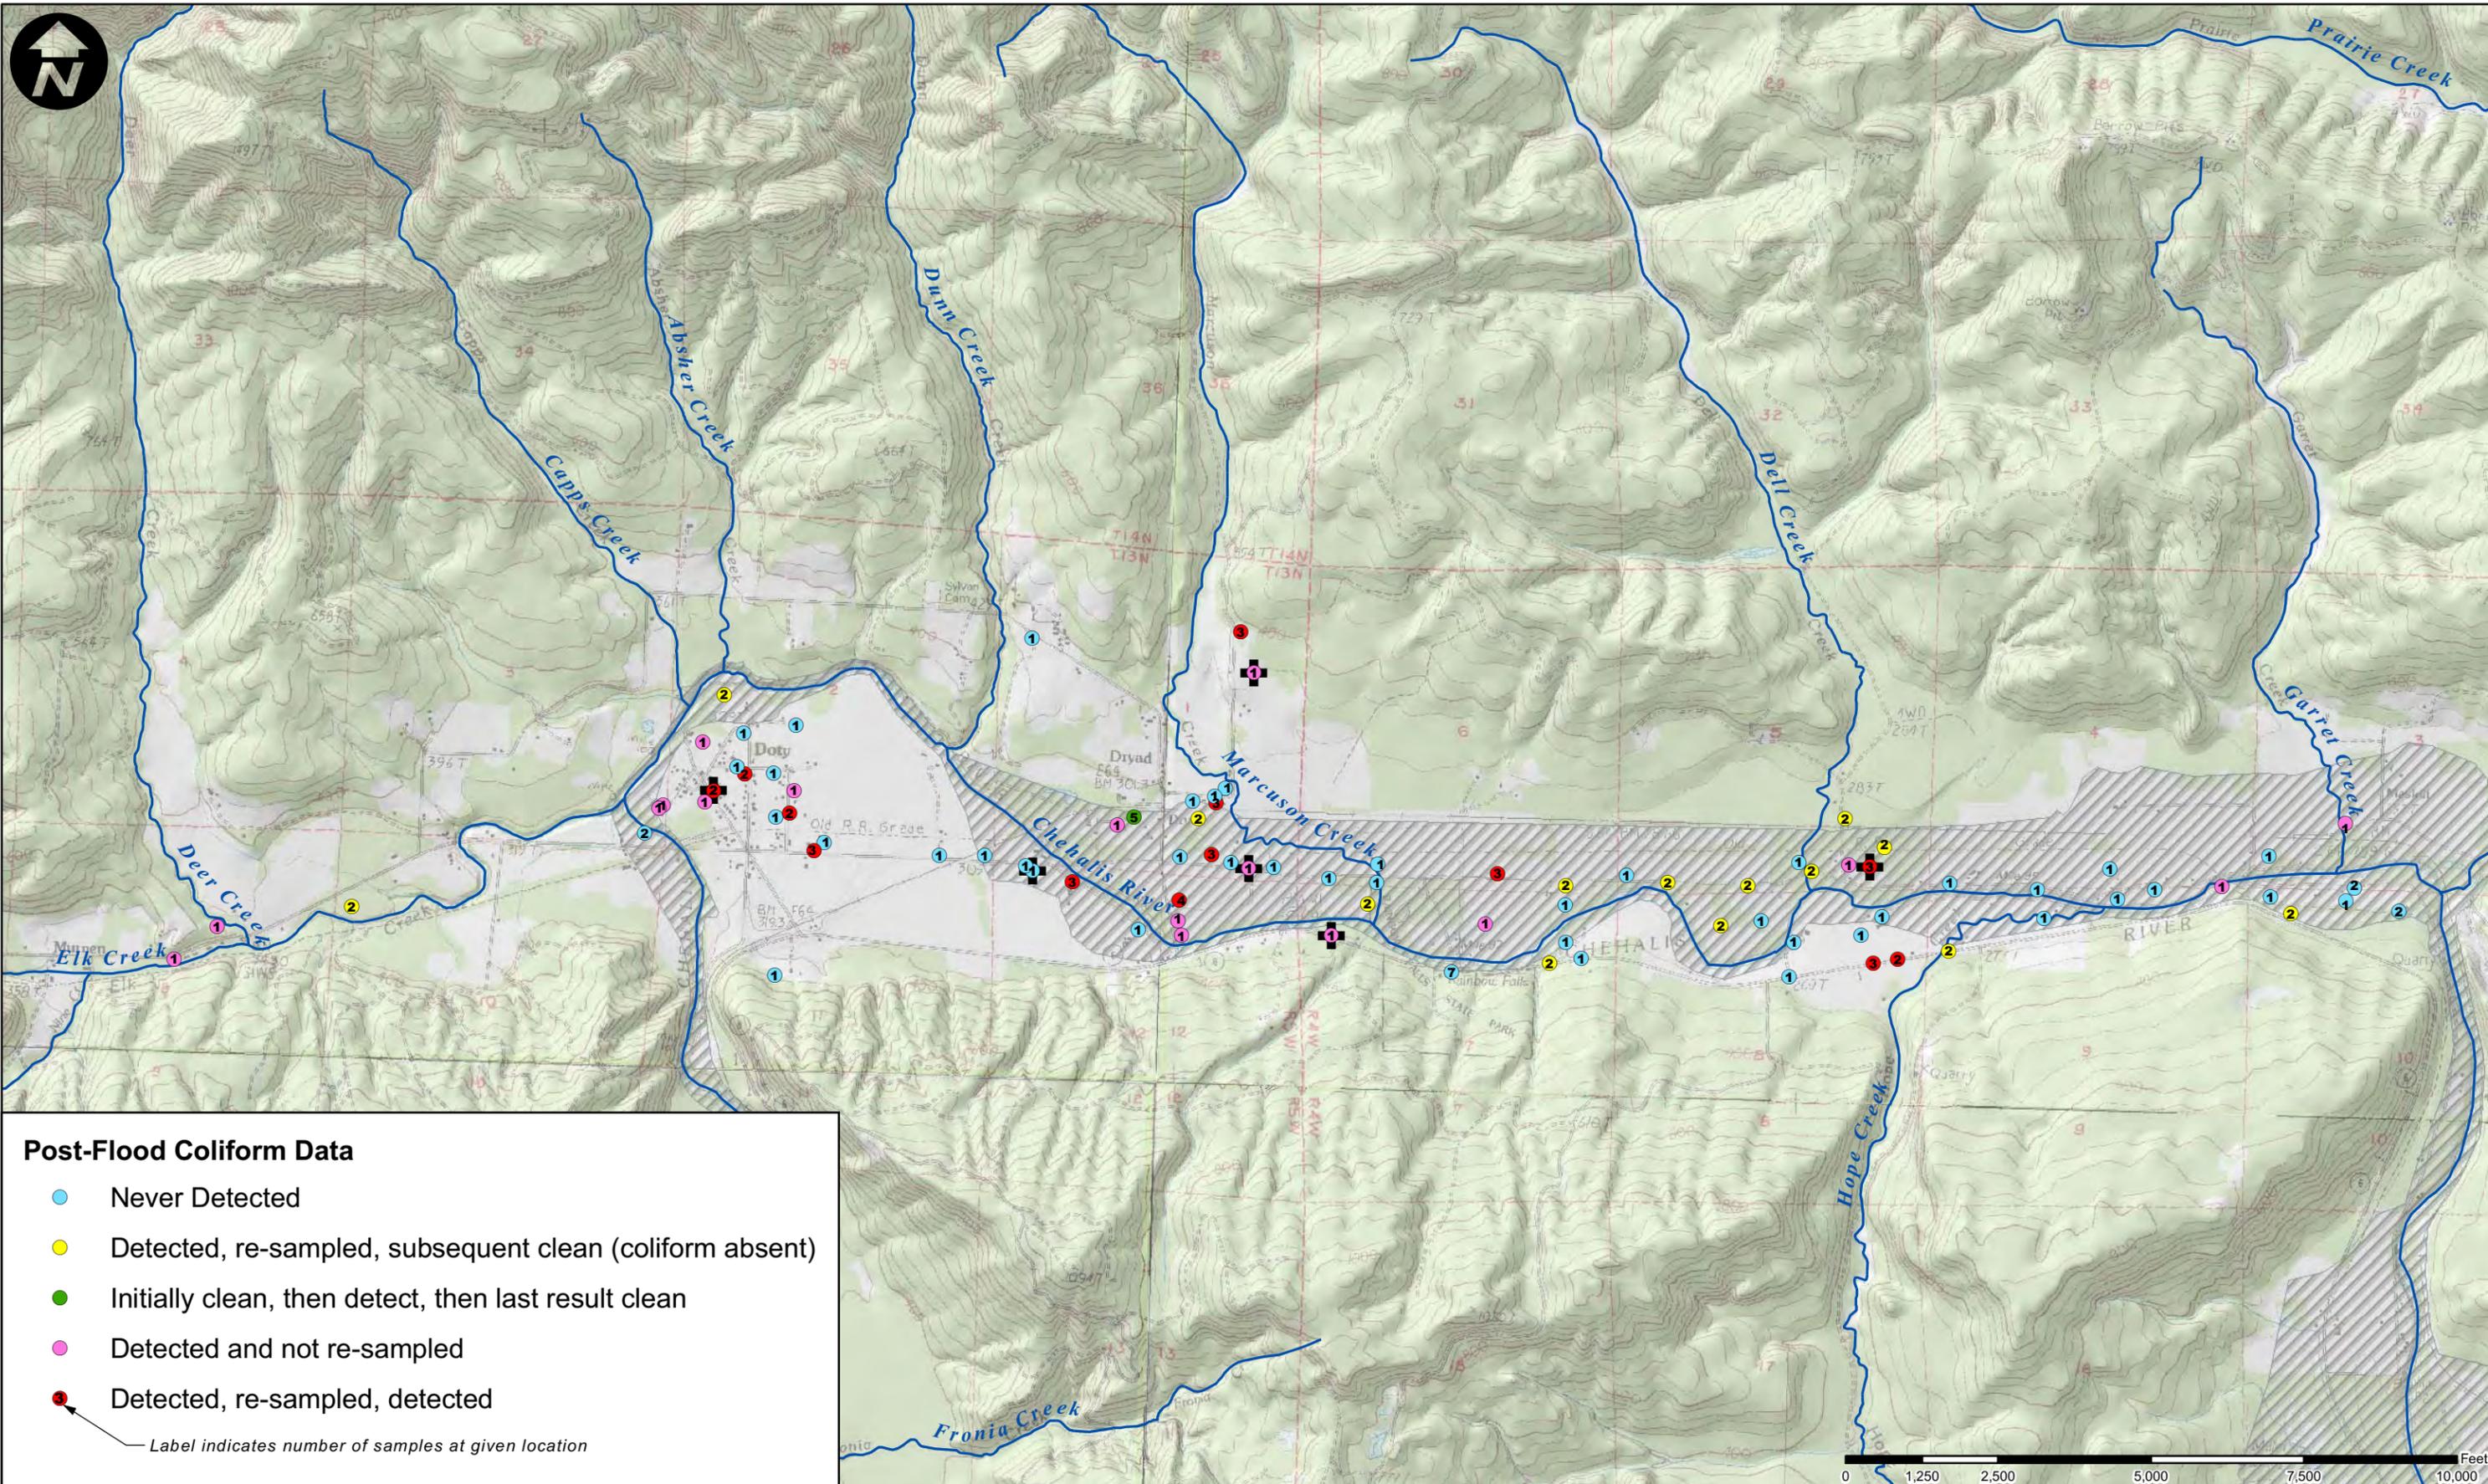
Coliform data collected after the December 2007 flood are presented on Figure 9 and in Table 4. A total of 140 coliform samples were collected from 90 domestic wells in the study area after the flood. Well logs were identified for 37 of the sample locations. These coliform sample totals do not include samples collected from the Rainbow Falls State Park Group A Water System, all of which were non-detect for coliform. Total coliform was detected in 44 of the 90 domestic wells sampled after the flood, with *E. coli* detected at 12 locations. This represents an increase in wells with detected coliform of about 7 percent over pre-flood conditions.

Of the 44 locations with initial coliform detections, coliform was not detected at 15 locations in subsequent sampling, indicating the previous detections were probably due to localized contamination of the well or distribution system, rather than coliform contamination of the aquifer. Fifteen locations with initial detections of coliform were not resampled (Figure 9), and it is unknown if coliform persists at these locations. Notes in the post-flood coliform data provided by the County indicate that at least 11 wells in the study area are shallow, dug wells. Coliform was detected in 10 out of 11 dug wells, while only 13 out of 37 deeper, drilled wells for which well logs were identified were affected. Based on these data, coliform contamination of the aquifer, either preexisting or due to the flood, is likely limited to shallow groundwater near ground surface, and does not appear to impact deeper groundwater.

The 13 locations with associated well logs where coliform was detected in the initial sample were resampled (Table 4). Coliform was not detected in subsequent samples from eight of these locations, but was detected at five locations. These wells with confirmed detections are completed at depths of 80 to 200 feet. Samples collect from nearby locations with well logs had no coliform detected, either in the initial sample or in subsequent samples. As discussed in the following section, four of these five locations with continued coliform detections have some form of wellhead deficiency that could act as a route for coliform to enter the well or distribution system.
