Madsen, Kneppers & Associates, Inc.

Construction Consultants & Engineers

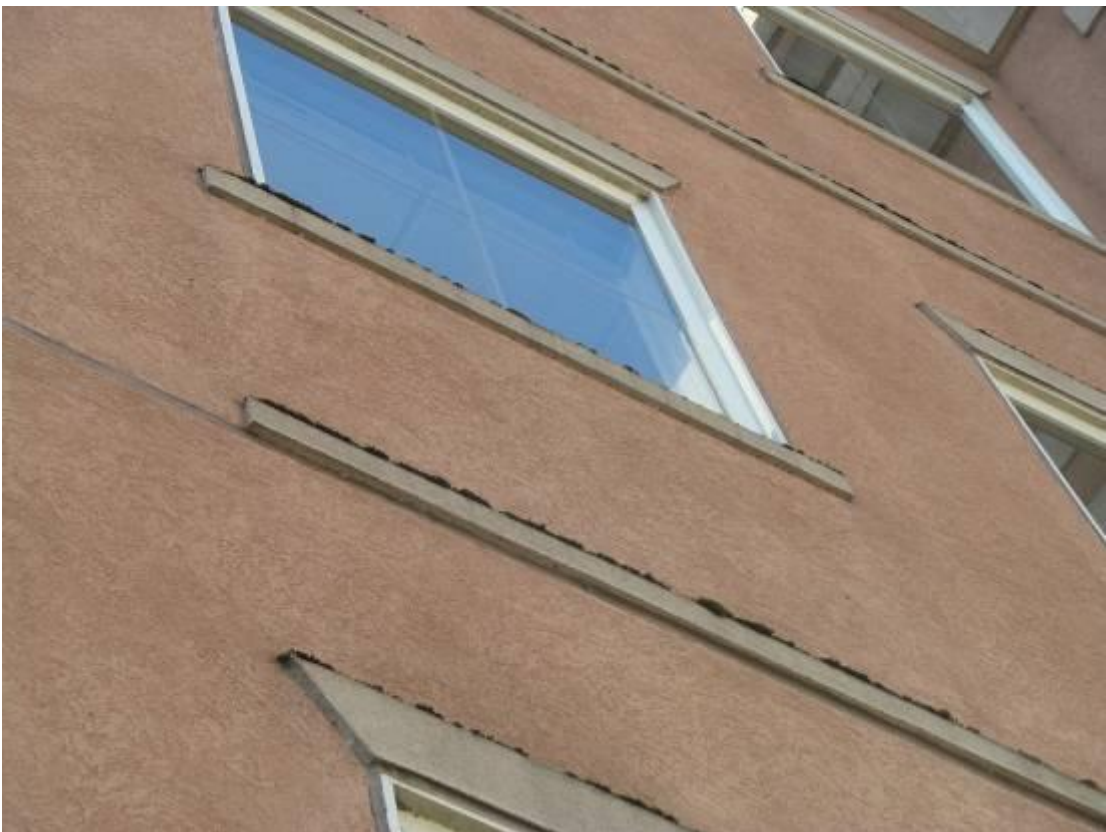
6. Organic growth observed on north elevation on horizontal trim surfaces.

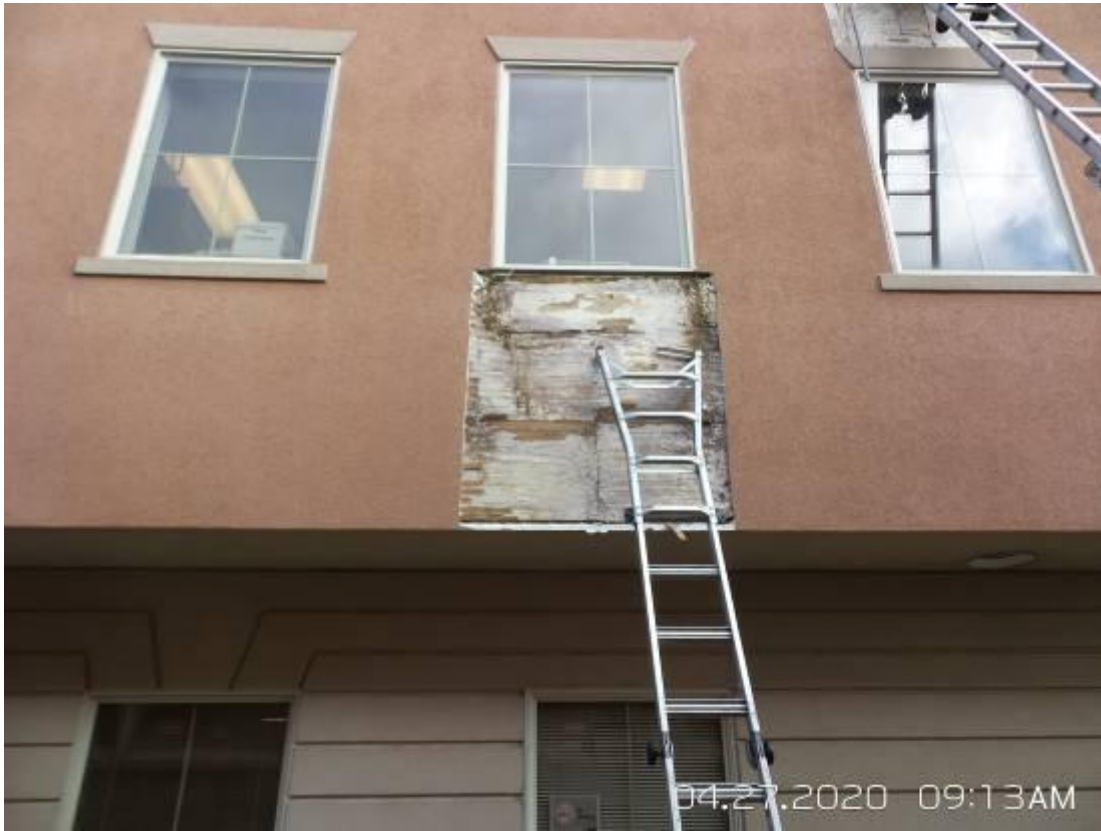
7. [No WRB installed at any opening; south elevation shown.](#)

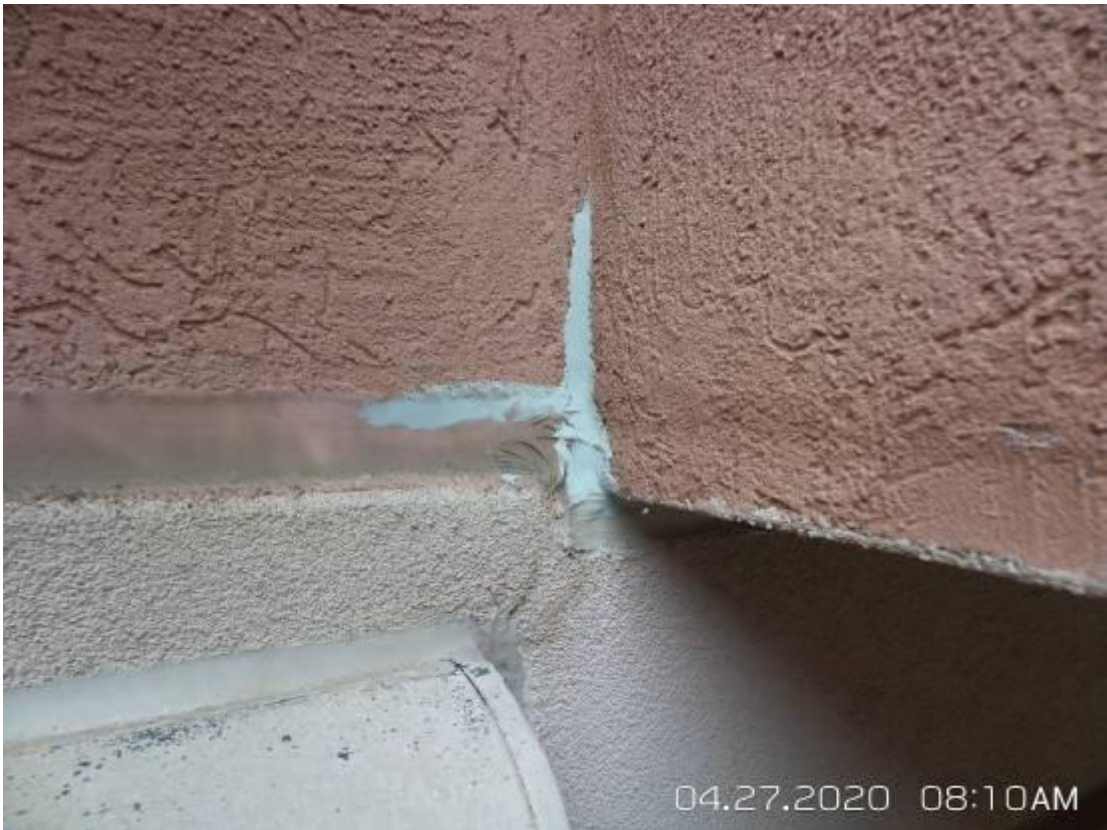
12. Opening 1 – new sealant observed at inside corner of wall and at wall to soffit intersection.

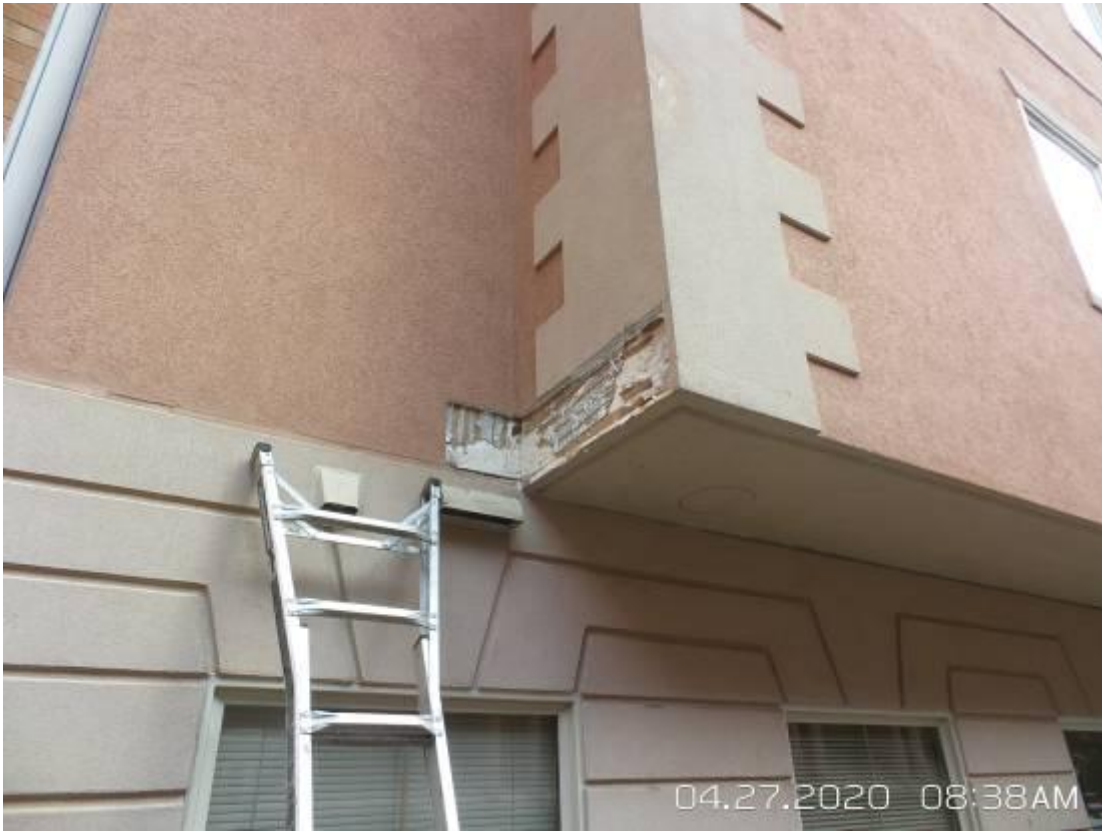
13. Opening 1 –the paper facer of the gypsum sheathing was delaminated primarily at the base of the opening.

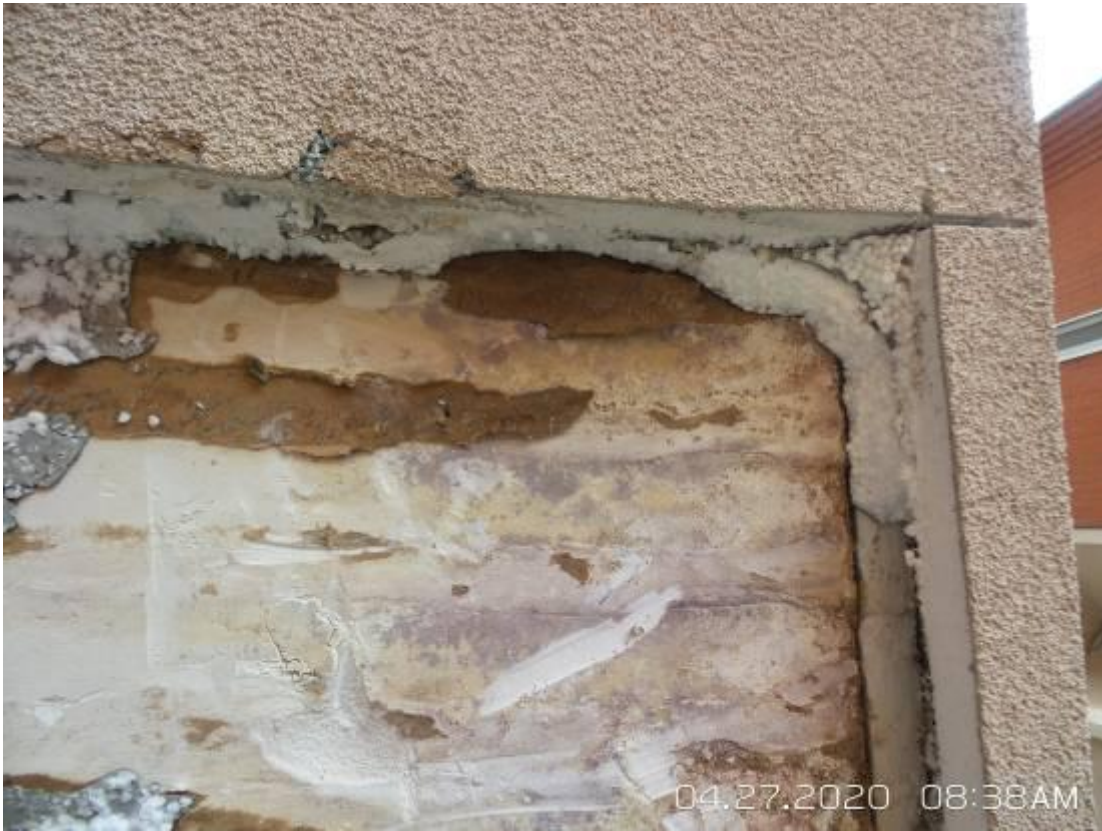
15. Opening 1 –the gypsum sheathing was stained at the outside corner of opening.

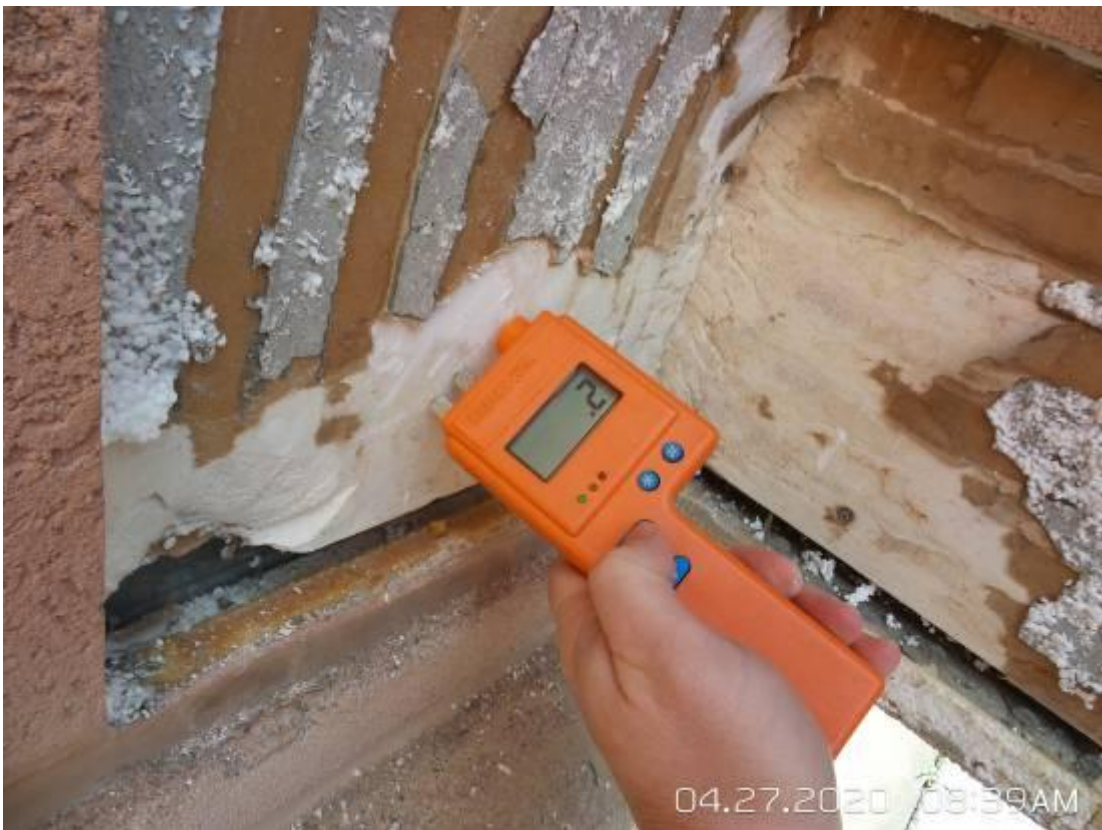
16. Opening 1 – moisture content readings of the gypsum sheathing were normal (0.1% - 0.2%).

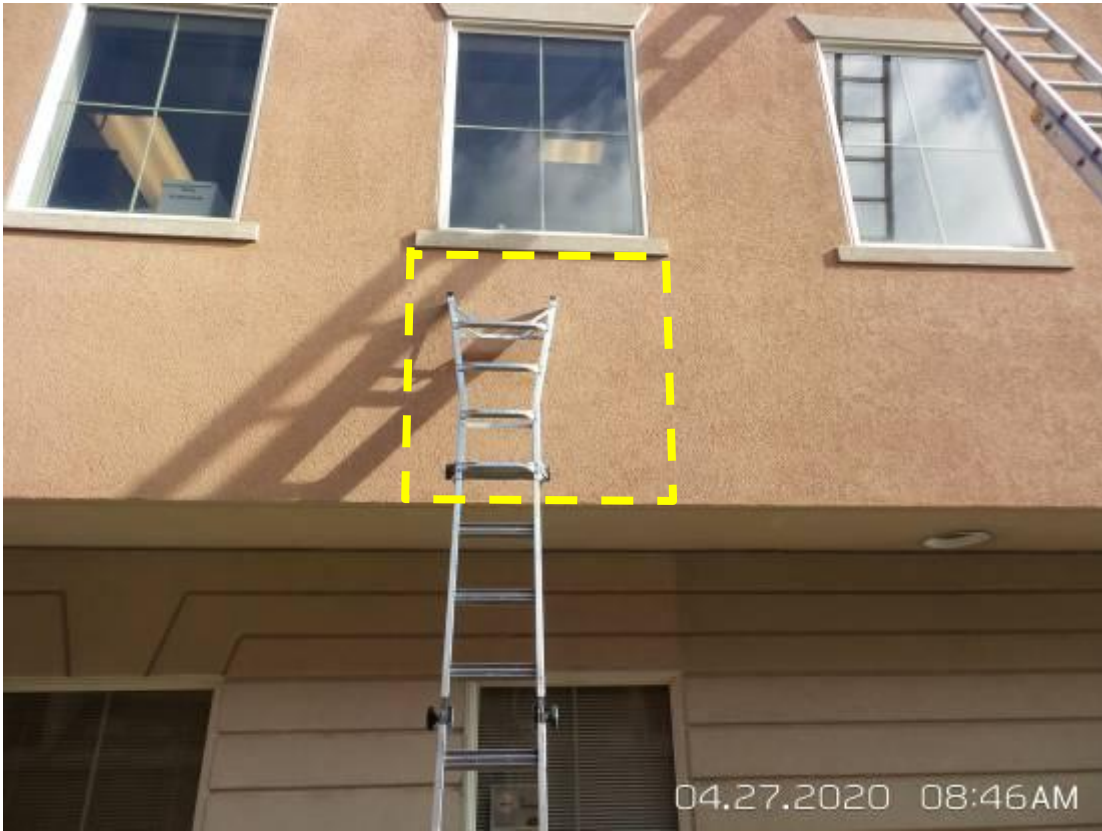
17. Opening 2 – remove cladding from window sill to soffit.

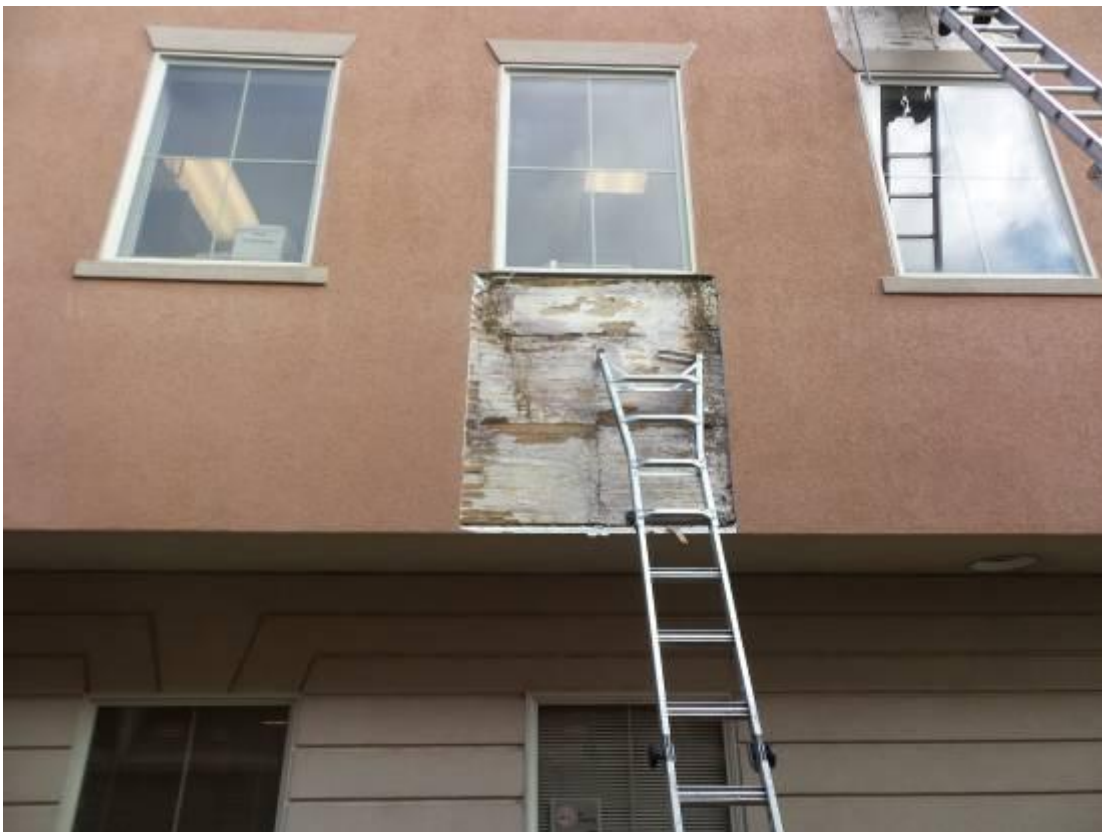
18. Opening 2 – gypsum sheathing was deteriorated across the opening area.

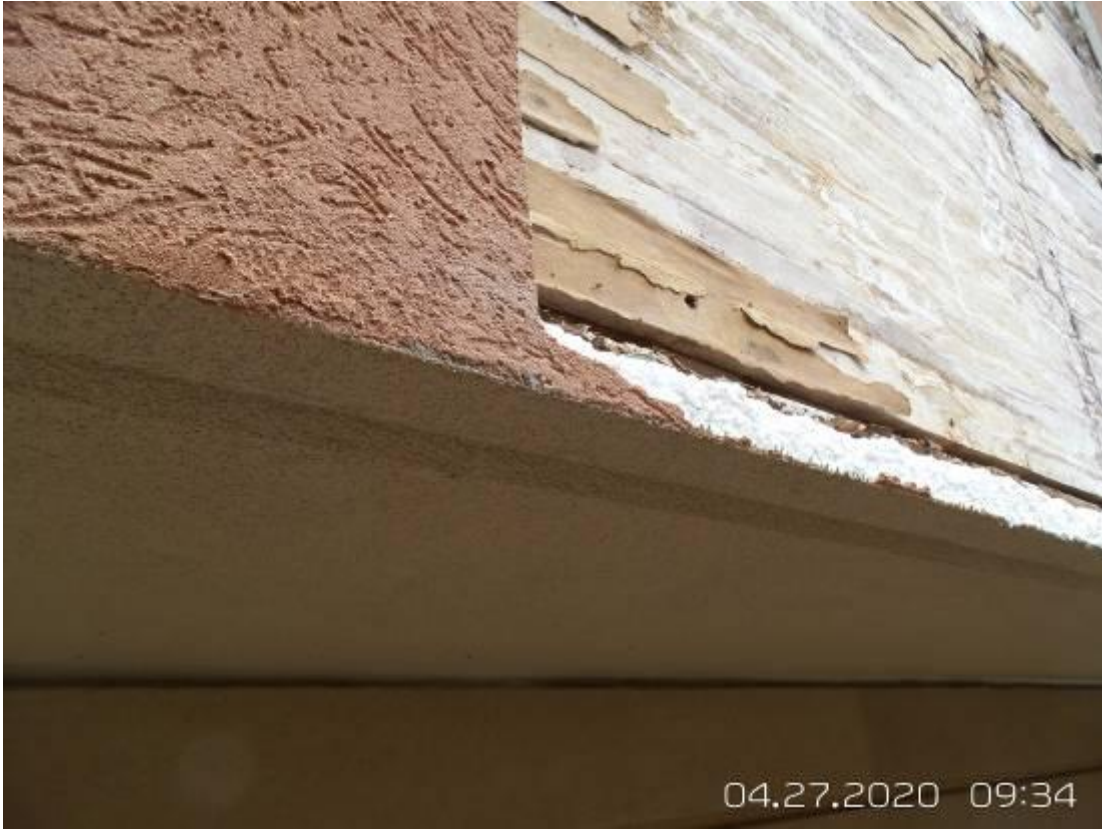
19. Opening 2 – no weeps or gap for drainage of incidental moisture was provided as part of the cladding assembly.

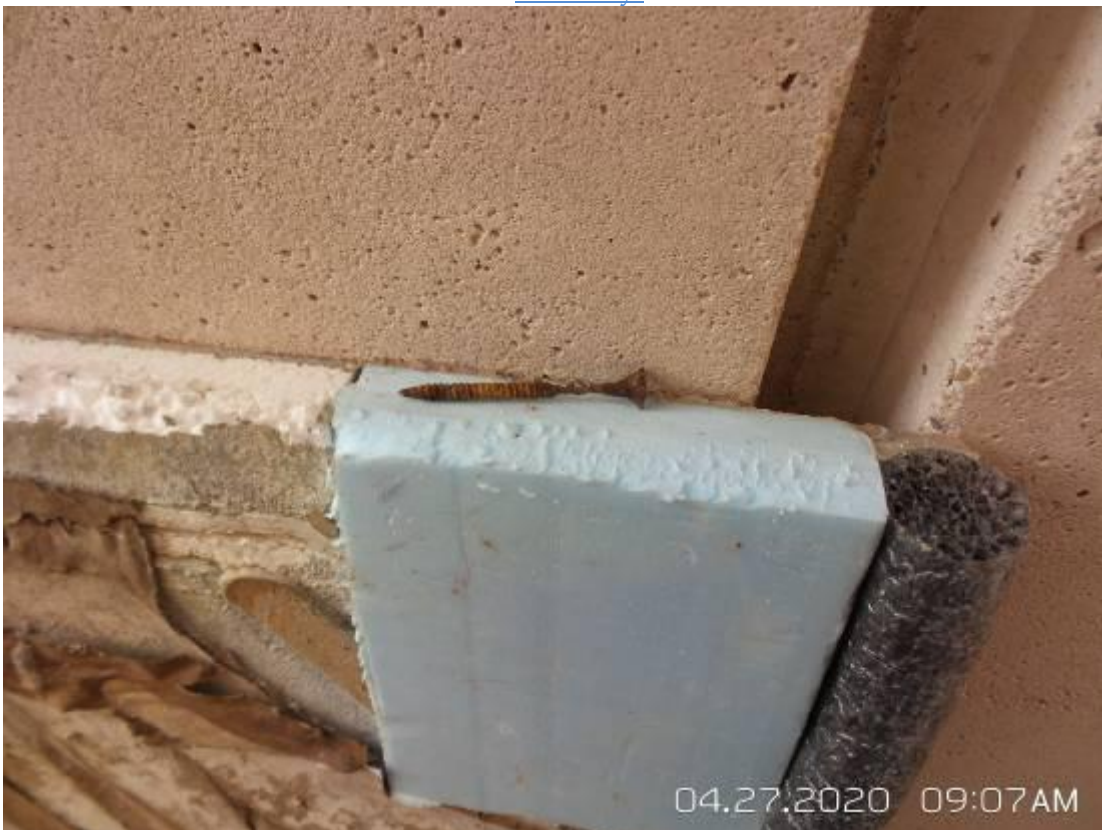
20. Opening 2 – insulation board fastener deterioration was noted.

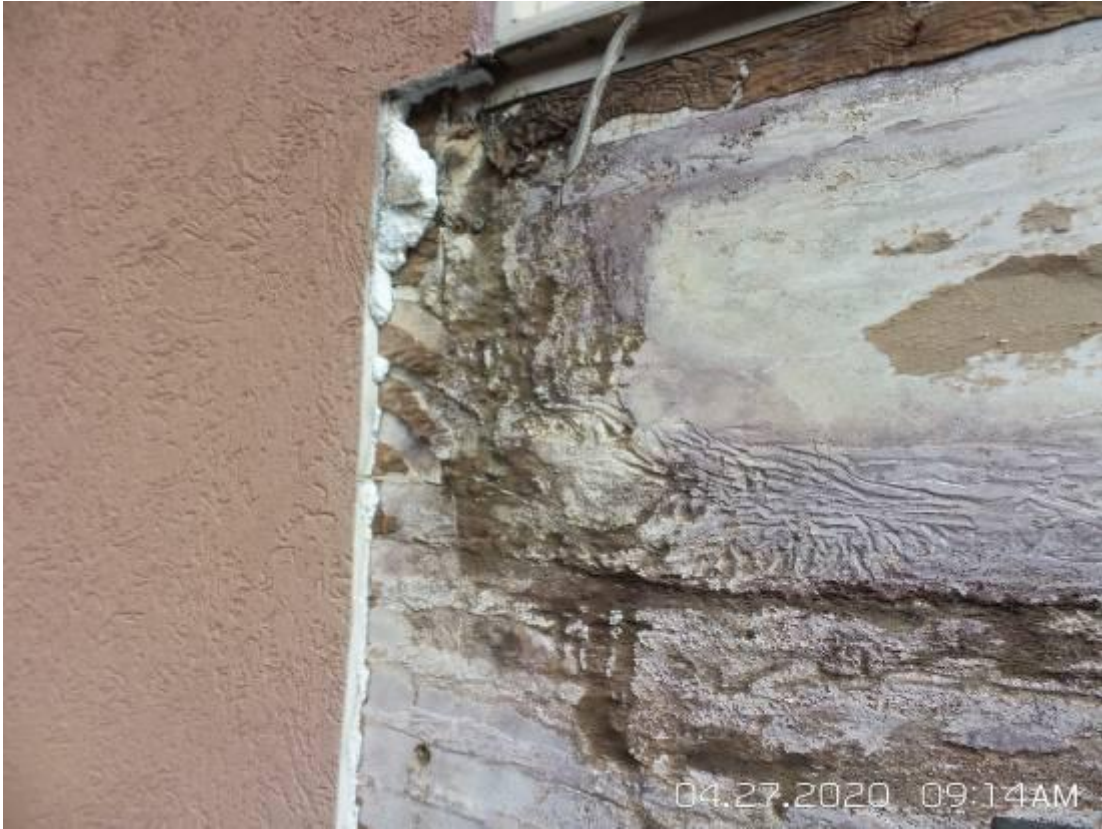
21. Opening 2 – the gypsum sheathing core was deteriorated below the window sill.

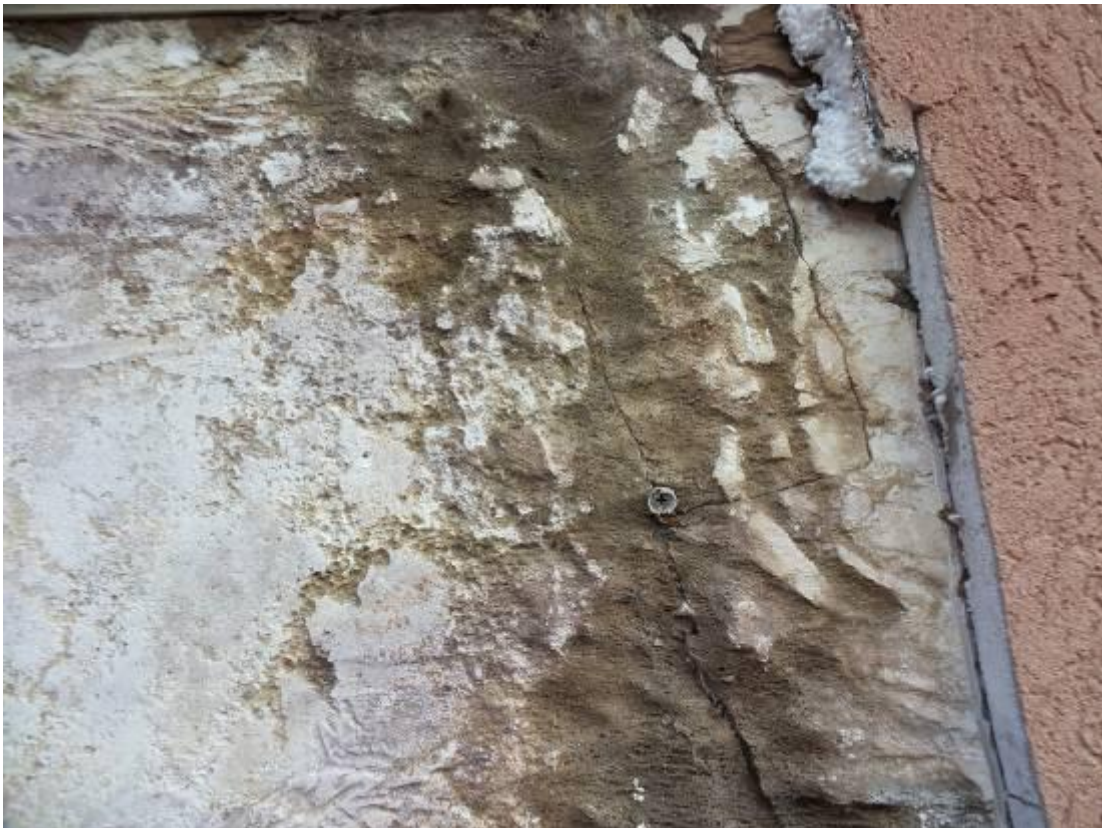
22. Opening 2 –the gypsum sheathing core was cracked and deteriorated.

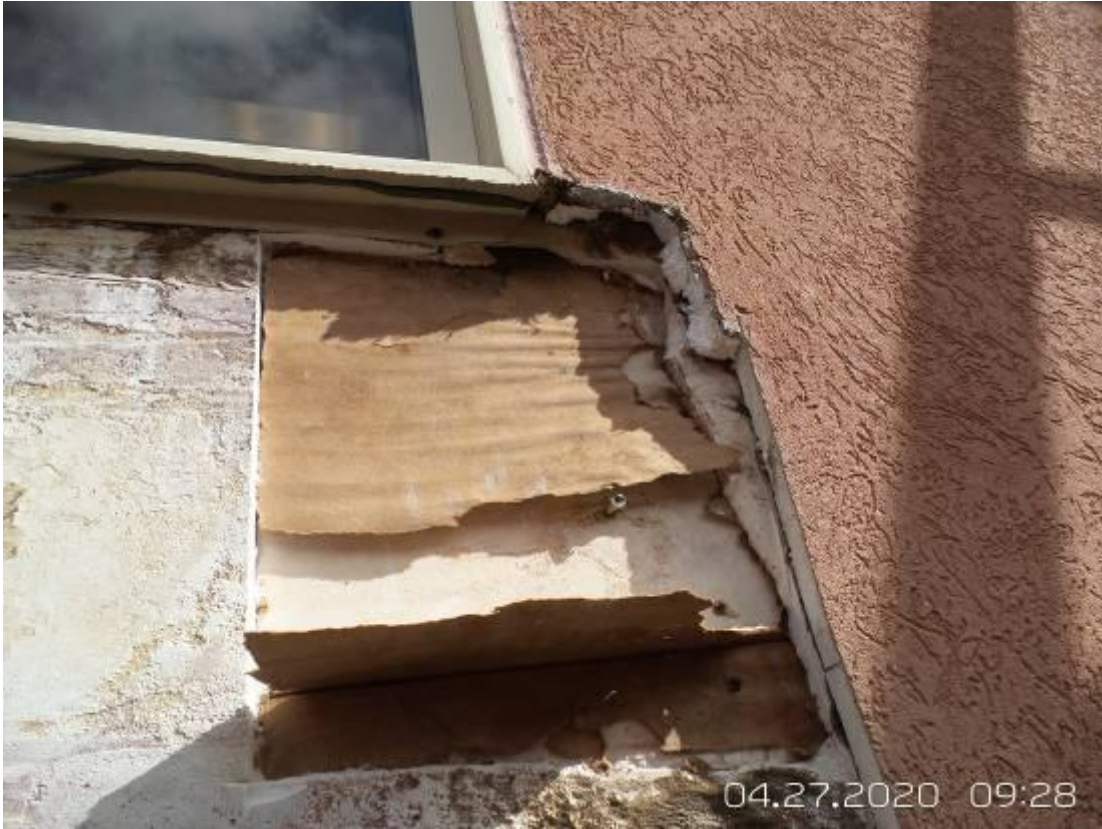
23. Opening 2 – the paper facer at the second layer of gypsum sheathing was delaminated.

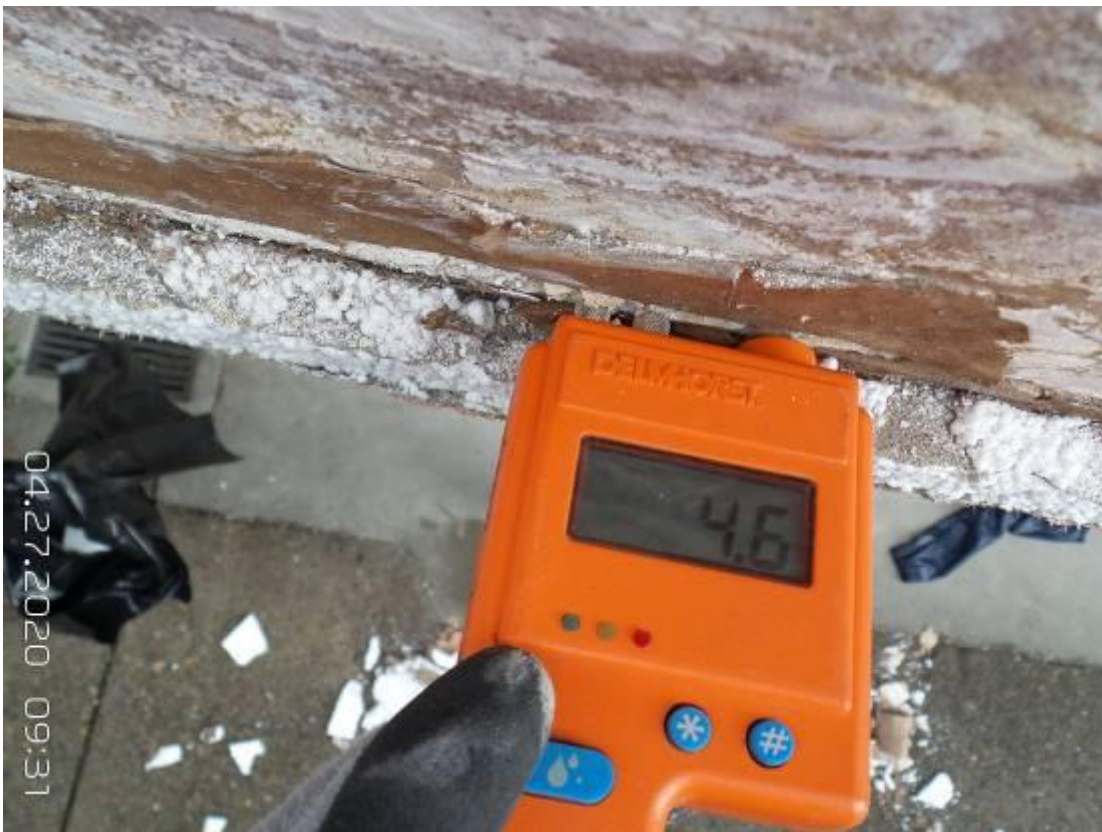
24. Opening 2 – moisture content readings of the gypsum sheathing were normal to wet (0.1% - 4.6%).

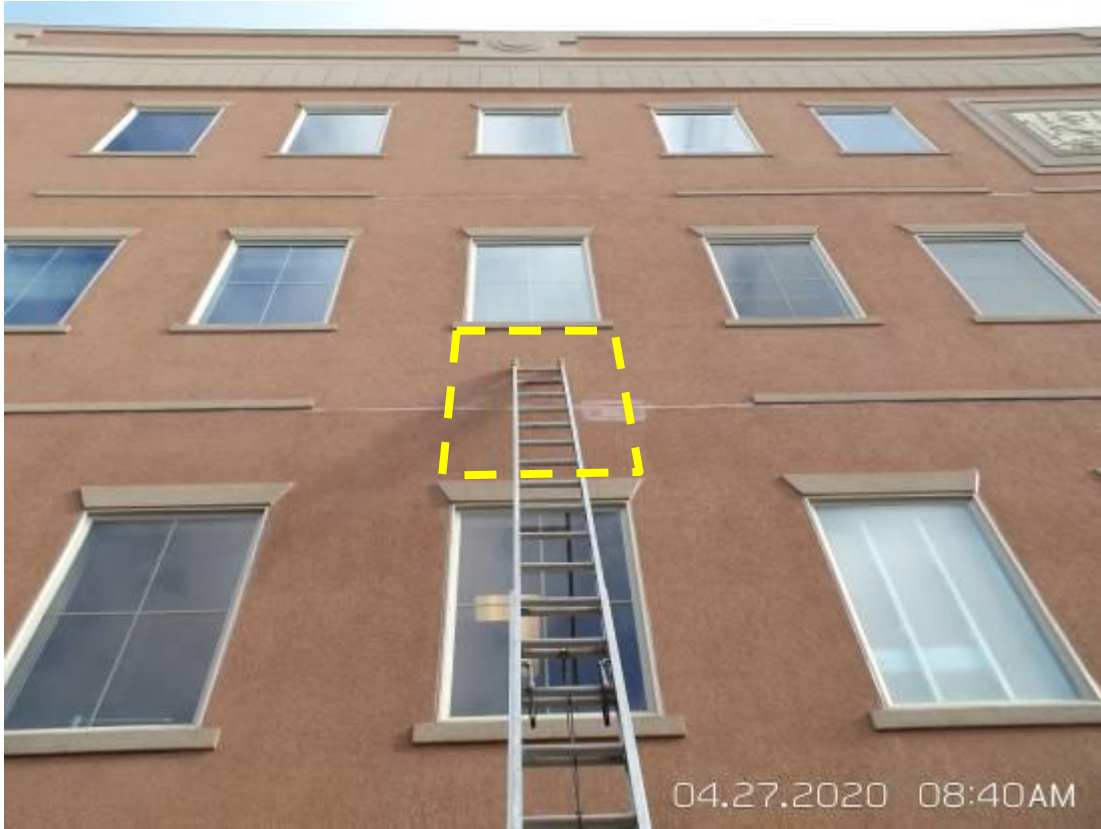
25. Opening 3 – remove cladding from third floor window sill to second floor window head.

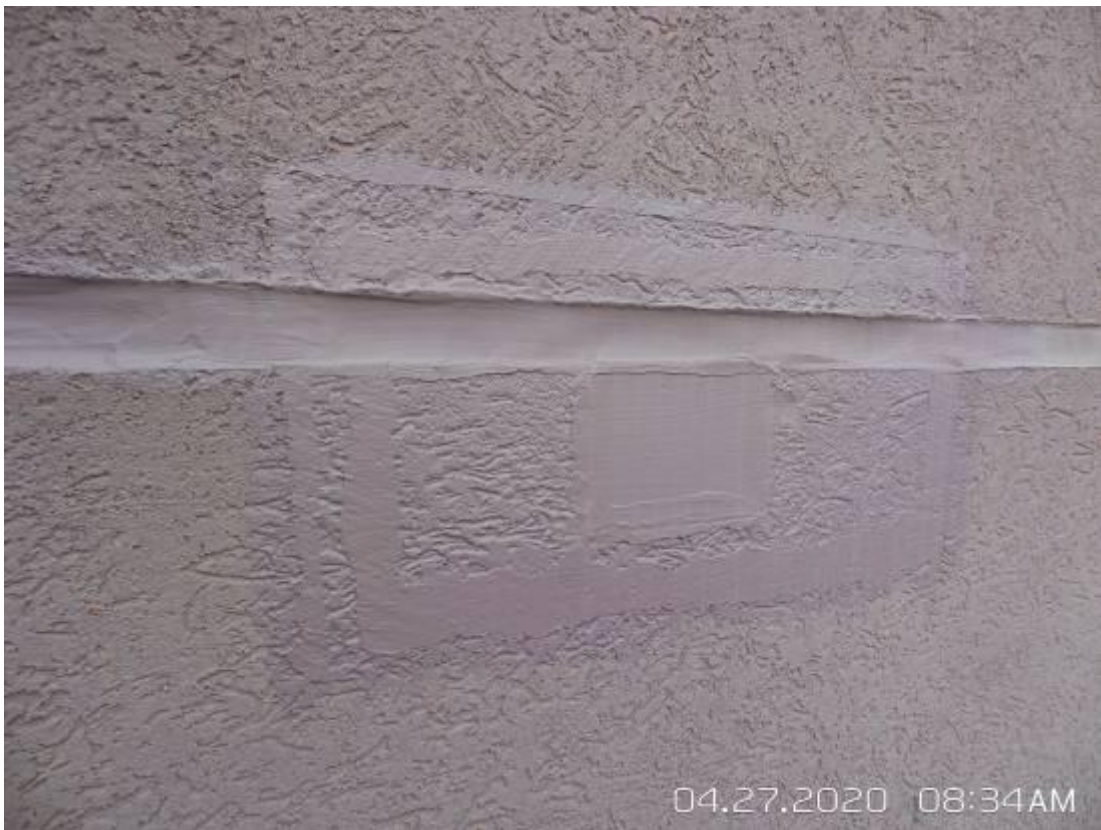
26. Opening 3 – previous repair observed at control joint between second and third floors.

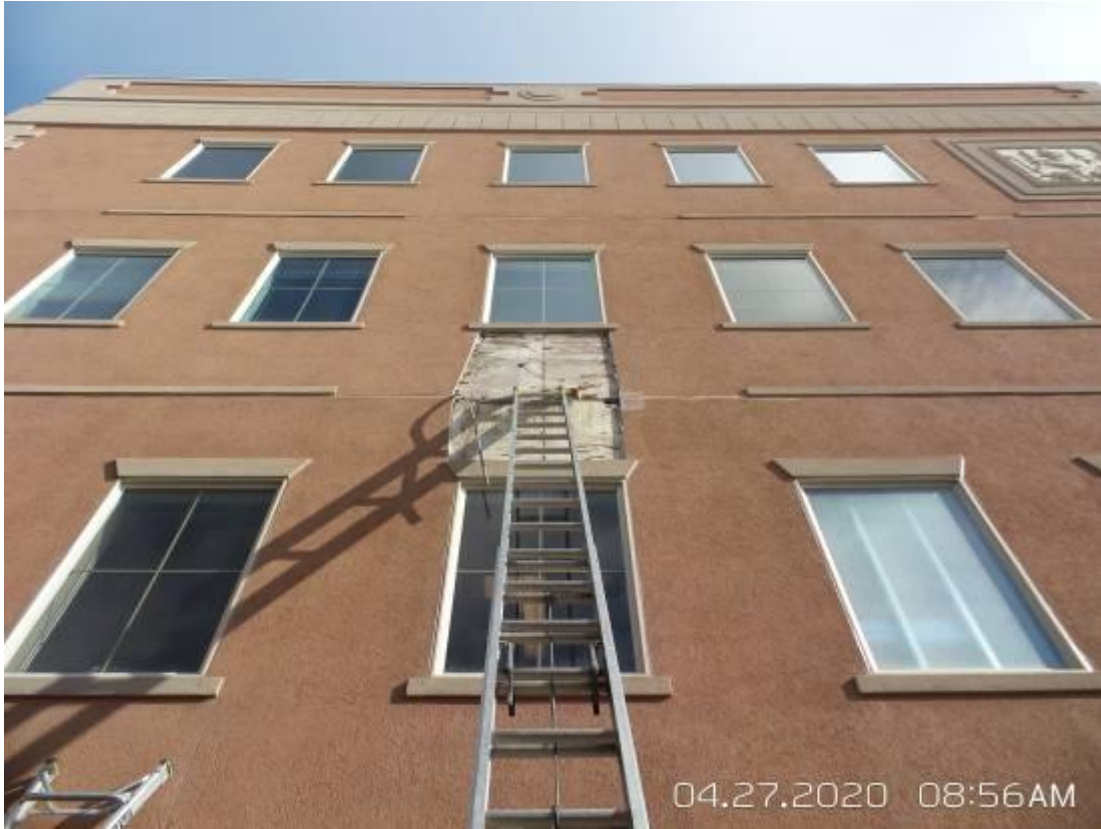
27. Opening 3 – gypsum sheathing was deteriorated across the opening area.

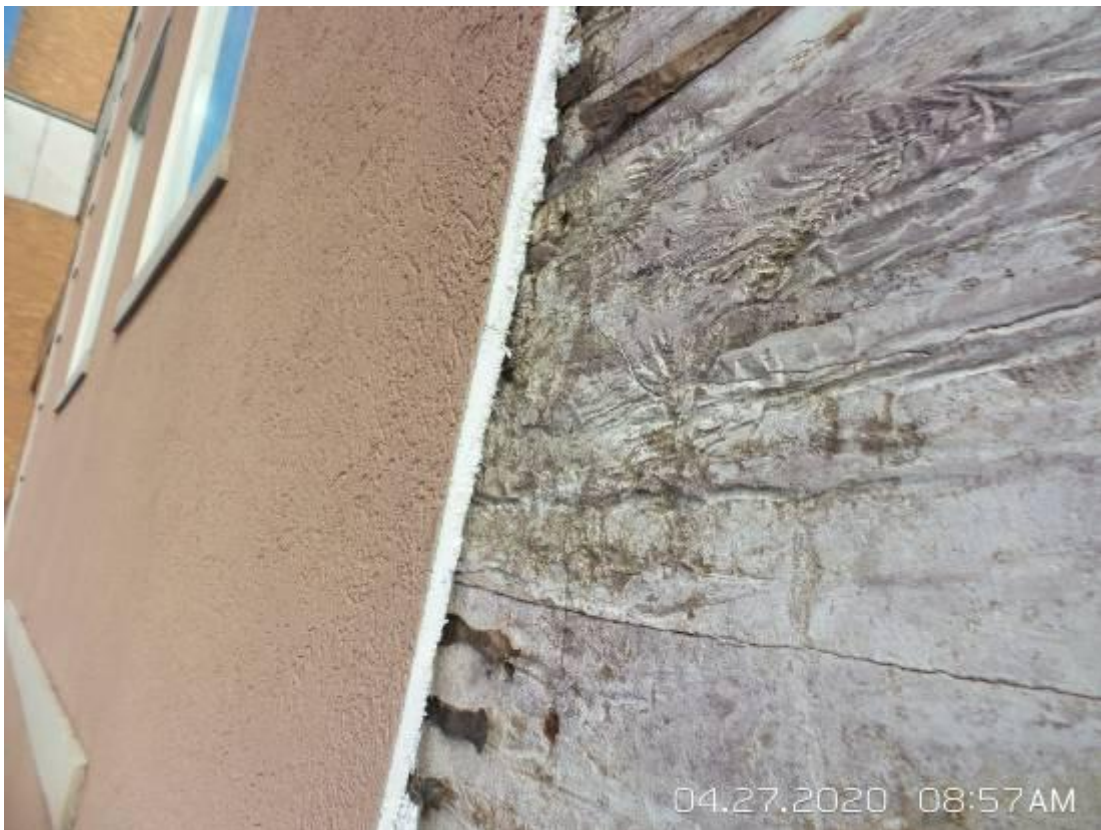
28. Opening 3 –the gypsum sheathing core was deteriorated.

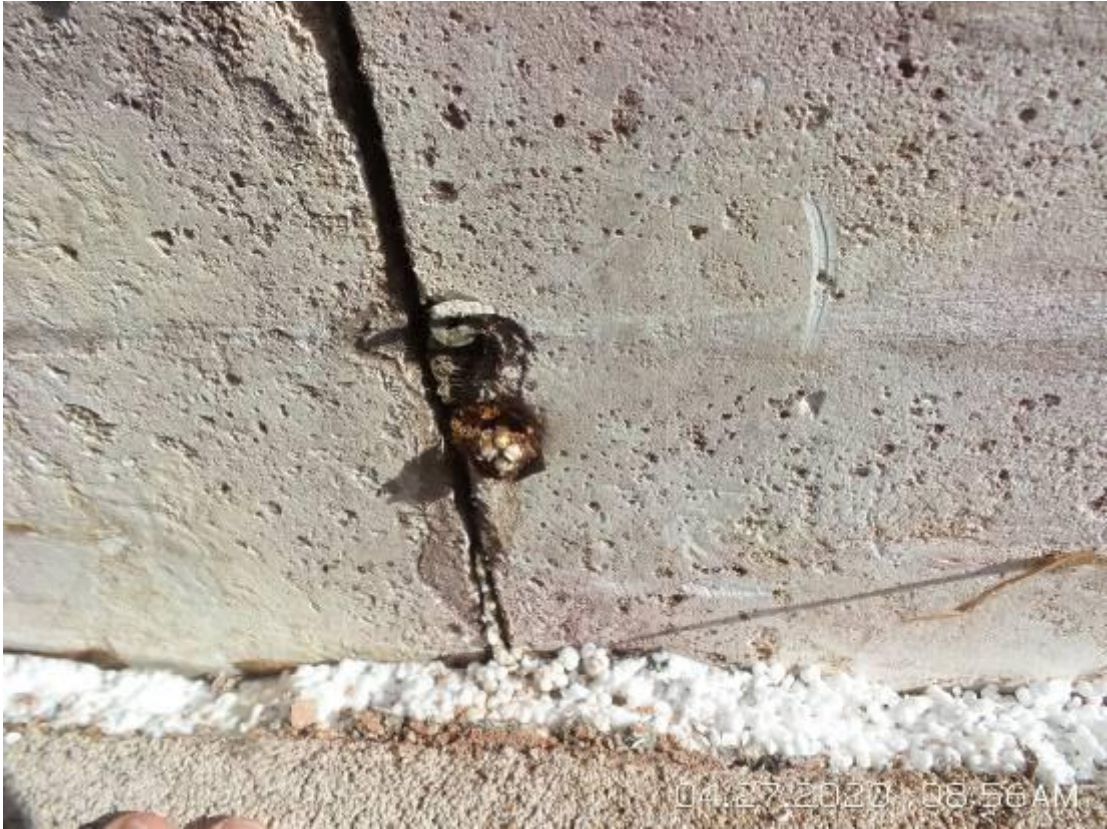
29. Opening 3 – corroded fasteners were observed across the opening.

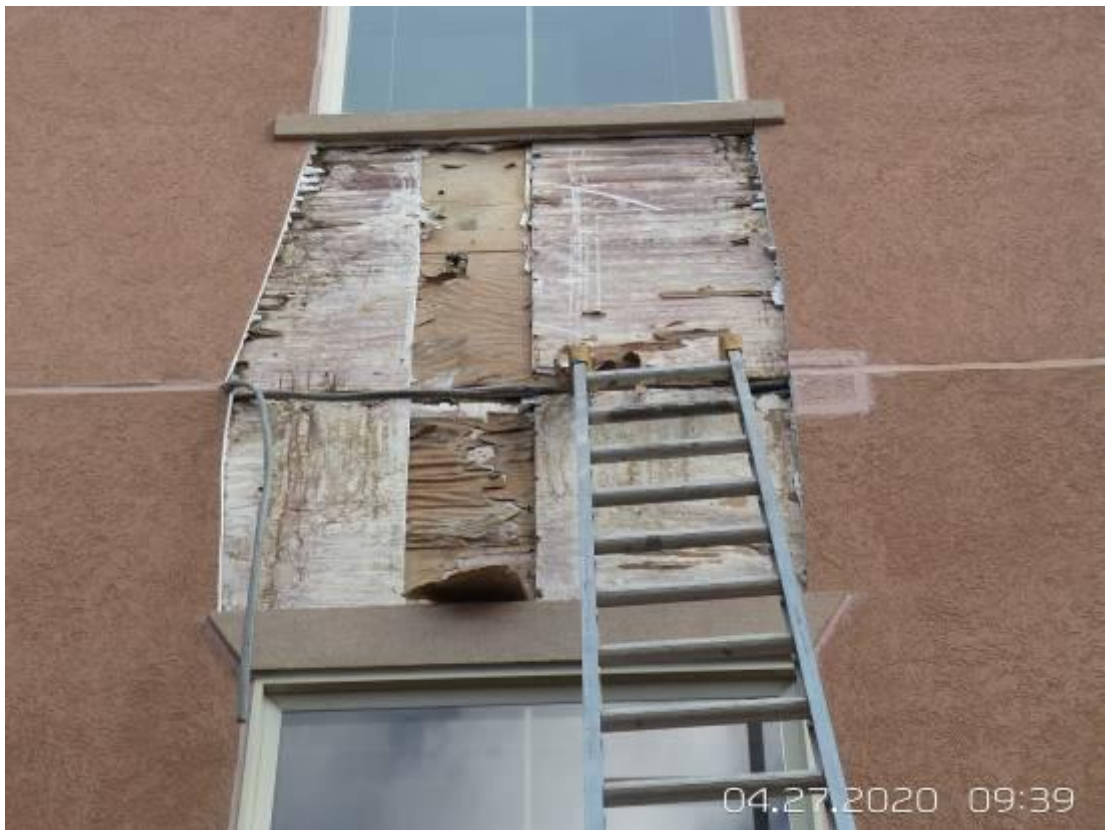
30. Opening 3 – the paper facer at the second layer of gypsum sheathing was delaminated

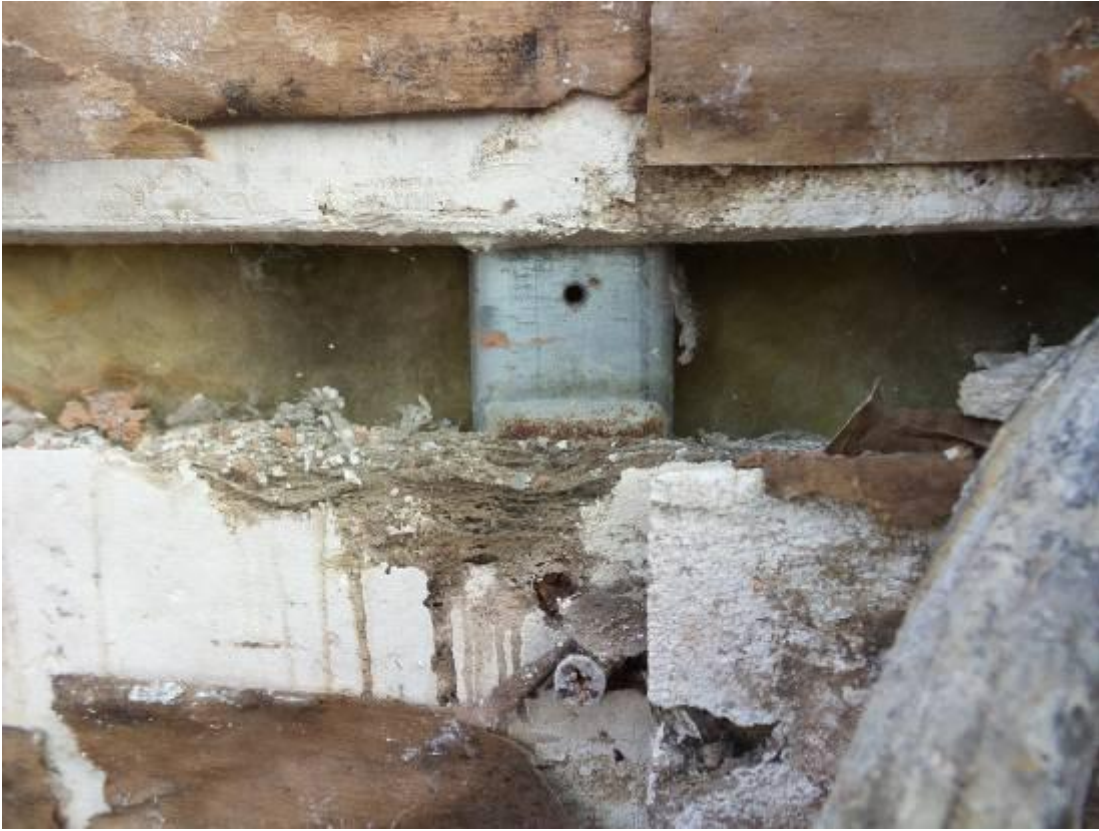
31. Opening 3 – surface corrosion of steel stud framing was observed.

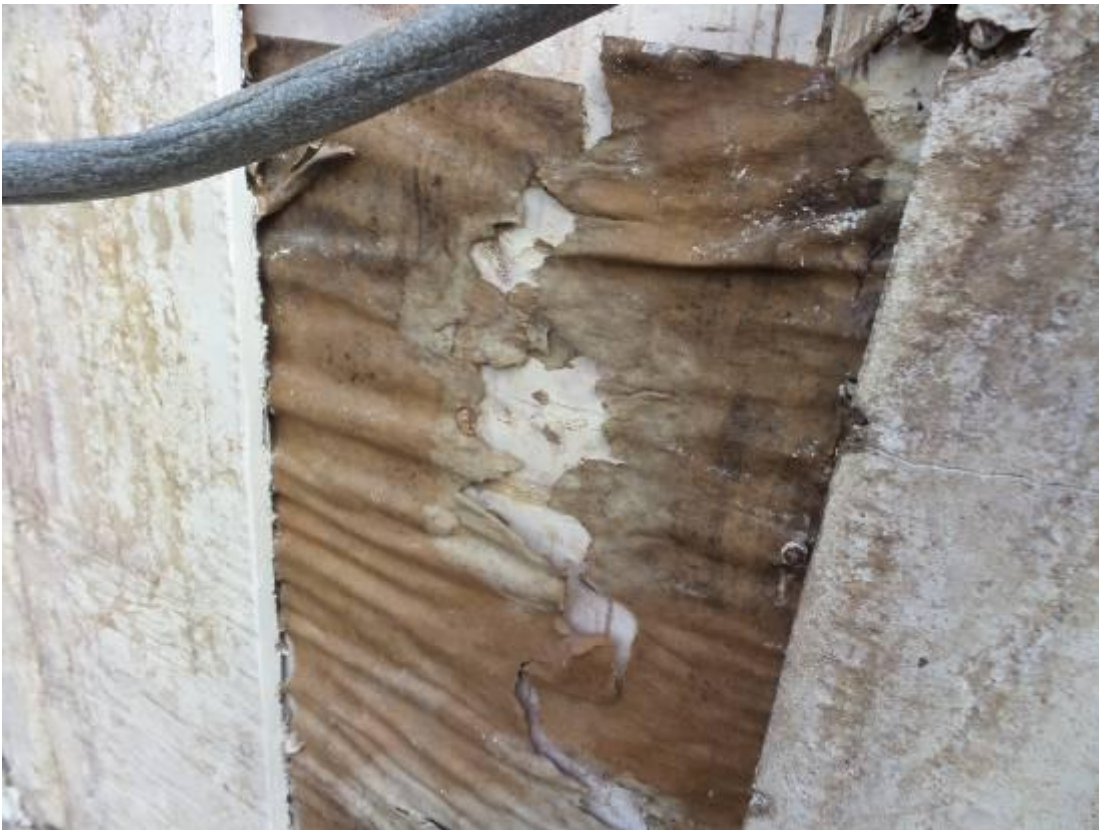
32. Opening 3 –the paper facer of the gypsum sheathing was delaminated and deteriorated.

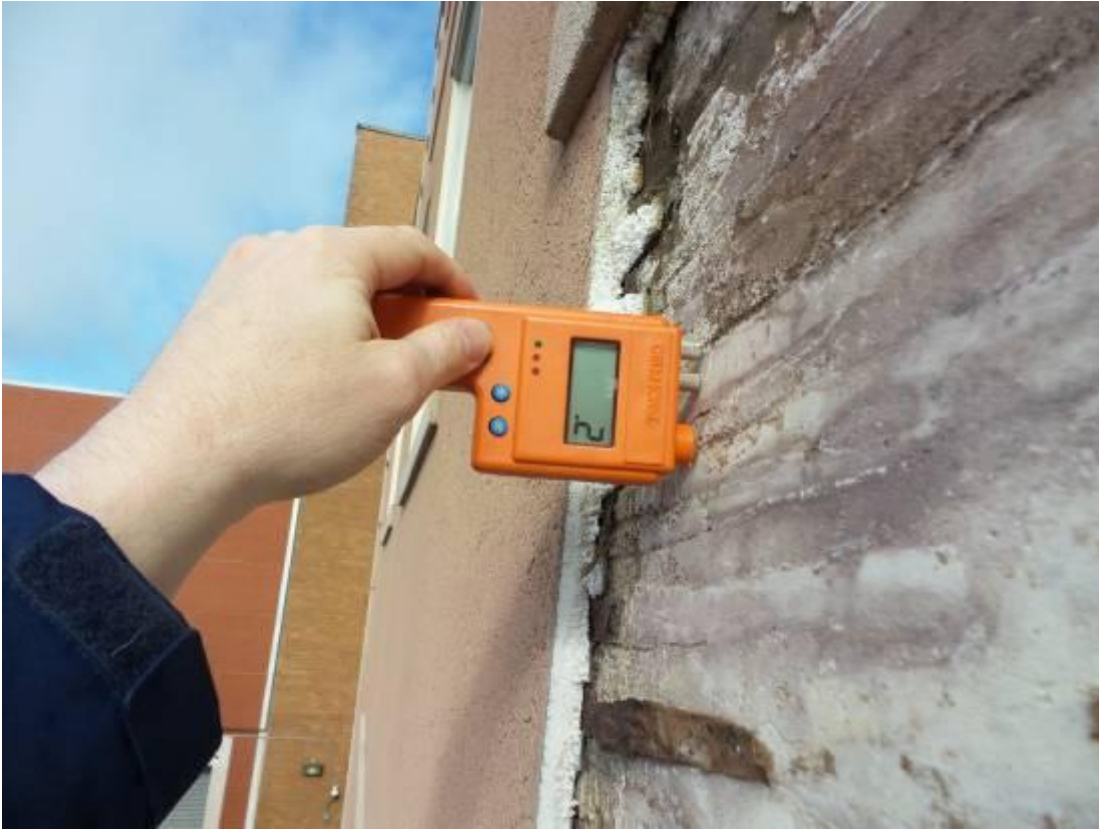
33. Opening 3 – moisture content readings of the gypsum sheathing were normal (0.1% - 0.2%).

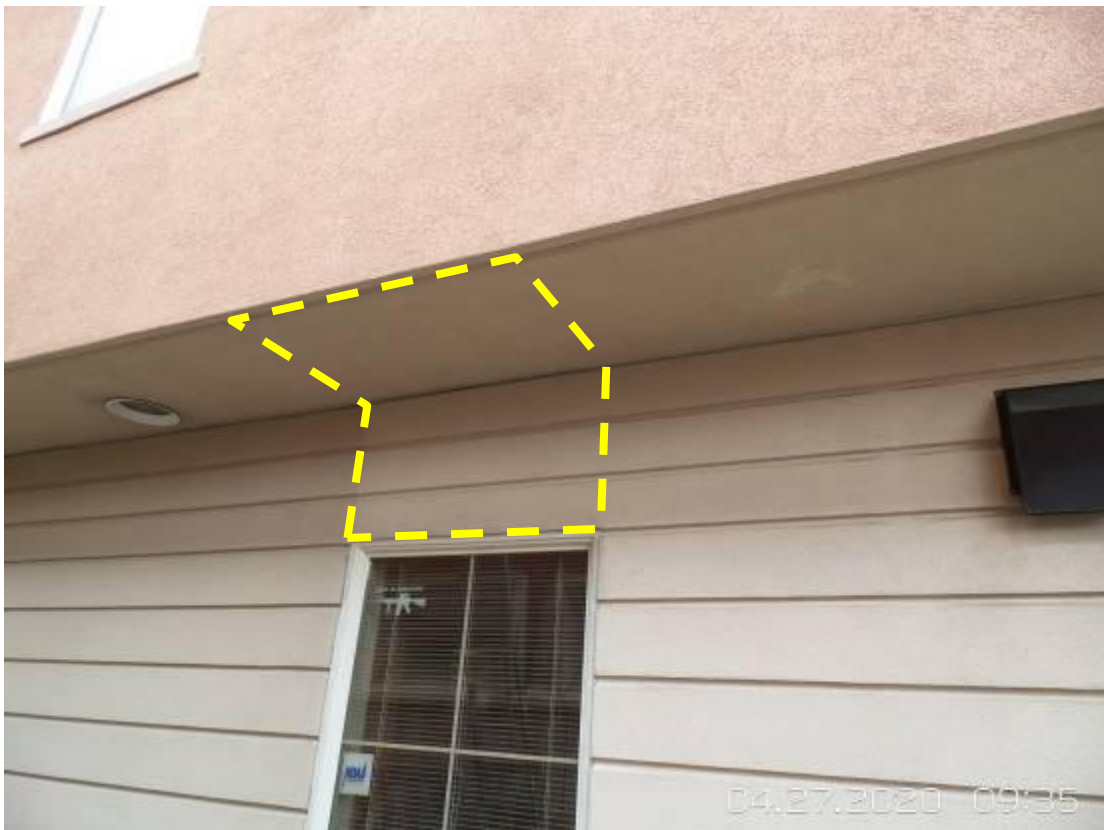
34. Opening 4 – remove cladding at window head and soffit.
