Madsen, Kneppers & Associates, Inc.

Construction Consultants & Engineers

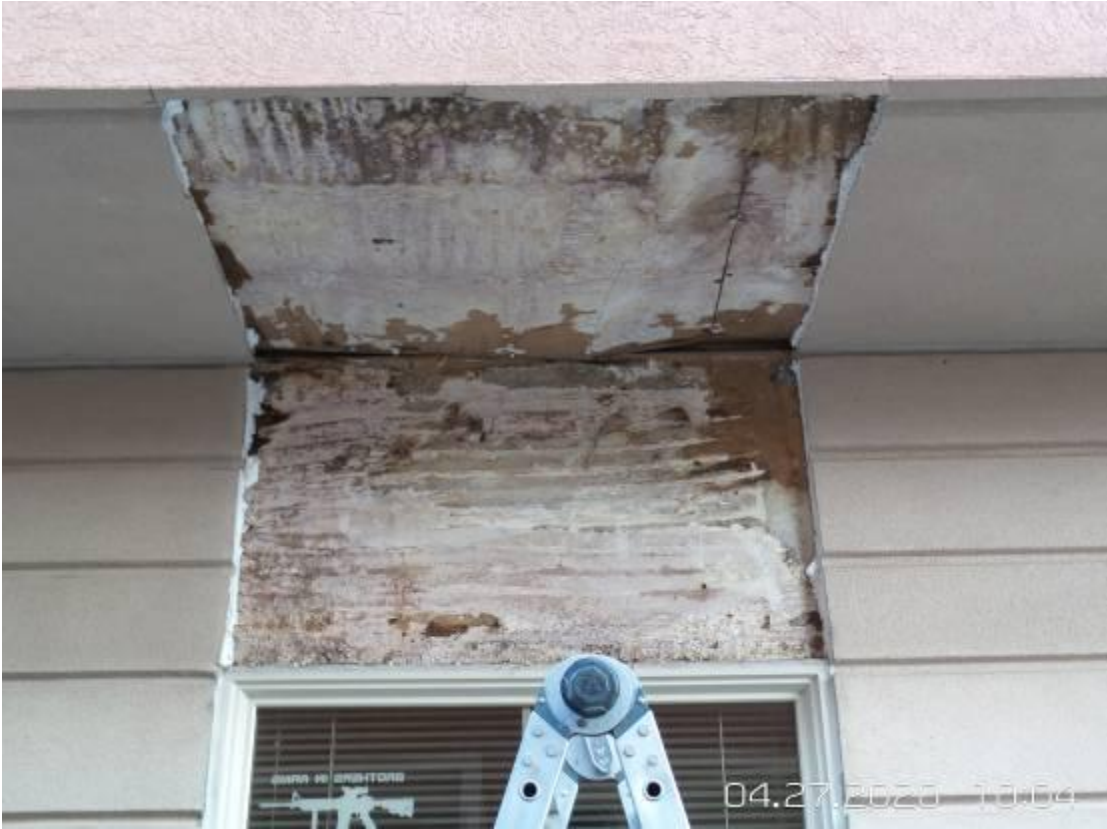
35. Opening 4 – gypsum sheathing was deteriorated and delaminated across opening.

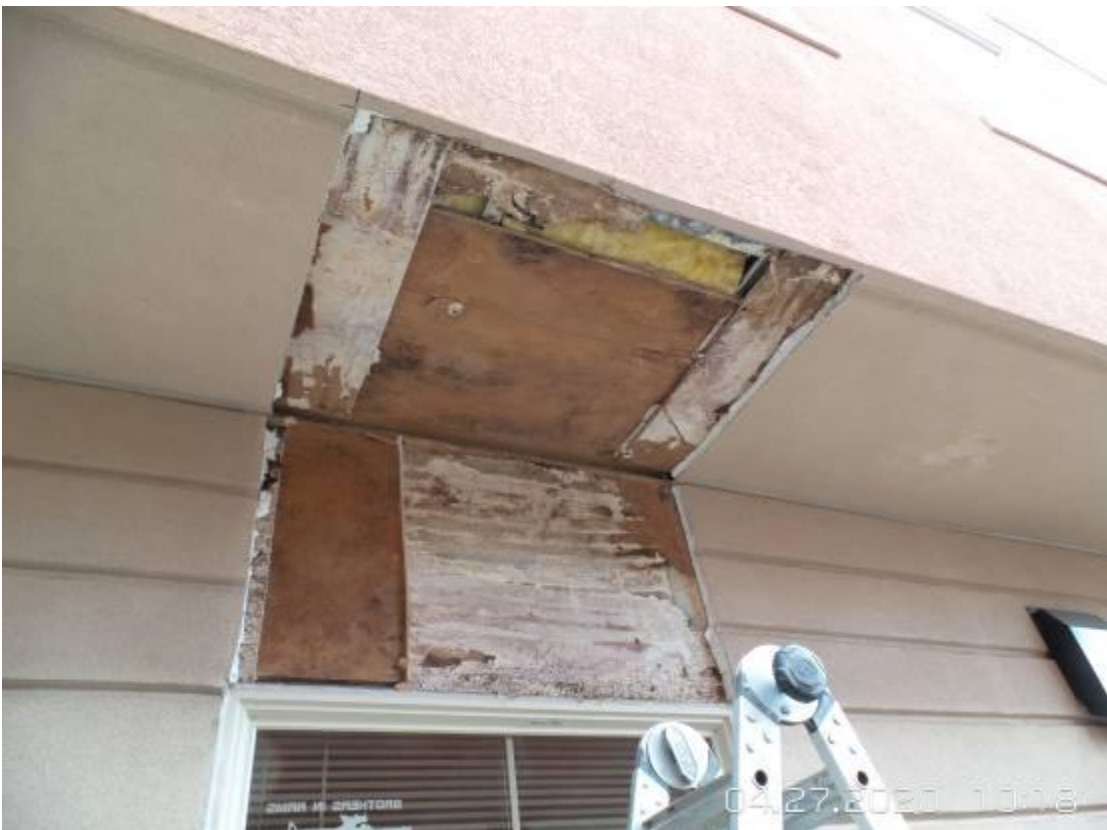
36. Opening 4 – staining of second layer of gypsum sheathing was observed.

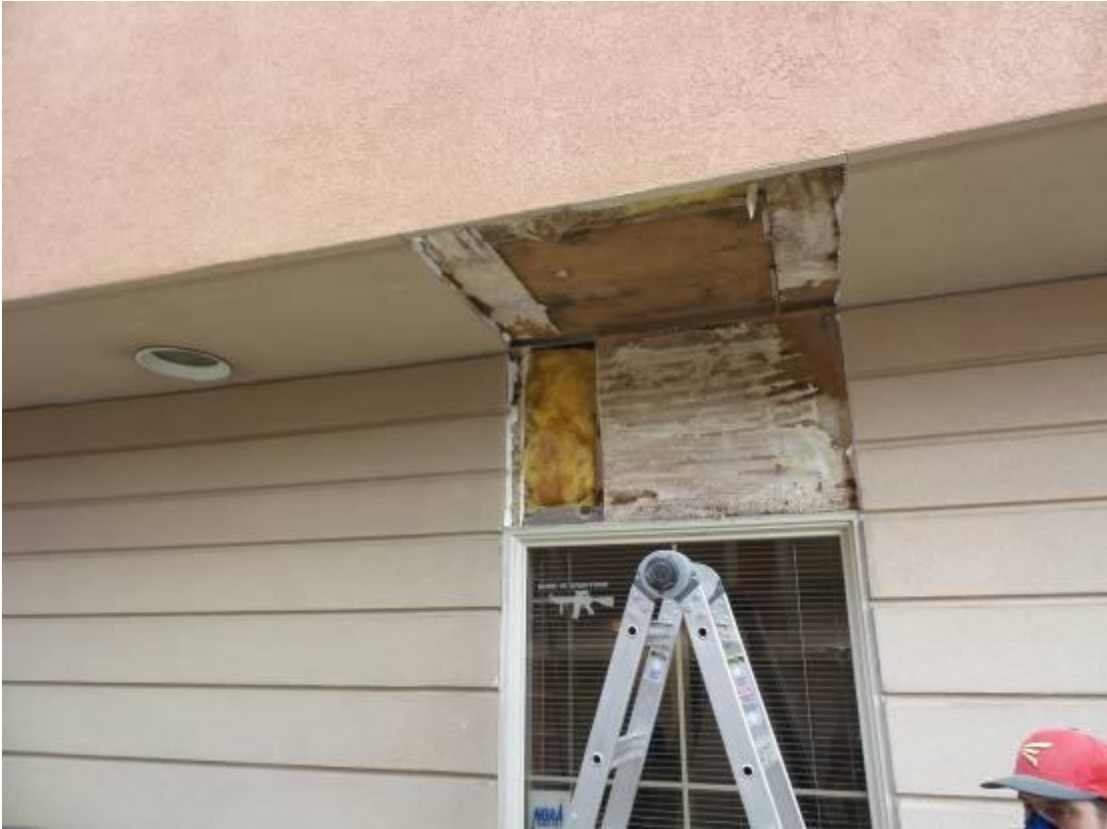
37. Opening 4 – second layer of gypsum sheathing was removed to observe wall cavity.

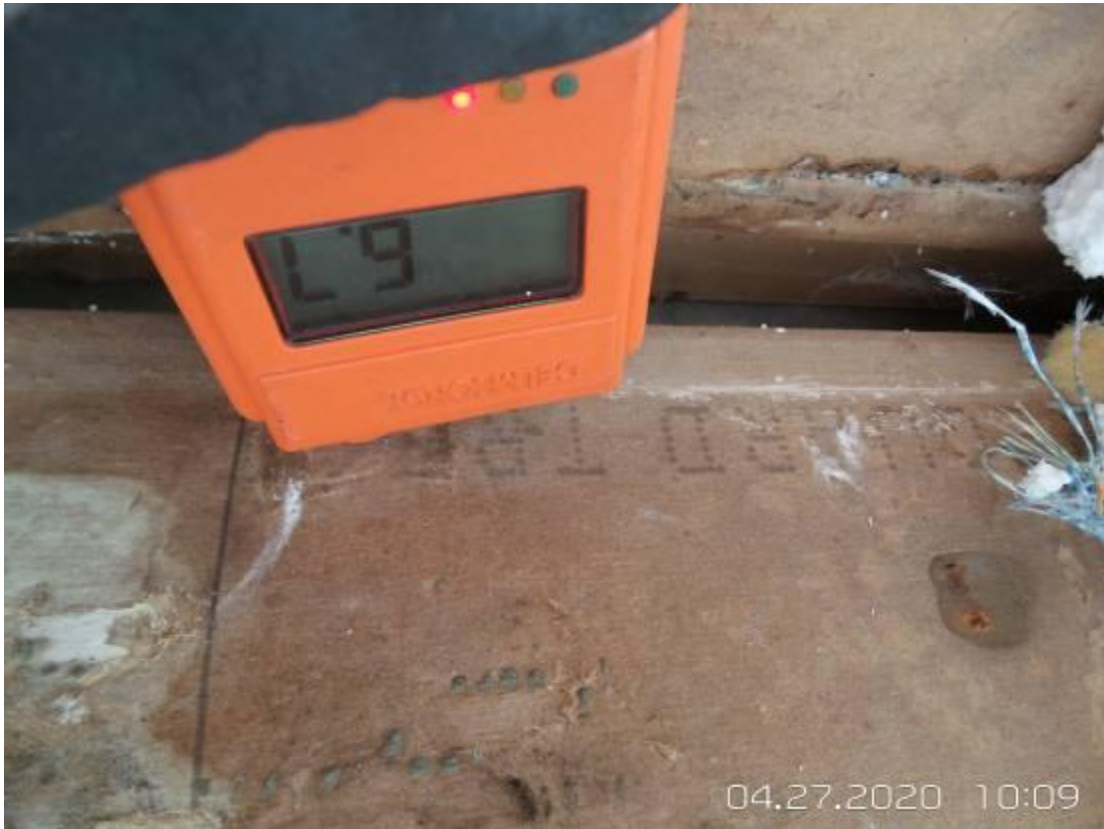
39. Opening 4 – moisture content readings of the gypsum sheathing were normal to wet (0.1% - 6.7%).

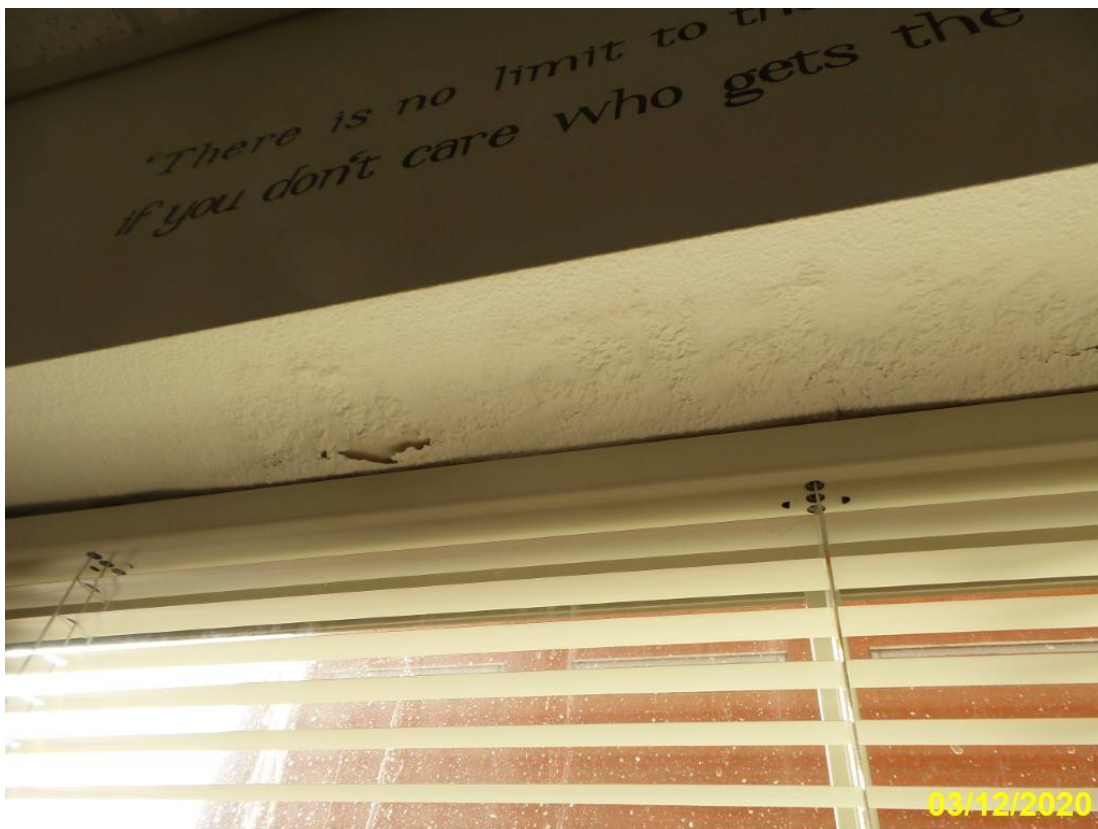
40. Opening 4 – staining and peeling paint at the interior finish above window head.

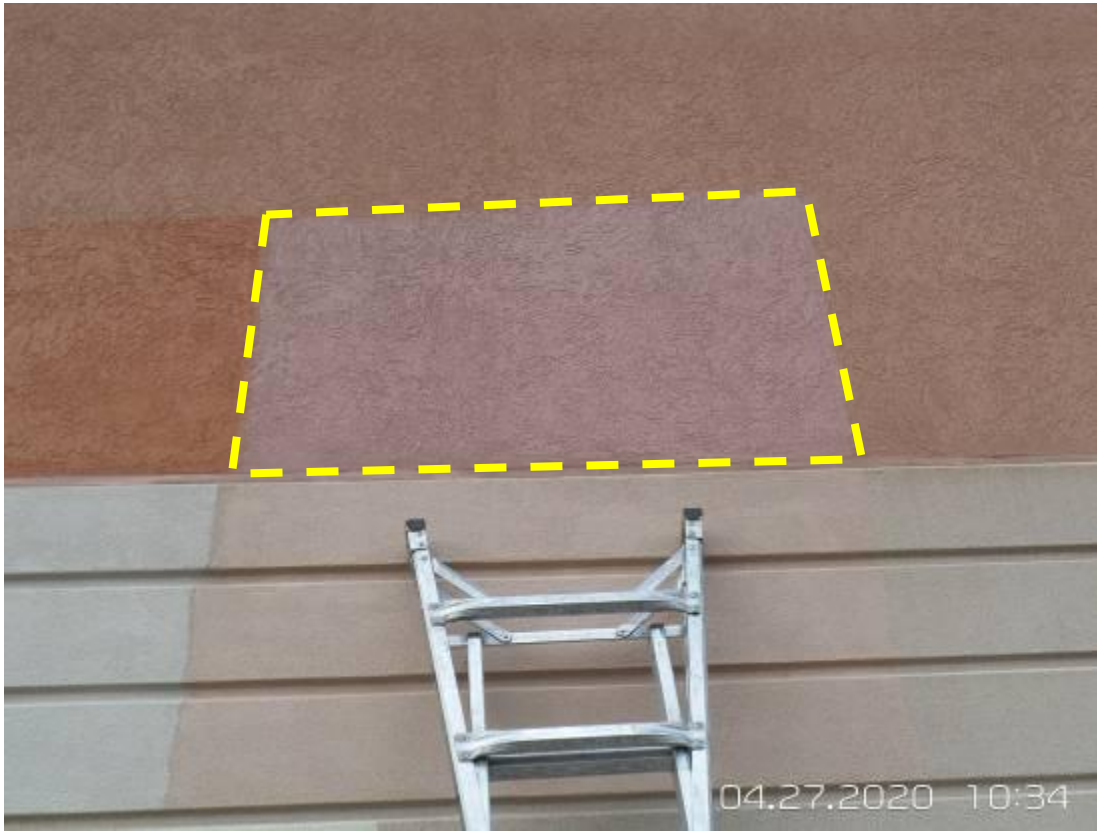
41. Opening 5 – remove 2'x2' section of cladding in the field of wall.

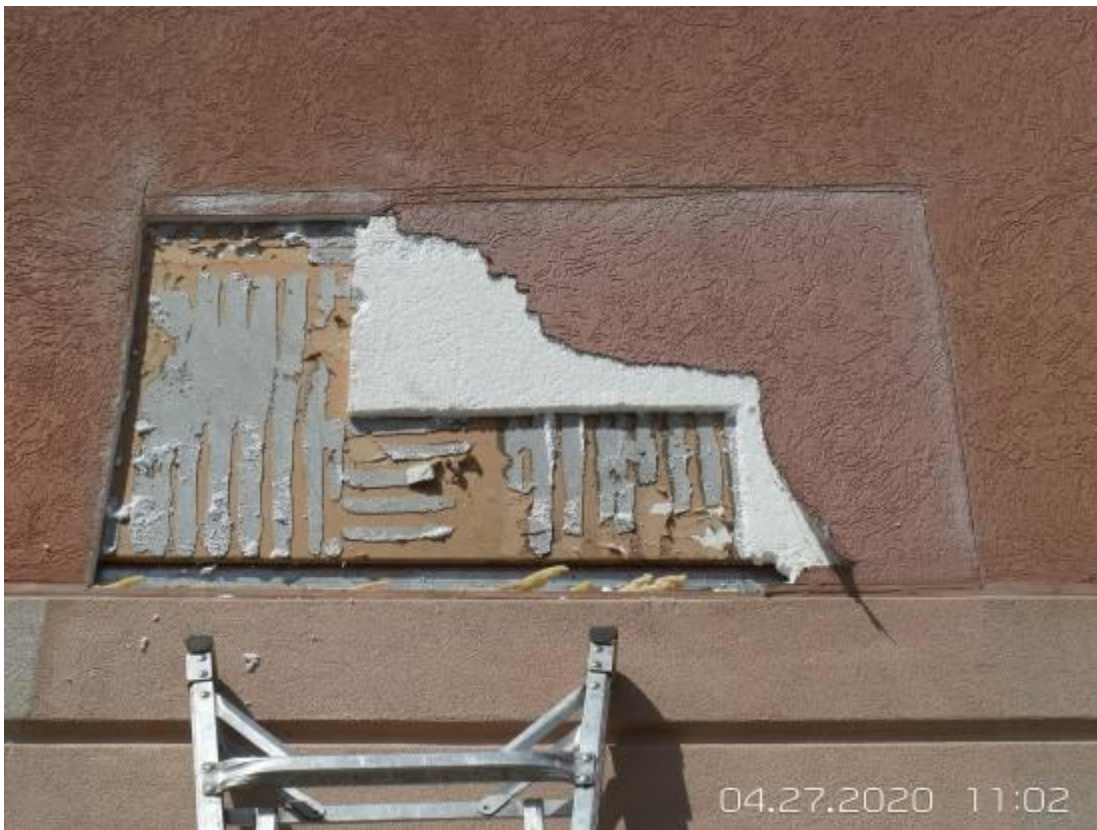
42. Opening 5 – insulation board was adhered to gypsum sheathing, no deterioration of the gypsum sheathing was noted at the opening.

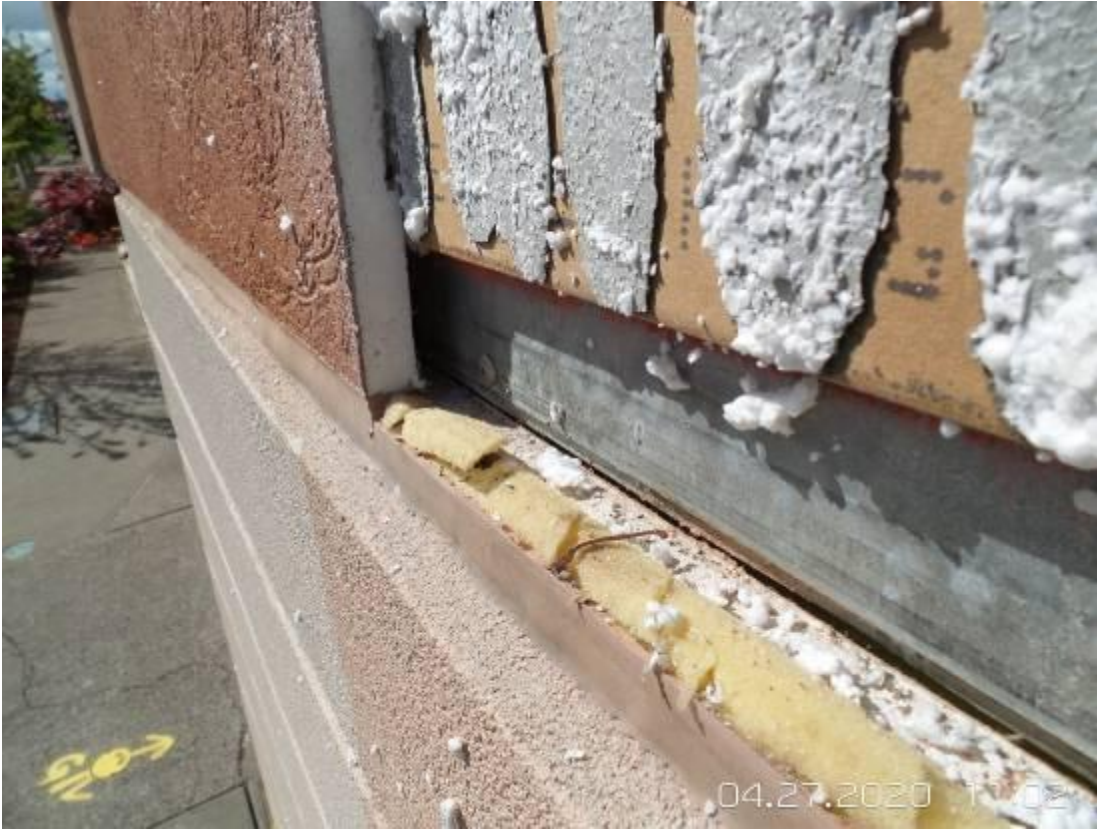
43. Opening 5 – no corrosion was observed on the steel stud framing.

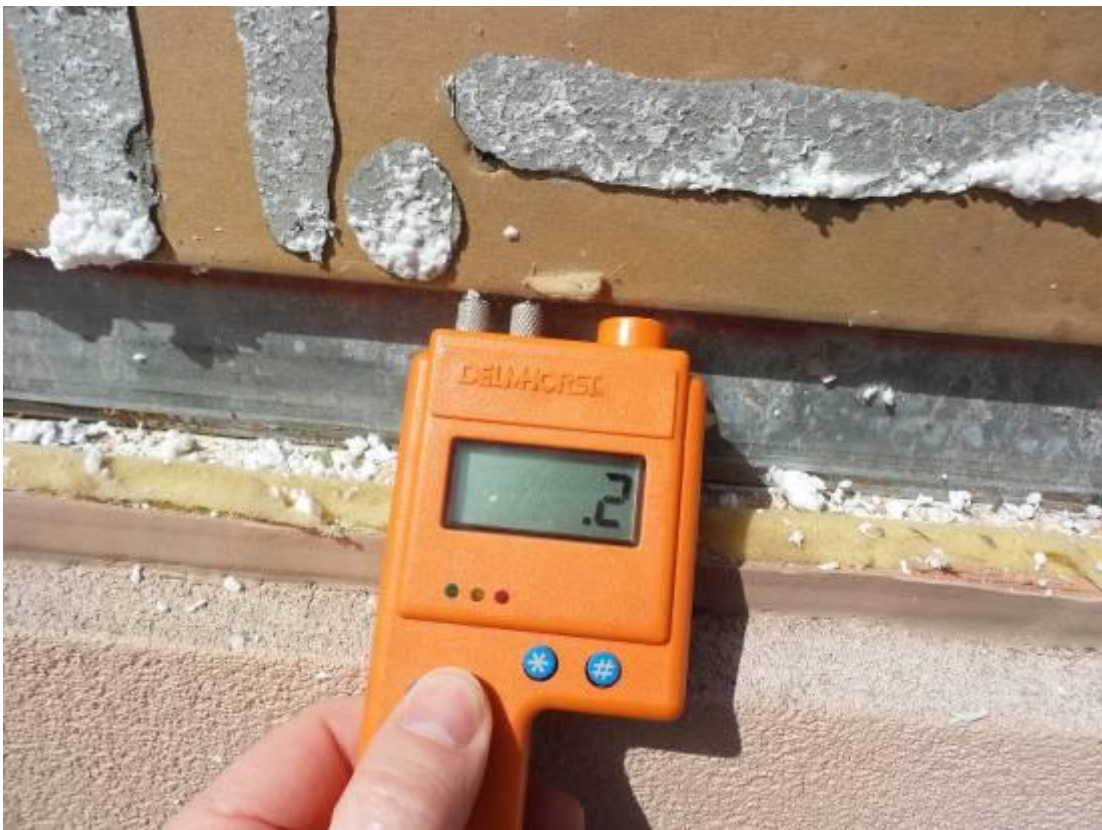
44. Opening 5 – moisture content readings of the gypsum sheathing were normal (0.1% - 0.2%).

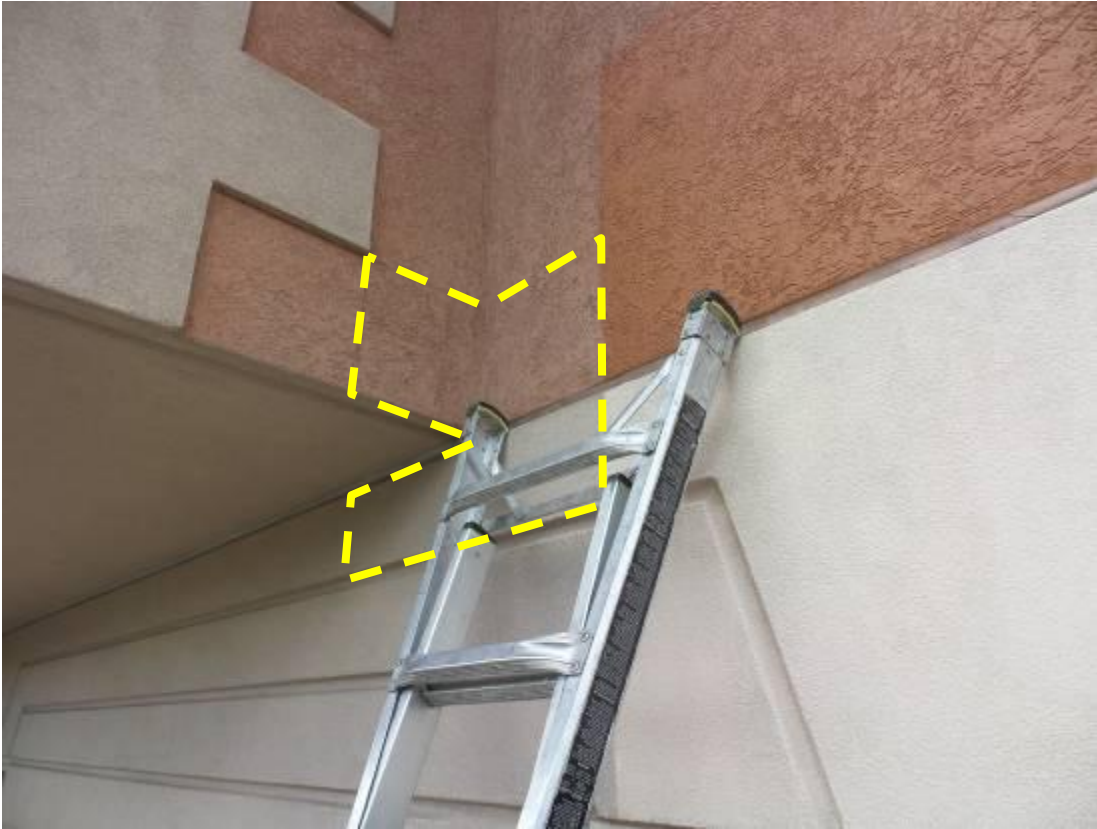
45. Opening 6 – remove cladding at inside corner and below soffit.

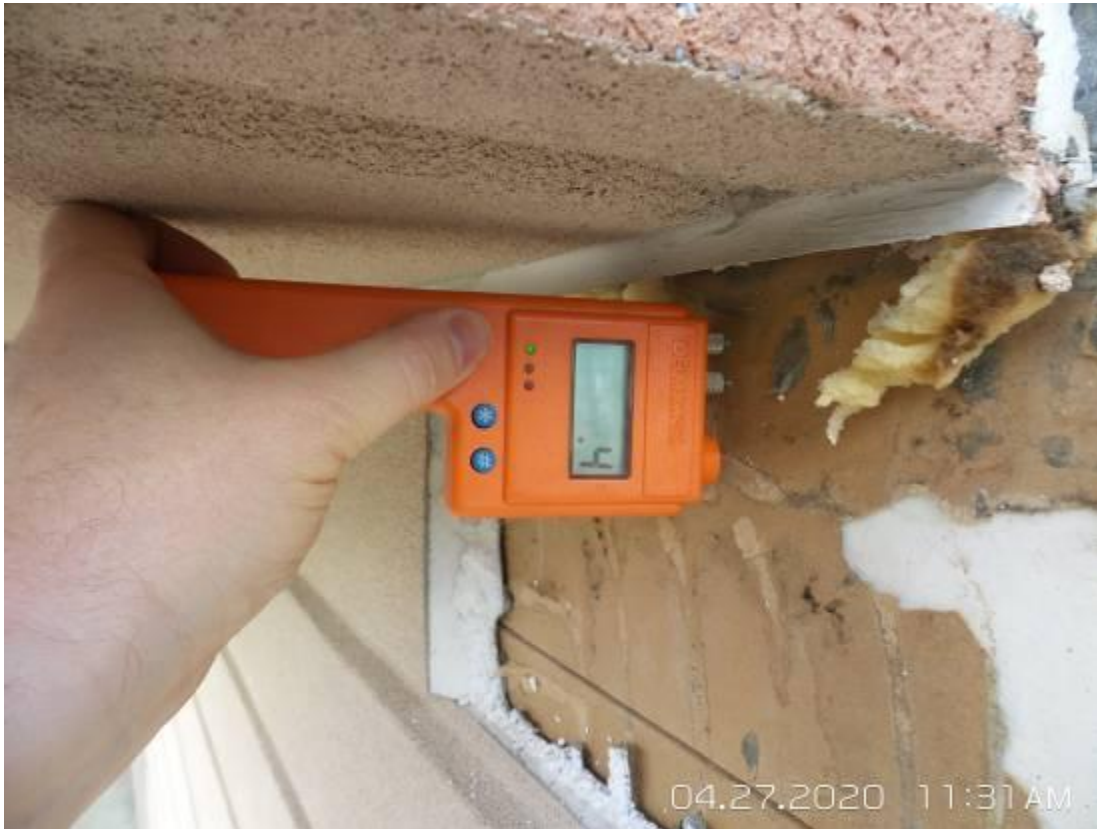
49. Opening 6 – moisture content readings of the gypsum sheathing was normal (0.2% - 0.4%).

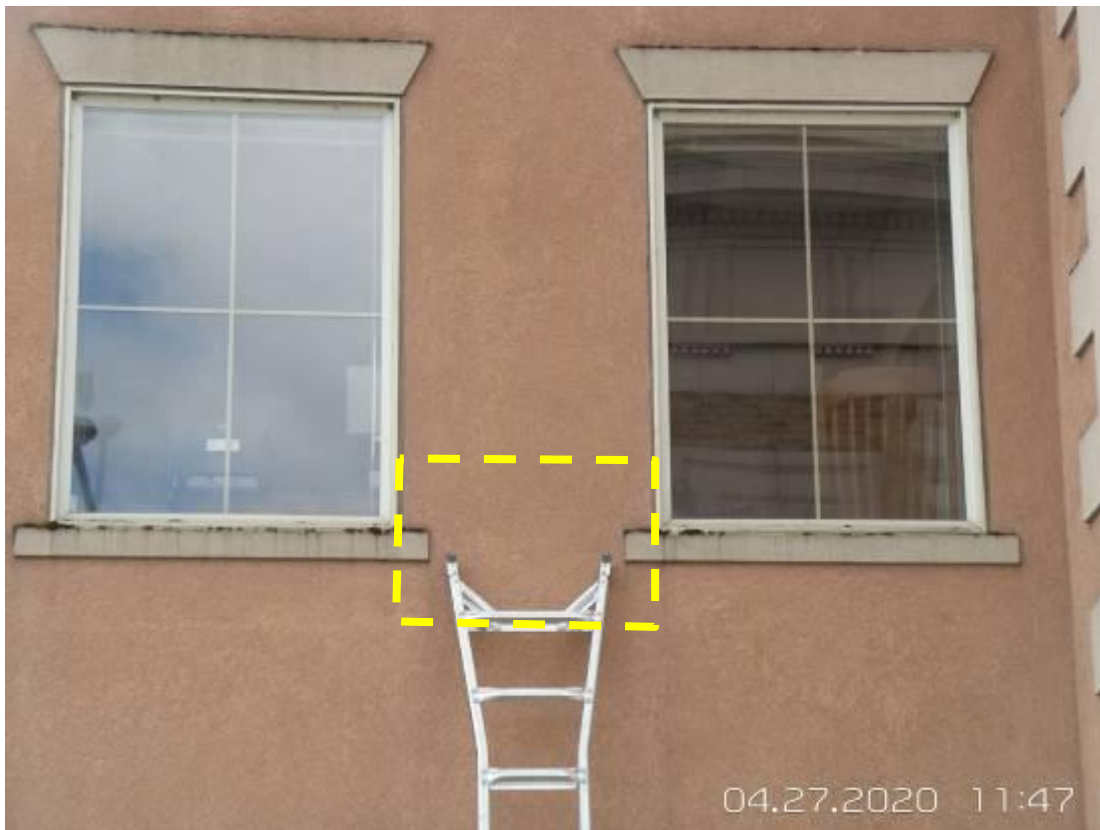
50. Opening 7 – remove cladding between windows.

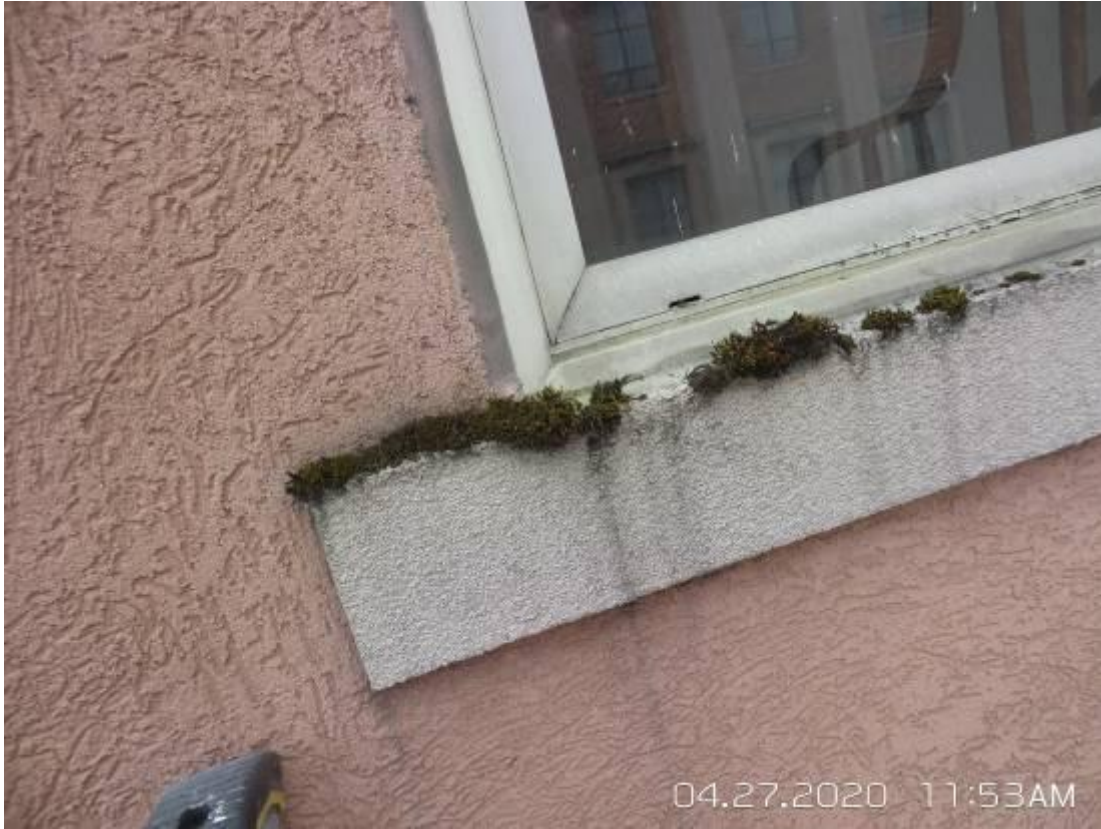
51. Opening 7 – organic growth observed on all horizontal trim accents.

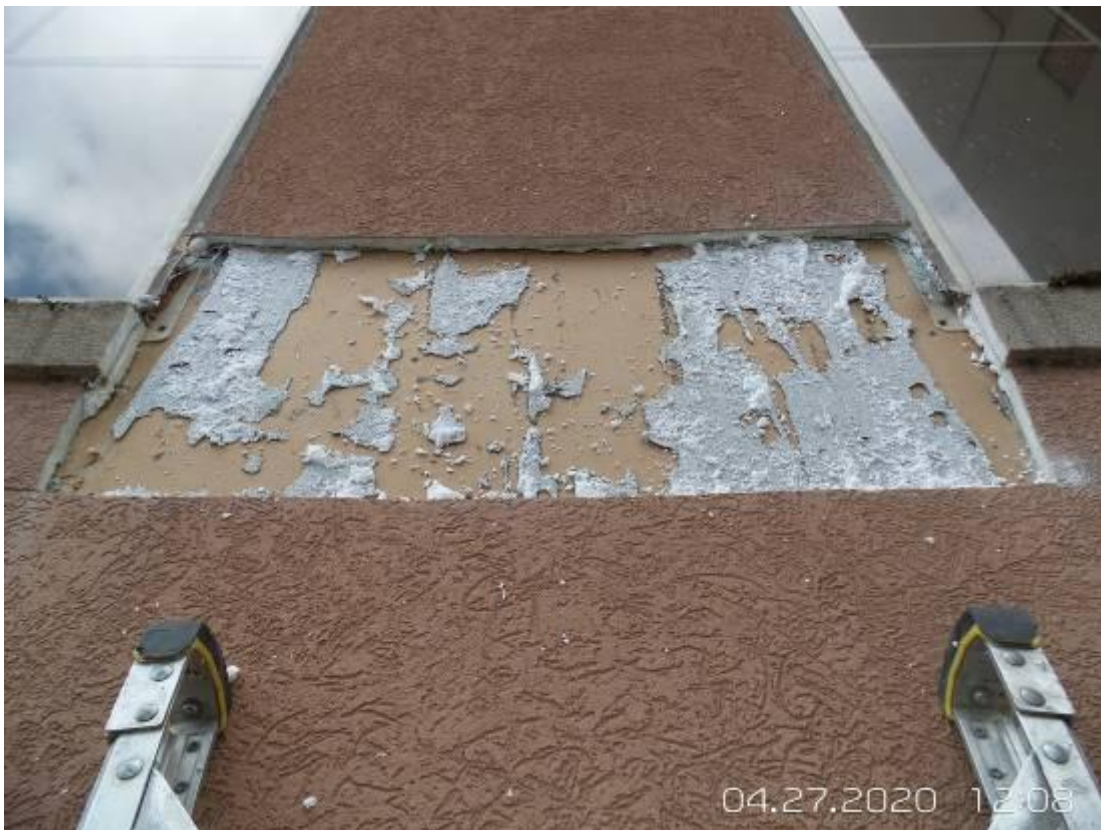
52. Opening 7 – delamination of gypsum sheathing was not observed.

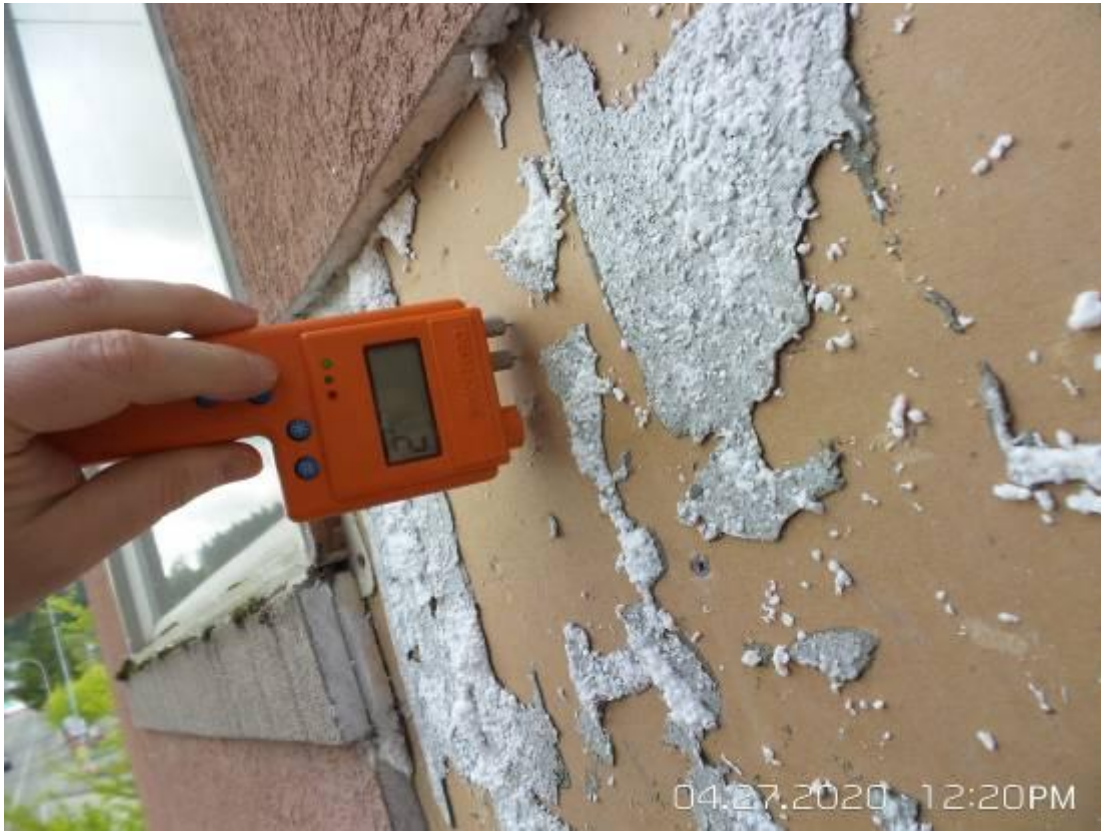
53. Opening 7 – moisture content readings of the gypsum sheathing were normal (0.1% - 0.2%).

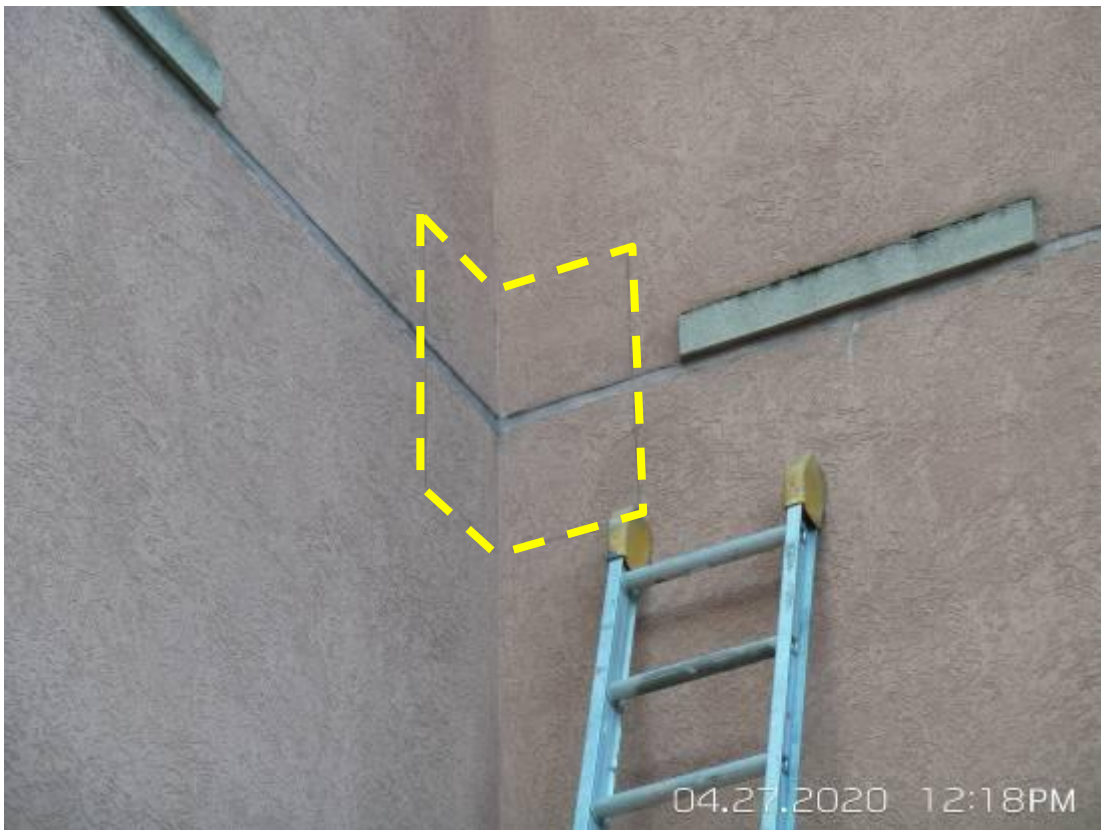
54. Opening 8 – remove cladding from inside corner at control joint.

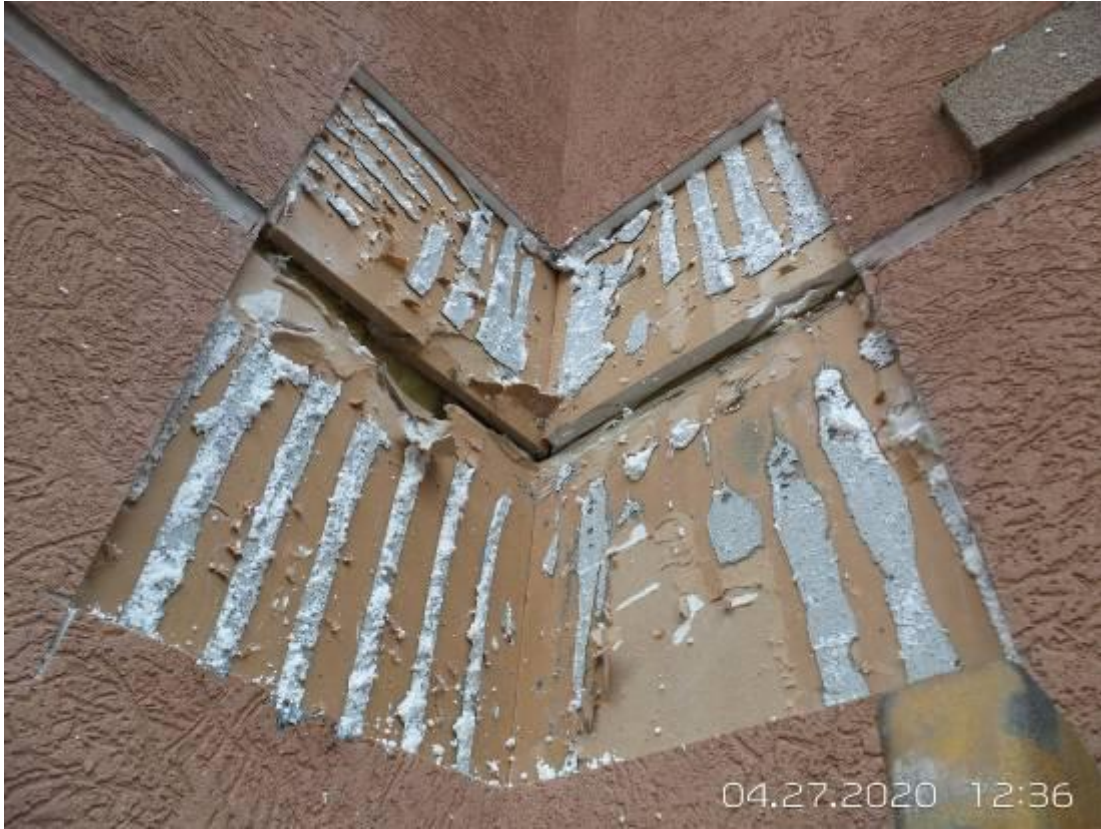
55. Opening 8 – no delamination or deterioration of the gypsum sheathing was observed.

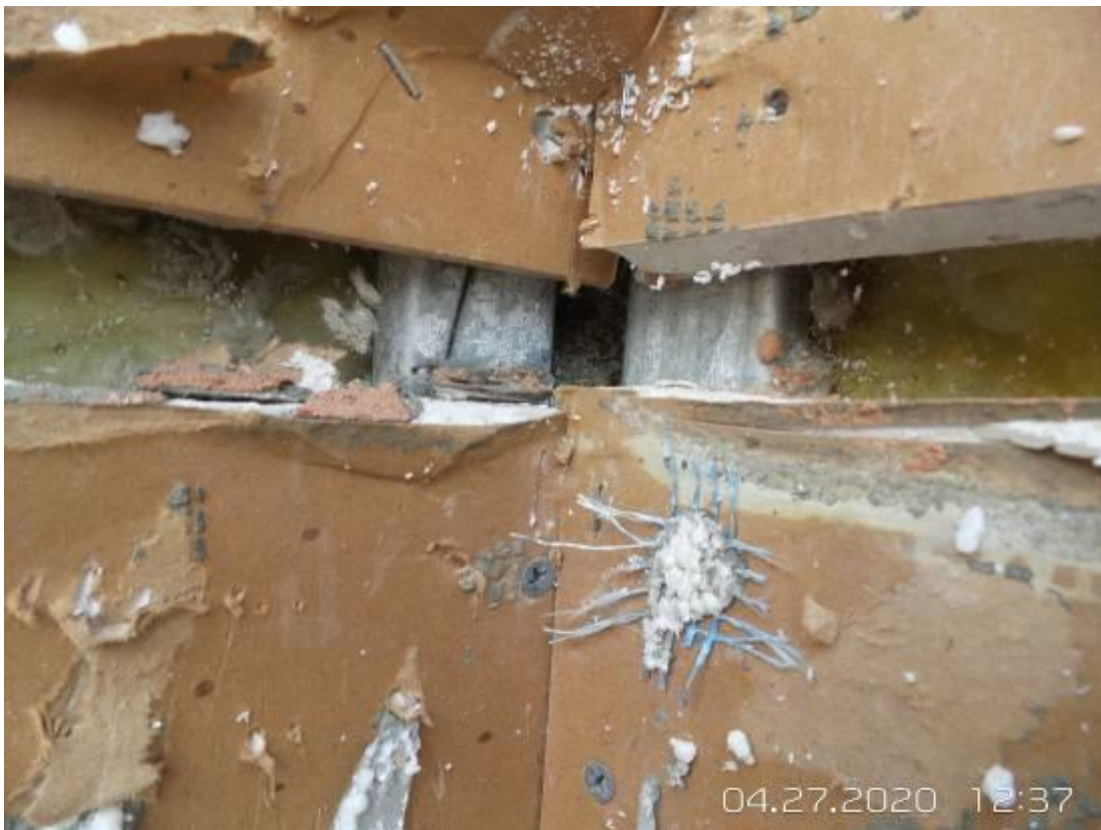
56. Opening 8 – no corrosion of steel stud framing was observed.

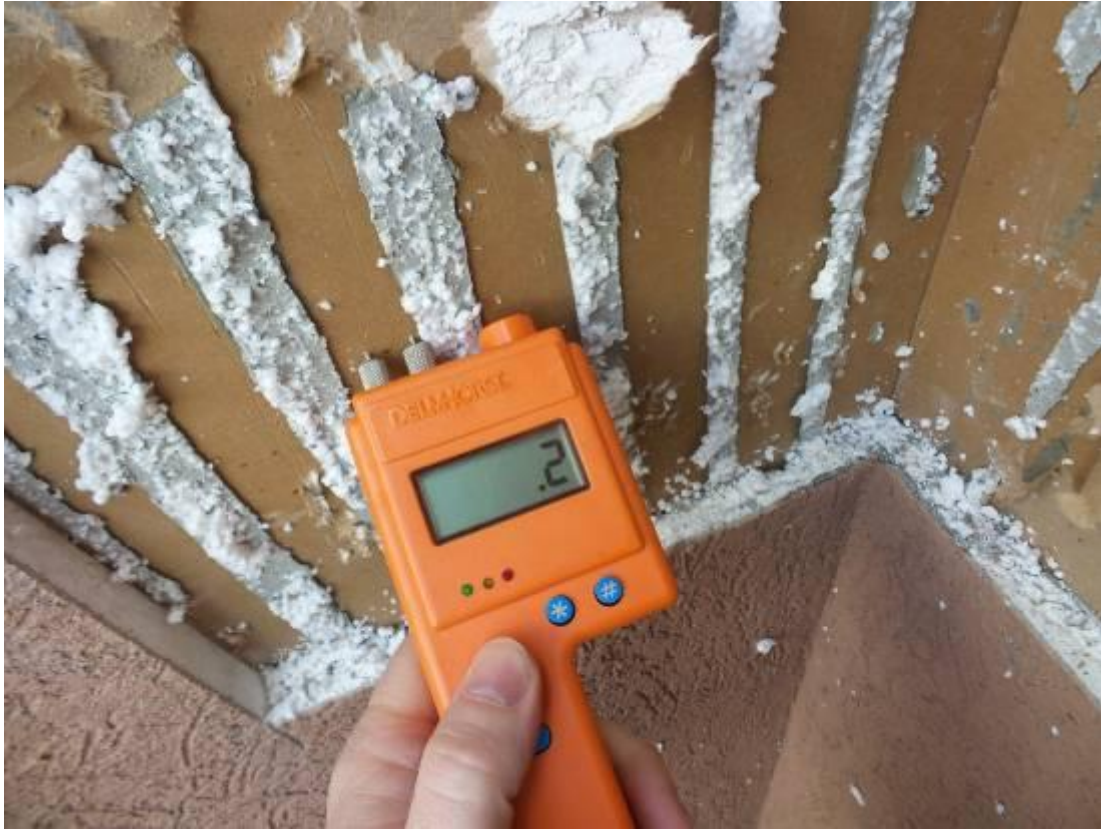
57. Opening 8 – moisture content readings of the gypsum sheathing were normal (0.1% - 0.2%).
