Geotechnical Inspection Report

FIELD REPORT

Report # 021018TB-1

DATE: February 10, 2018
PROJECT: Hamilton Excavating QC
LOCATION: Vader Hwy. 506 Pit
PROJECT # 180008
PERMIT # _____

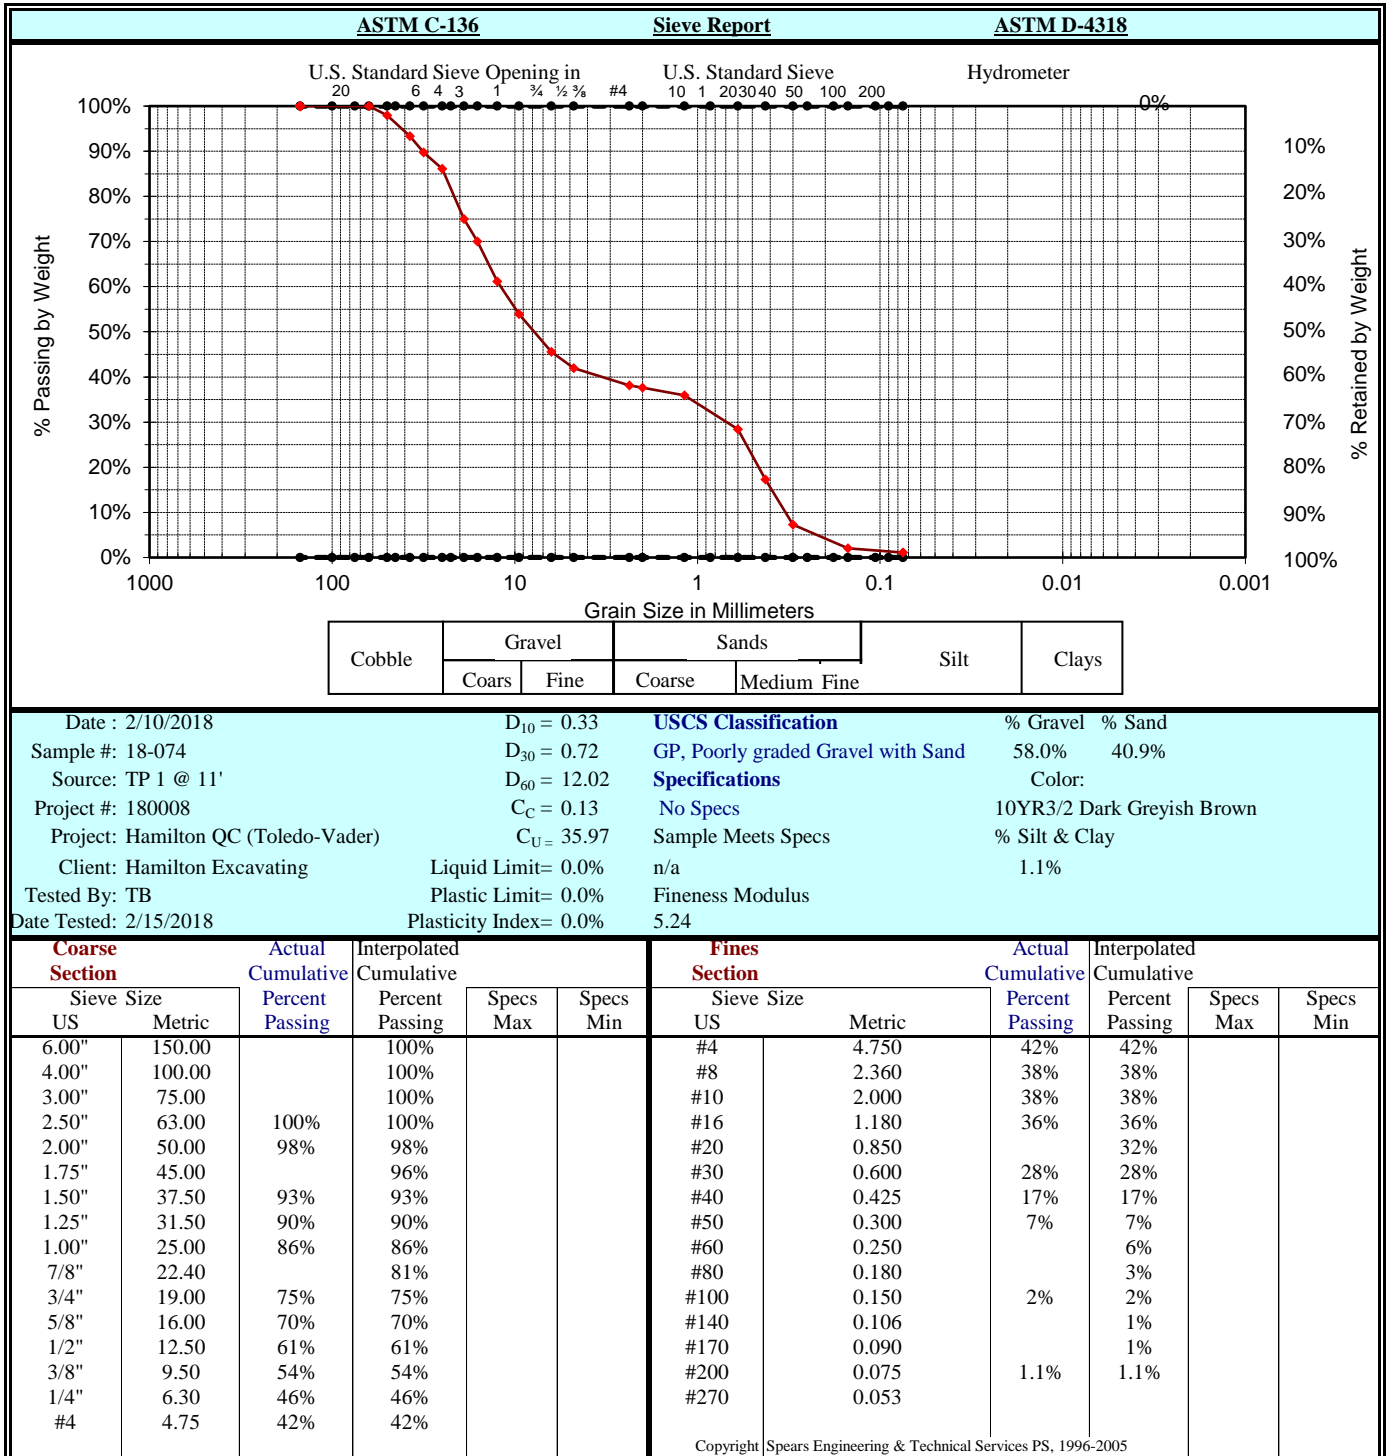
Comments: Moisture content - 3%

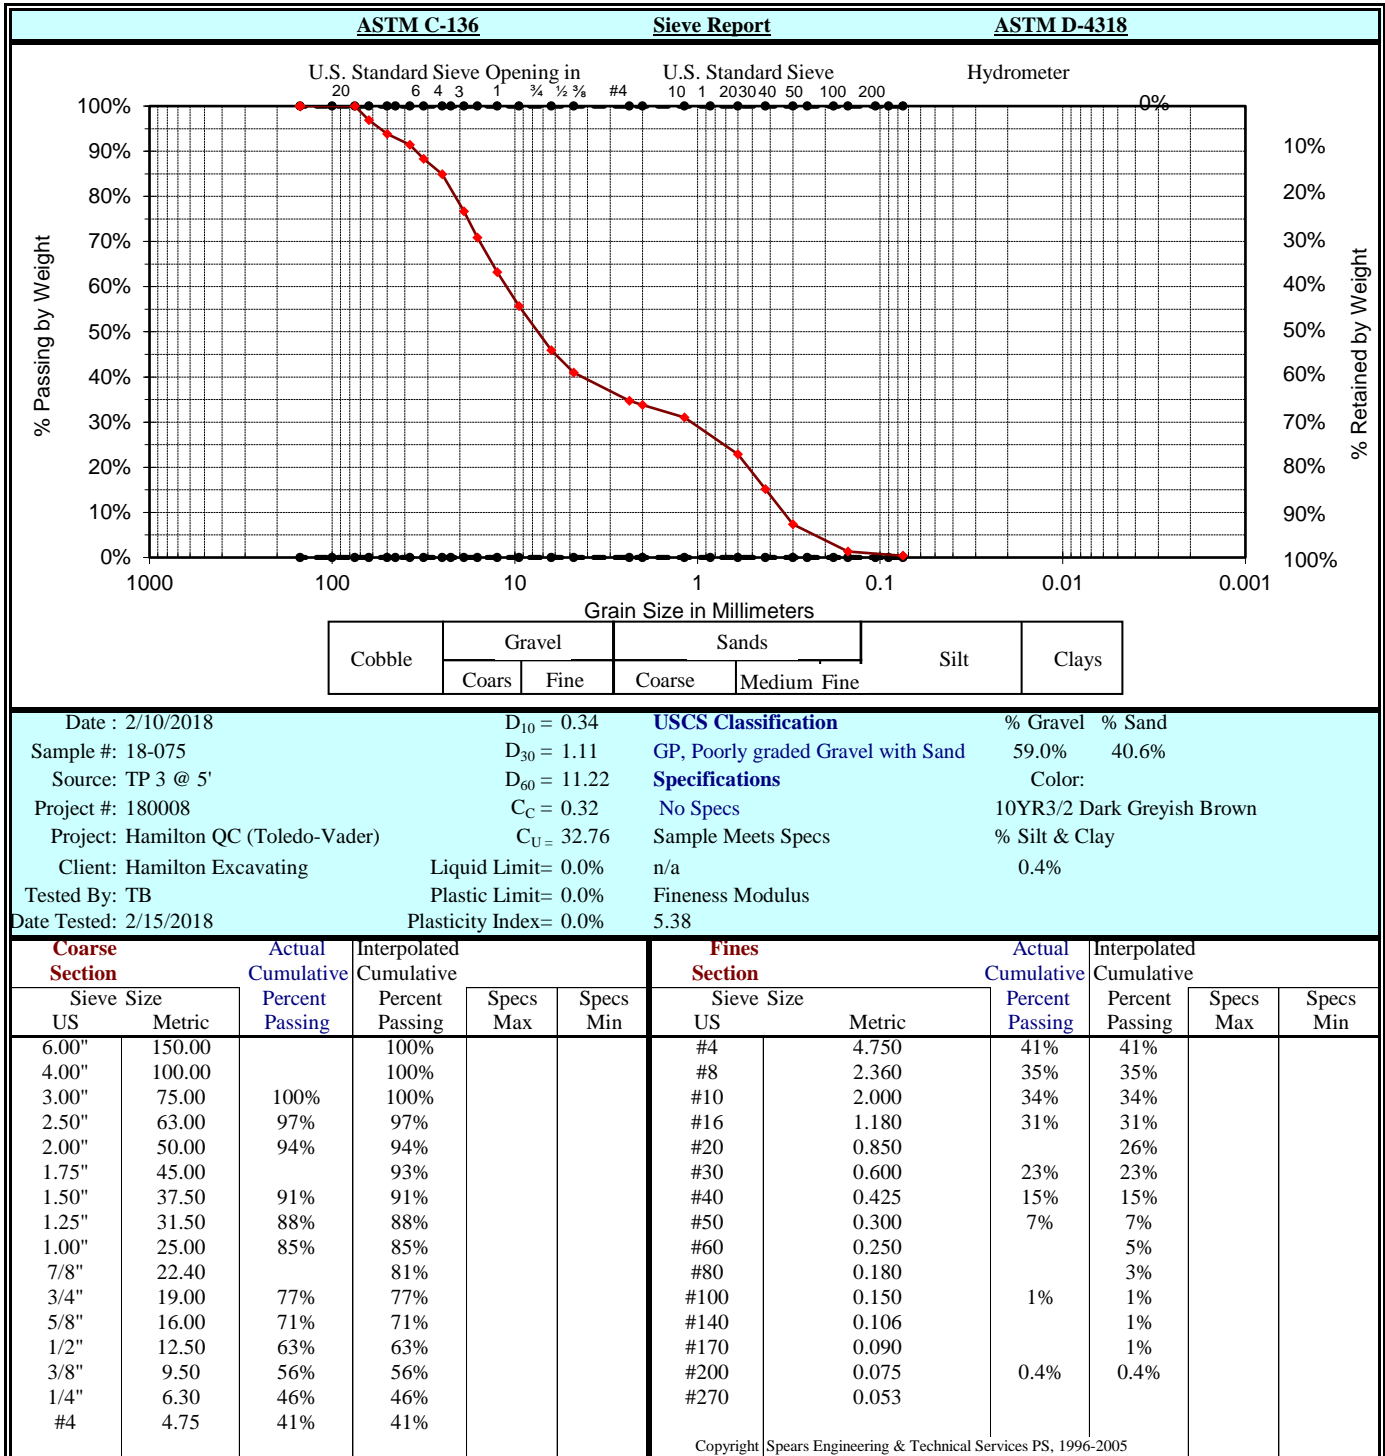
Comments: Moisture content - 2.4%

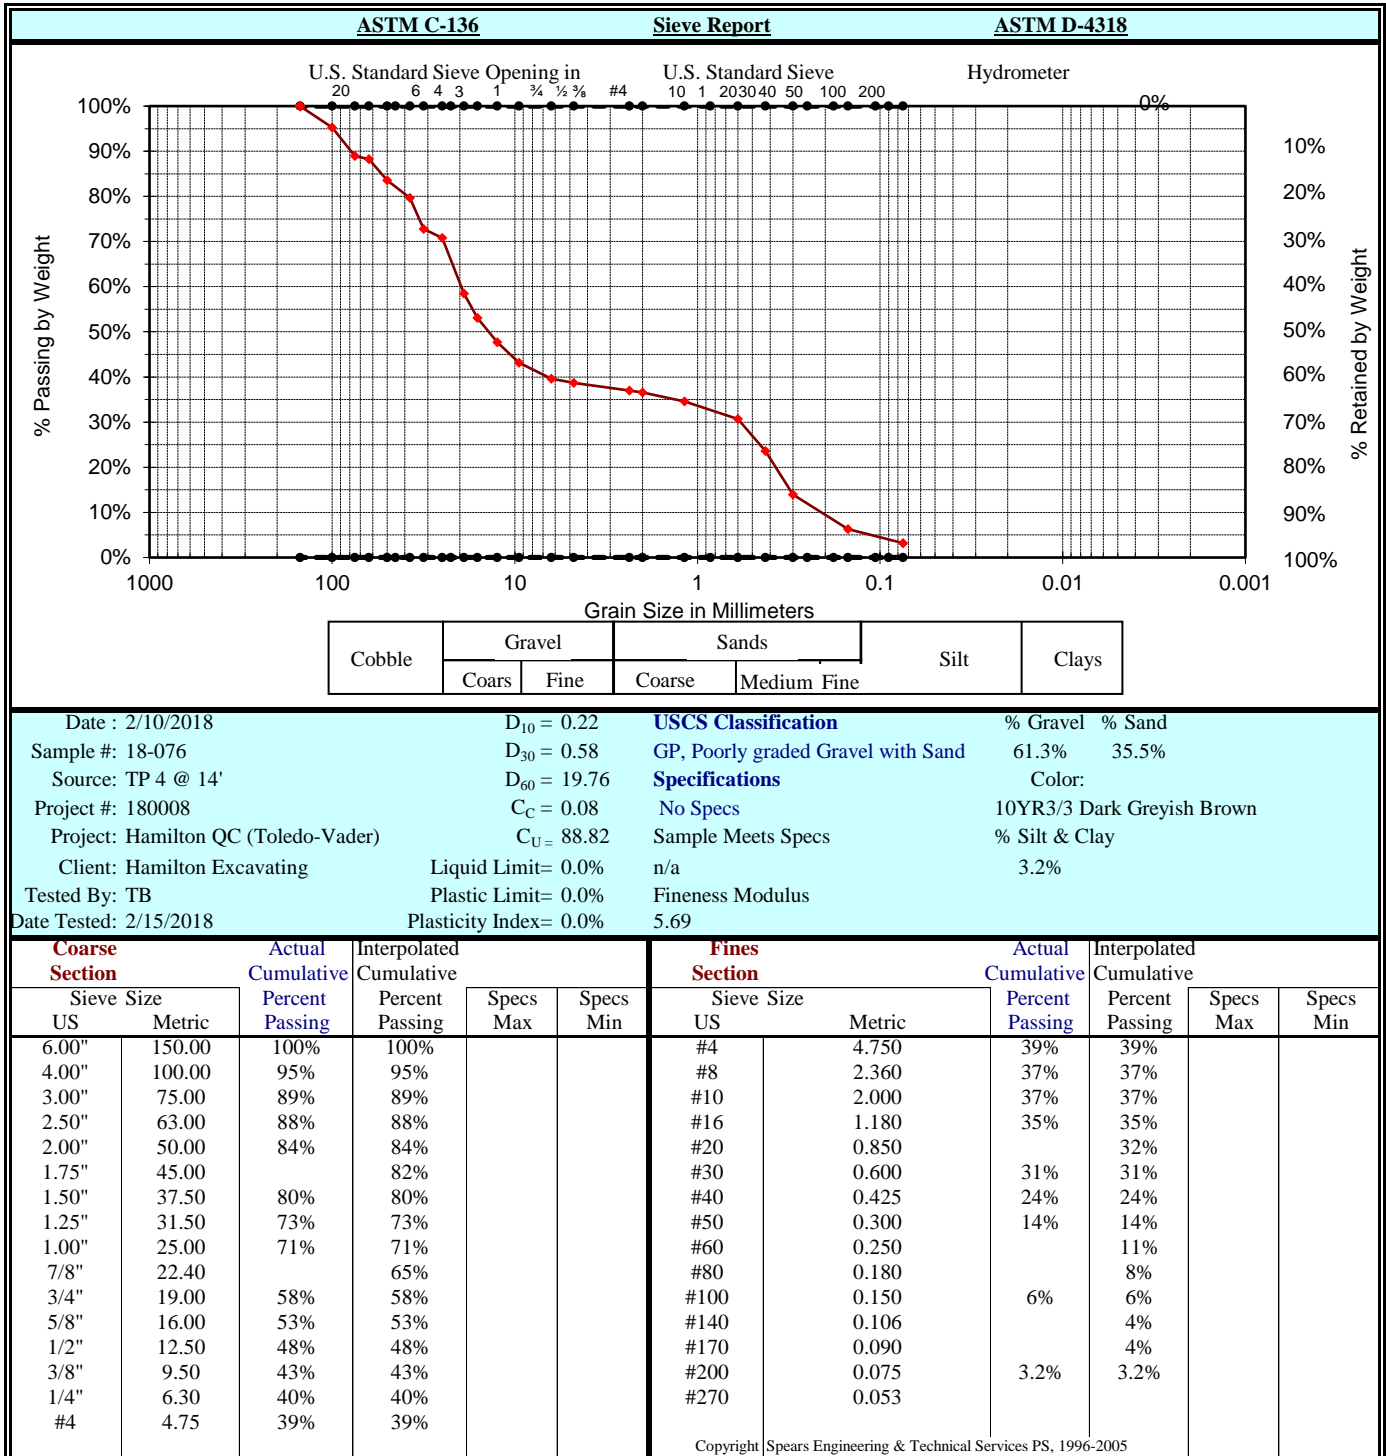
Comments: Moisture content - 4.3%

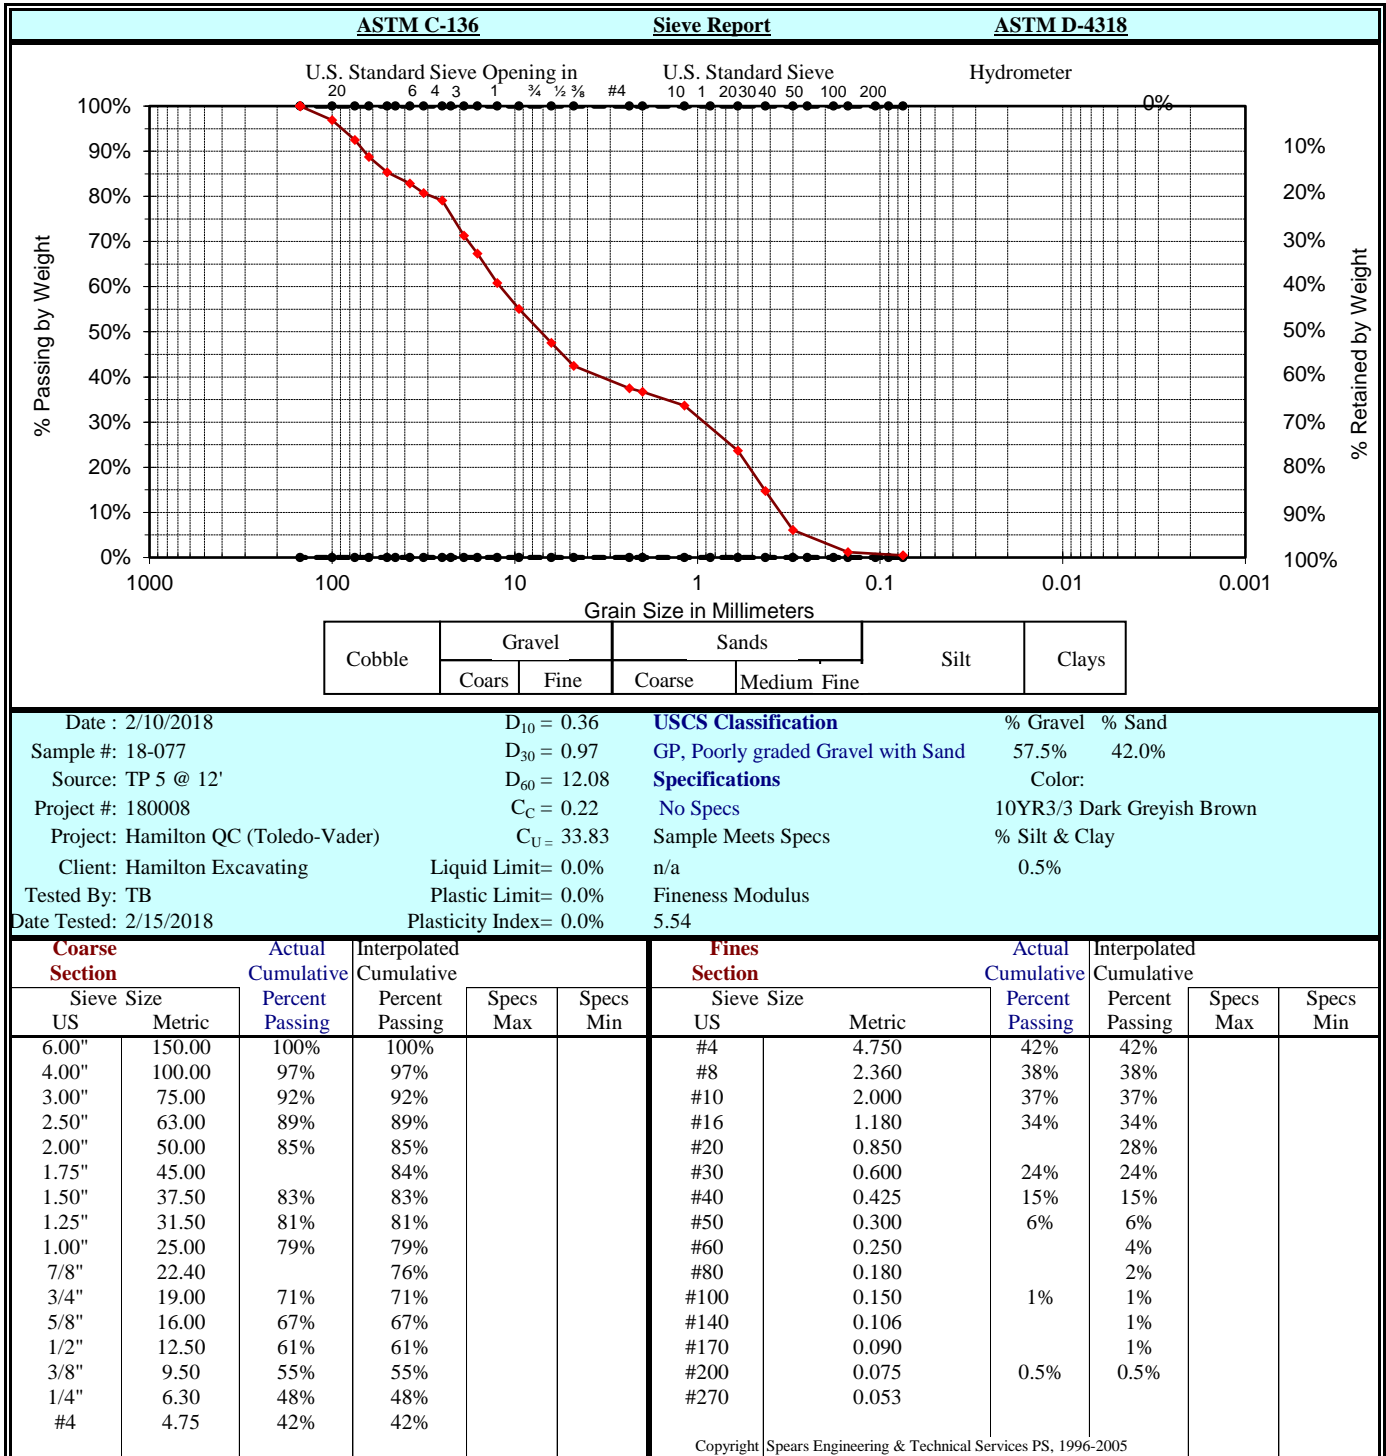
Comments: Moisture content - 2.5%
