**Lewis County Short Line Railroad Feasibility:
Environmental Study**

Lewis and Thurston Counties, Washington

October 2015

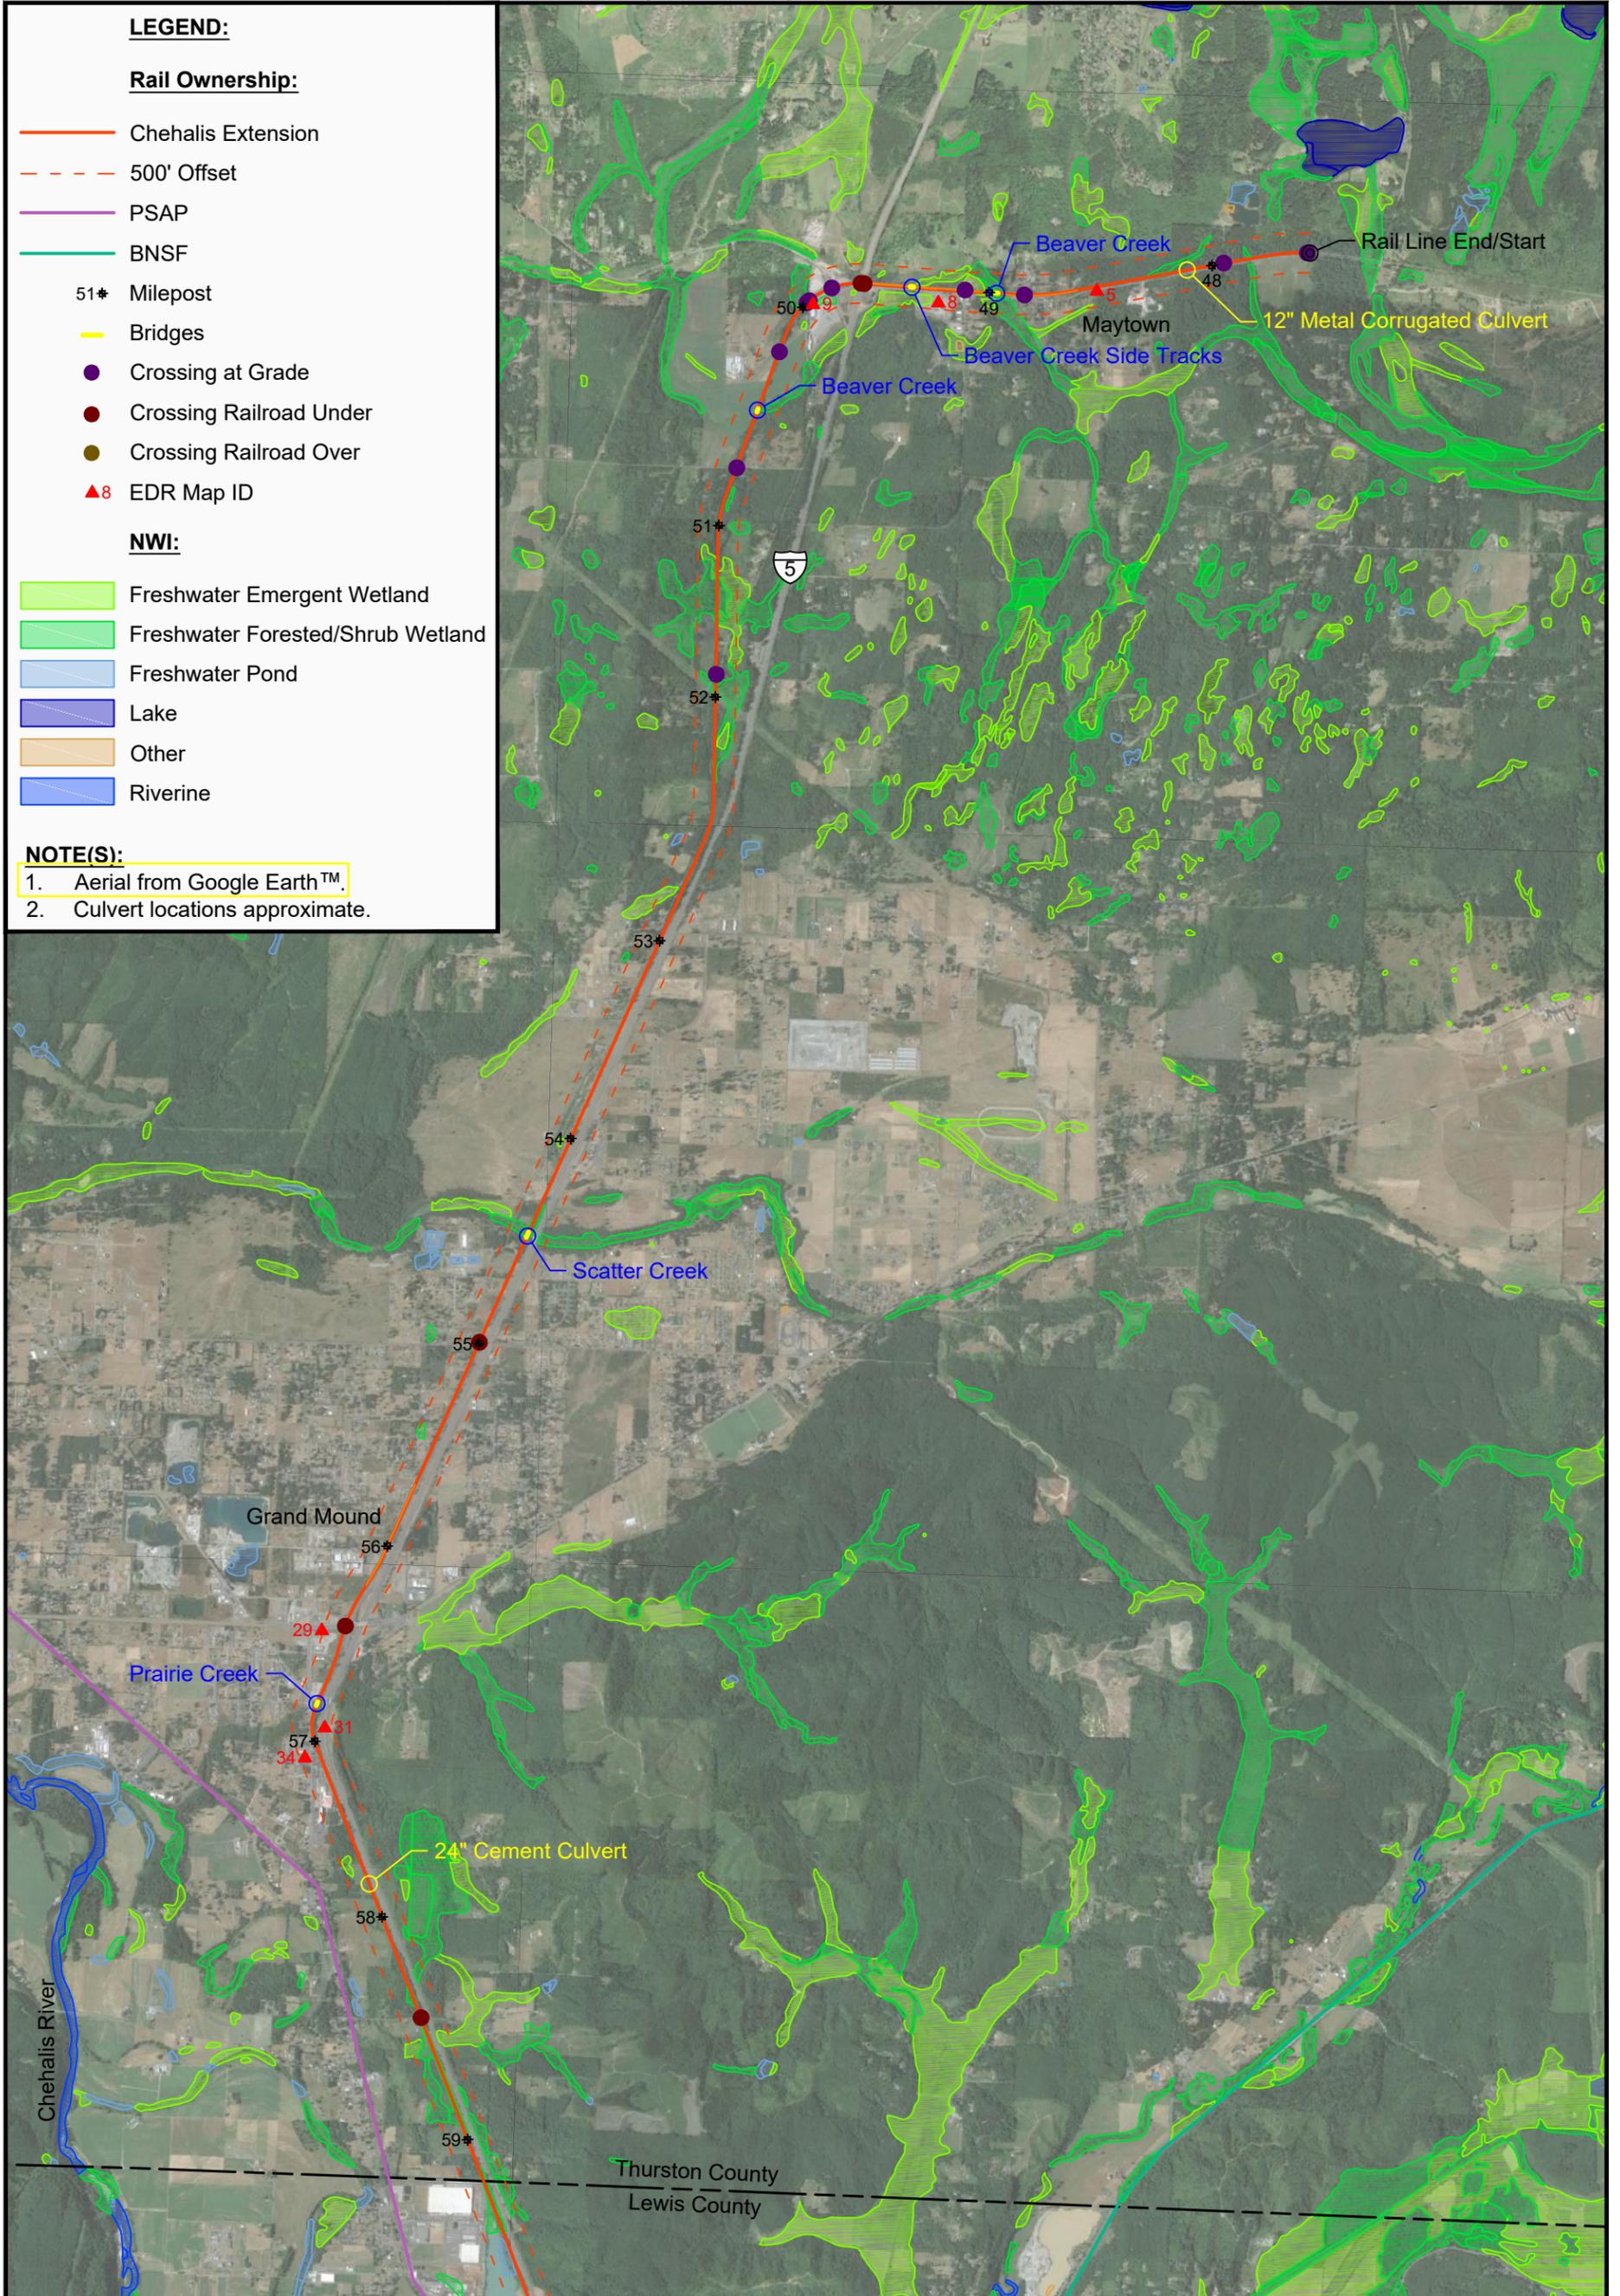
Figure 1A
 NATIONAL WETLANDS INVENTORY MAP
 Lewis County Short Line Rail Road Feasibility Study
 Tangent Services, Inc.
 Thurston & Lewis Counties, WA

ELS examined NWI maps in addition to WADNR stream maps to estimate critical areas that may cross the track or present additional maintenance costs. The wetlands found to cross the track from aerial imagery and NWI analysis are dominantly forest/scrub-shrub wetlands with some presence of freshwater emergent wetlands (Figures 1A and 1B). Further NWI analysis determined 4.68 miles of

forested/scrub-shrub wetlands and 0.35 miles of freshwater emergent wetlands are mapped as crossing the track within the proposed purchase area.

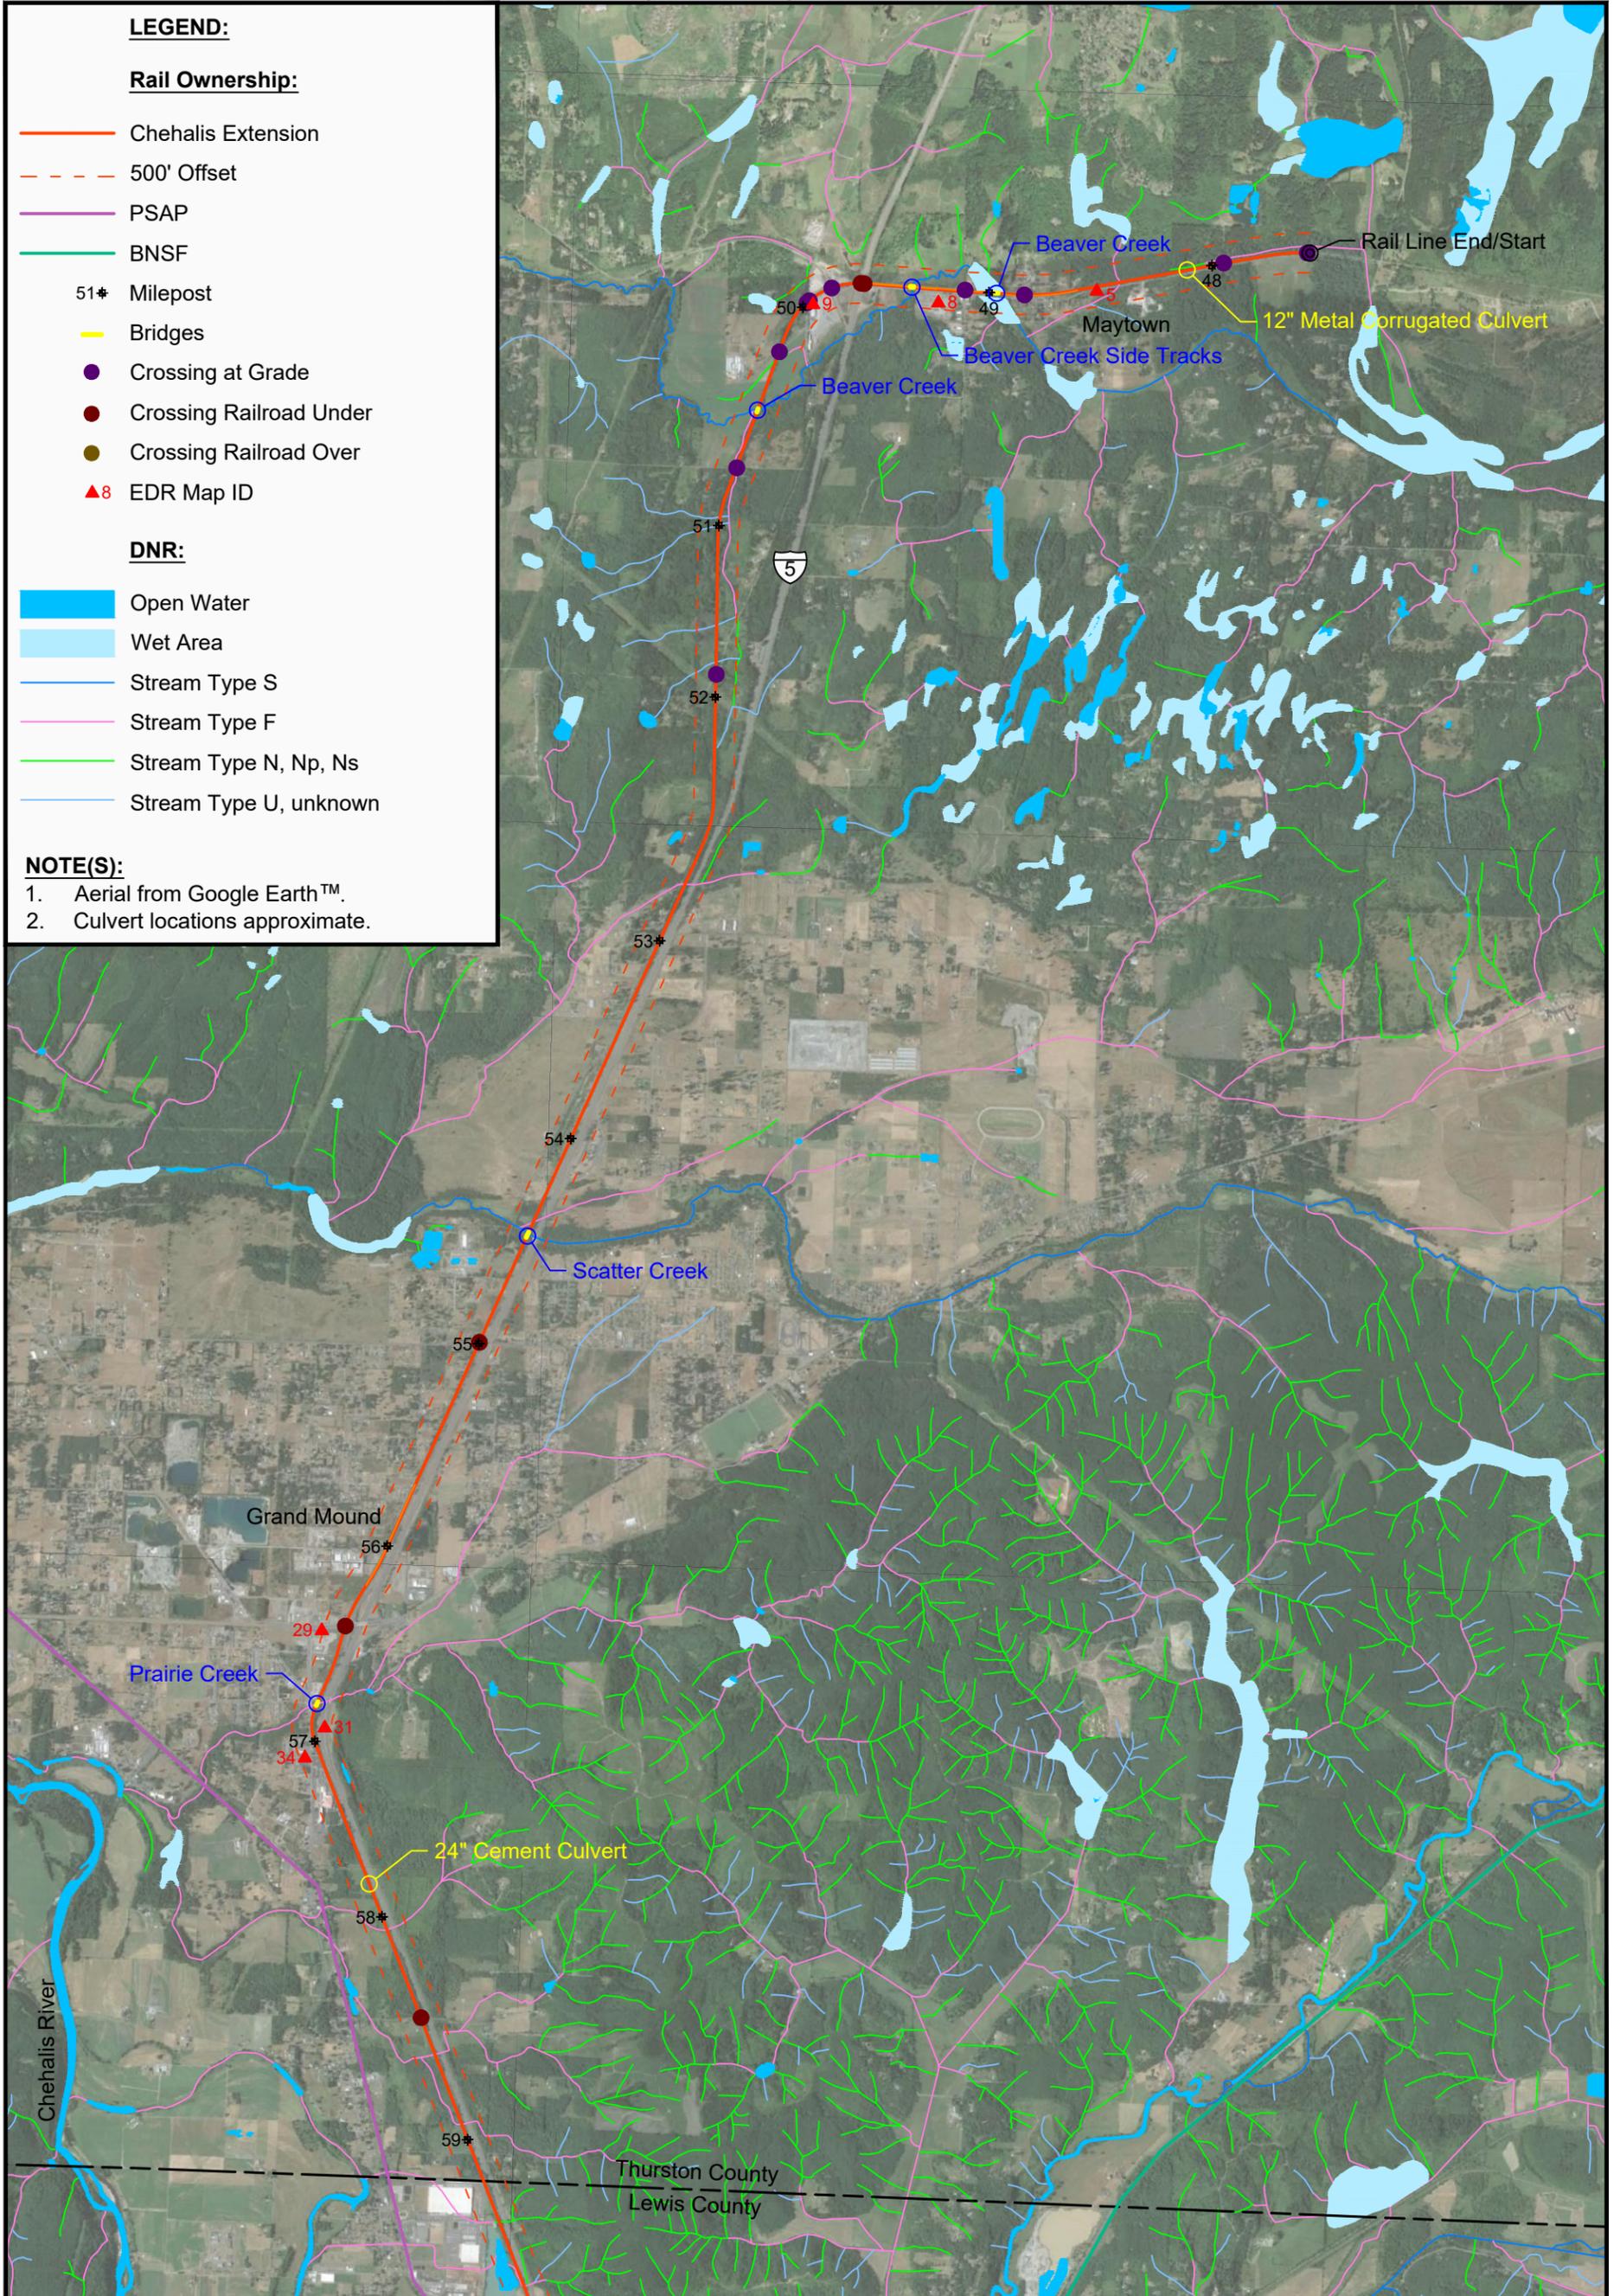
Figure 2A
 DNR STREAM MAP
 Lewis County Short Line Rail Road Feasibility Study
 Tangent Services, Inc.
 Thurston & Lewis Counties, WA

WADNR maps streams crossing the track in multiple locations. Known crossings are at bridge locations (Table 1), other crossings are assumed to have culverts, but could not be confirmed during the field reconnaissance. WADNR stream types are defined as Shoreline (S), Fish Bearing (F), Non-Fish Bearing (N), and Unknown (U). Shoreline and Fish stream types both include streams with enough water flow and potential habitat to be considered fish bearing.

In addition to the above table listing streams, there are nine Type F streams, two Type N streams, and nine Type U streams mapped by WADNR that do not have known culverts or bridges. Most of these stream crossings are mapped between MP 50 and 53 and MP 58 and 62. Between MP 58 and MP 62 water was noted crossing the tracks with vegetation and soil present within the tracks (Photoplate 6). It is unknown if culverts currently exist in this area, if so, they will require high priority maintenance.

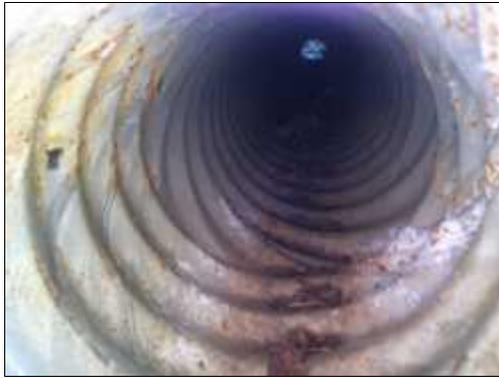
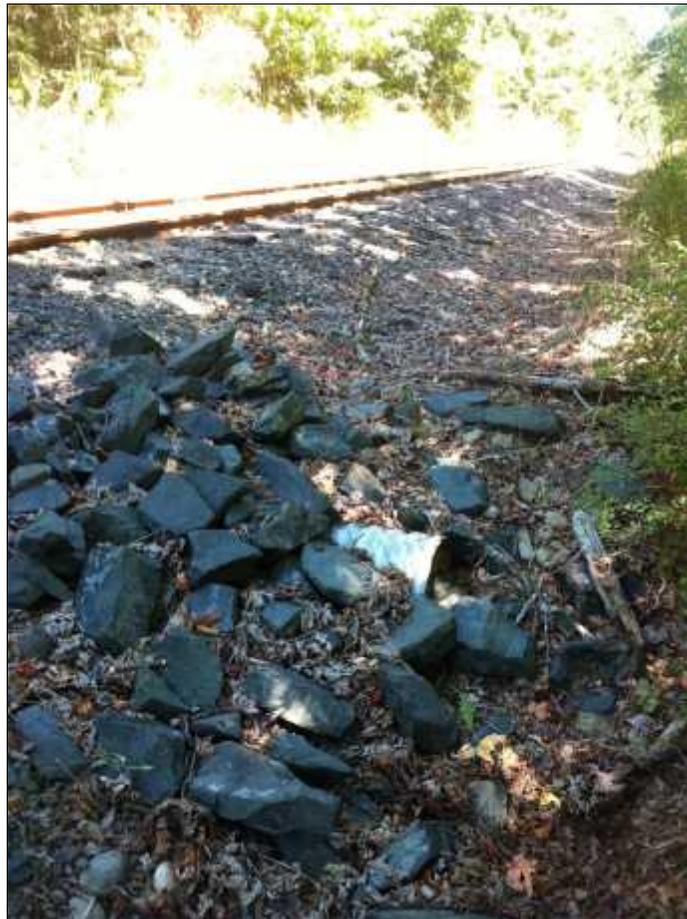
Photoplate 1

MP 48 12" CMP Culvert

MP48 12" CMP

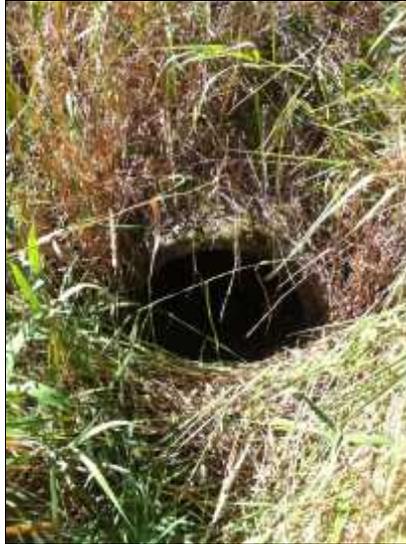
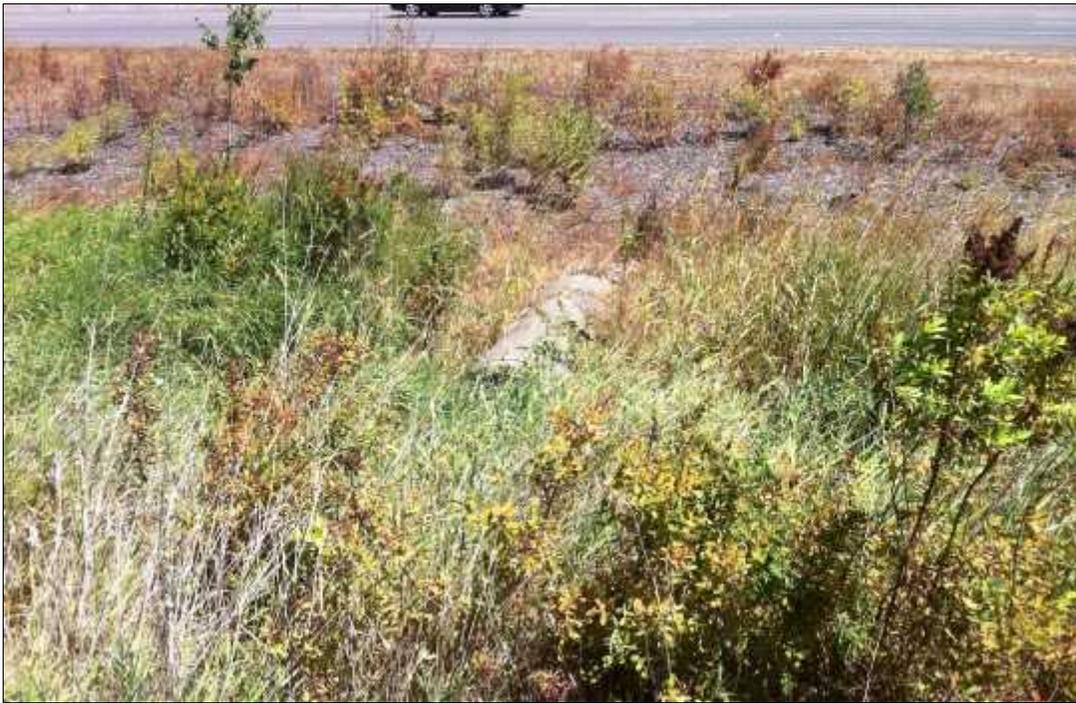
Photoplate 2

Of the five culverts observed, one of the culverts, found at Mile Post (MP) 58.6, matches the "concrete pipe culvert" descriptions of the majority of the culverts on the 1976 track profile (Photoplate 2). ELS is

only aware of one culvert replacement since the 1976 track profile was drawn,¹ and therefore assumes the condition of the remaining cement culverts along the railroad to be similar in condition to the concrete culvert found at MP 58.6. The concrete culvert at MP 58.6 is in good condition structurally. It was clogged with vegetation on both ends and had a boulder partially blocking the west end (Photoplate 2).

MP 58.6 24" Cement Pipe

MP 58.6 This photo shows the nearby WADOT culvert and the vegetation around both culverts

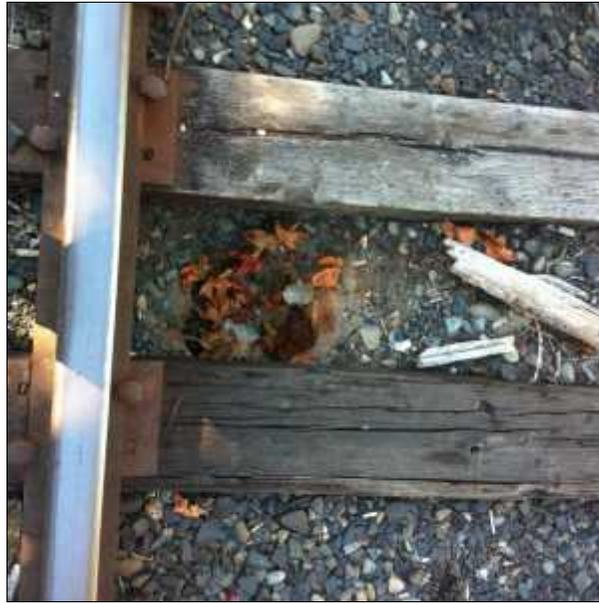
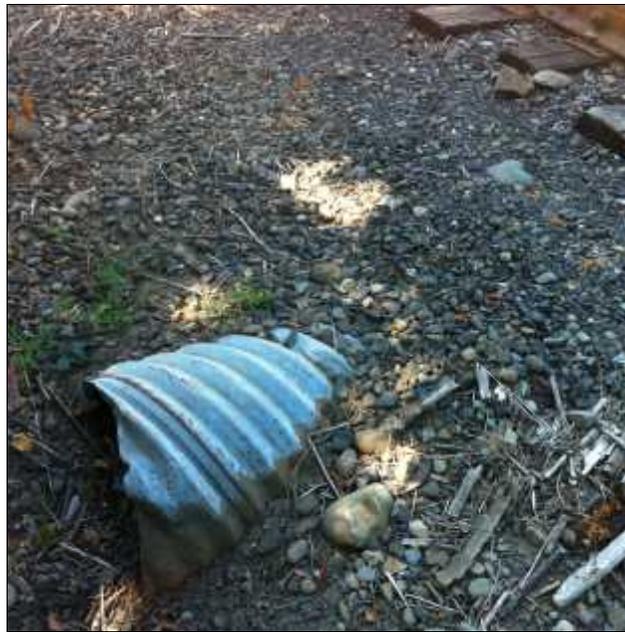
Photoplate 3

Culvert North of Prindle Street, collapsed in the middle

Culvert North of Prindle Street

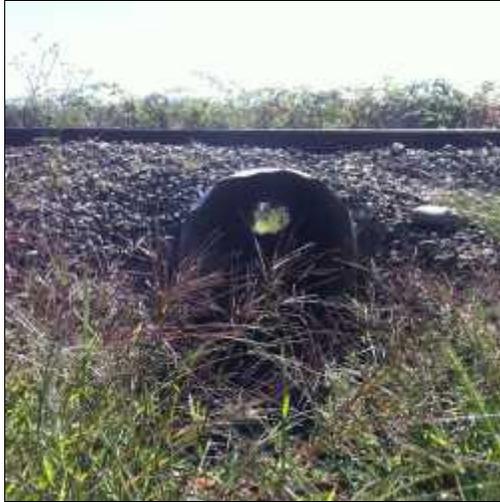
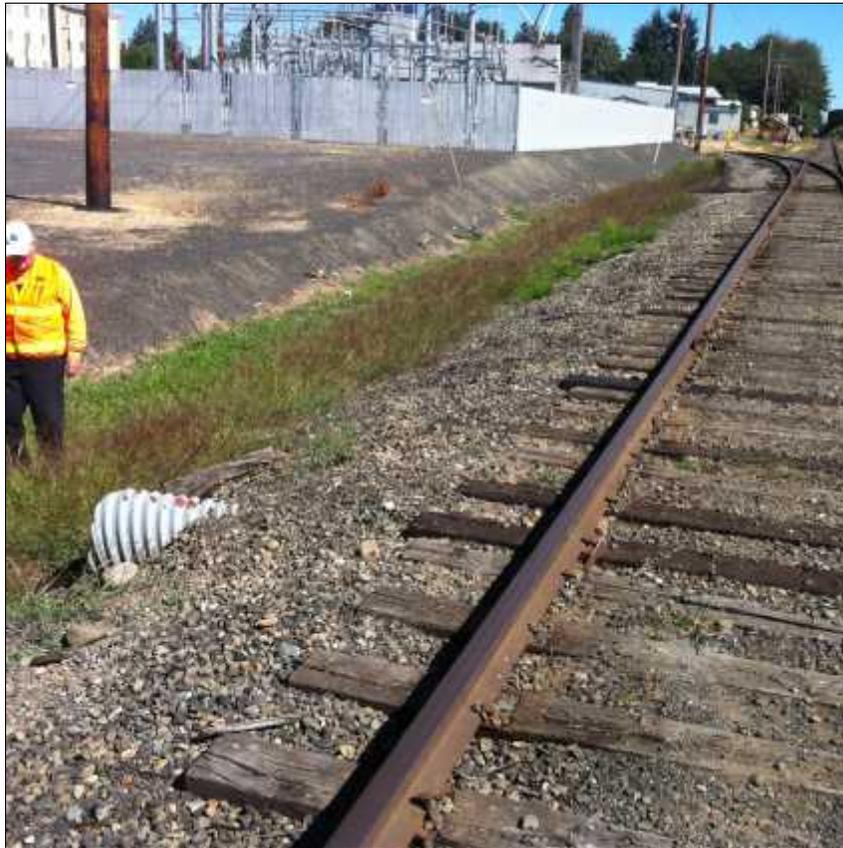
Photoplate 4

Culvert between Prindle and Main. Bottom of pipe rusted out.

Culvert between Prindle and Main with view of track.

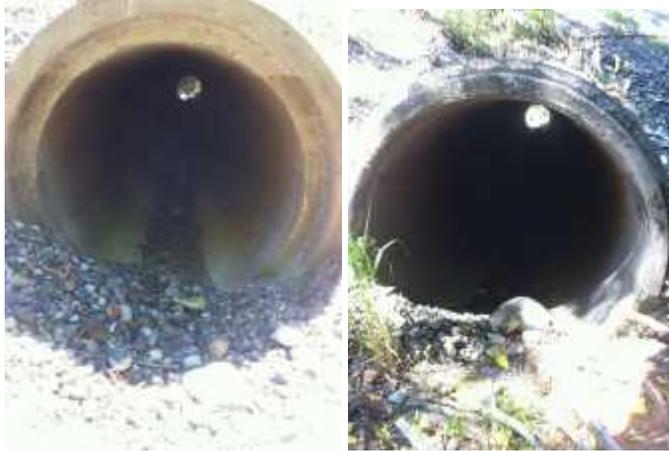
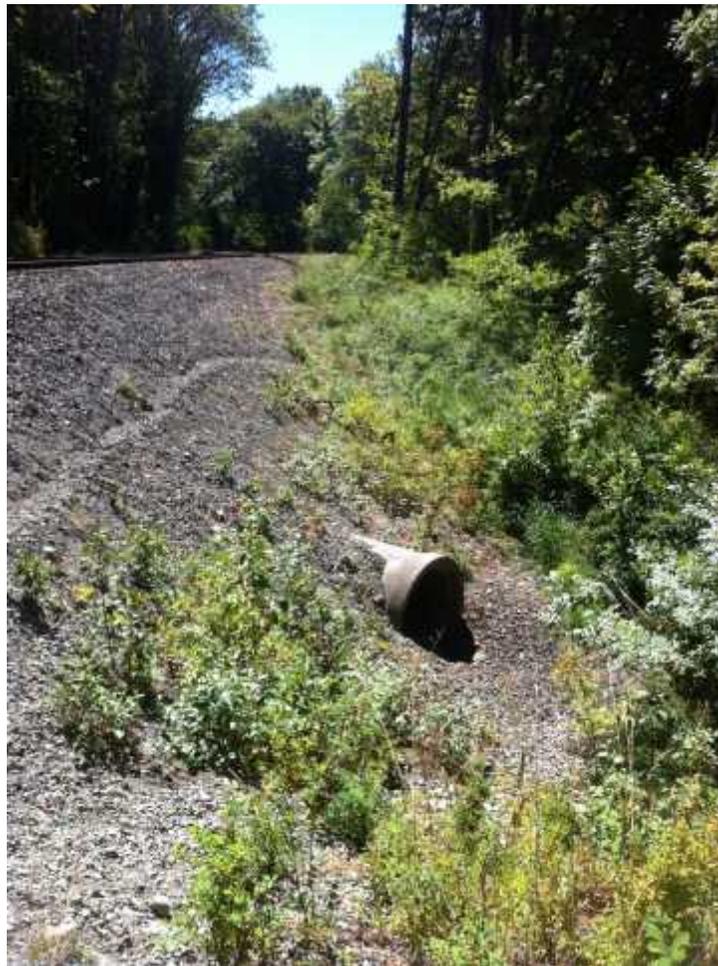
Photoplate 5

4 foot culvert between Skookumchuck River and Blakeslee Junction

Culvert between Skookumchuck River and Blakeslee Junction

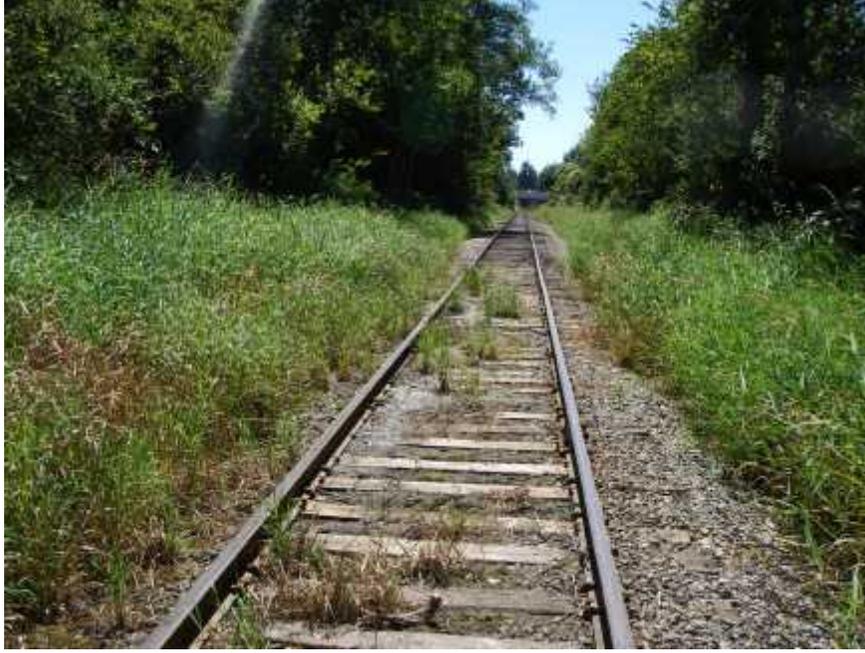
Photoplate 6

Evidence of water passing over tracks north of Blakeslee Junction.

ELS confirmed the general presence of these types of wetlands along the track, but did not perform any field mapping of wetlands adjacent to the track. The NWI analysis in combination with the field reconnaissance provides information regarding the possible risks posed to future maintenance by wetland presence along the track. With over five miles of wetlands mapped along the track, and wetlands observed by staff during the hi-rail tour, the need for maintenance of the track line due to water/wetlands can safely be assumed. Maintenance may be in the form of clearing existing ditches and culverts to reduce seasonally high water crossing over the tracks.
