Subject: Riverside Drive – Channel Migration Zone Evaluation
TPN: 035067002003; 107 Riverside Dr, Packwood WA 98361
Project Number QG23-175

At your request, Quality Geo NW, PLLC (QG) has completed a limited evaluation of the potential for channel migration within your property. The general potential for migration of the Cowlitz River is in question. It has been requested that QG evaluate the Channel Migration Zone (CMZ) and provide our interpretation of the possible CMZ hazard.

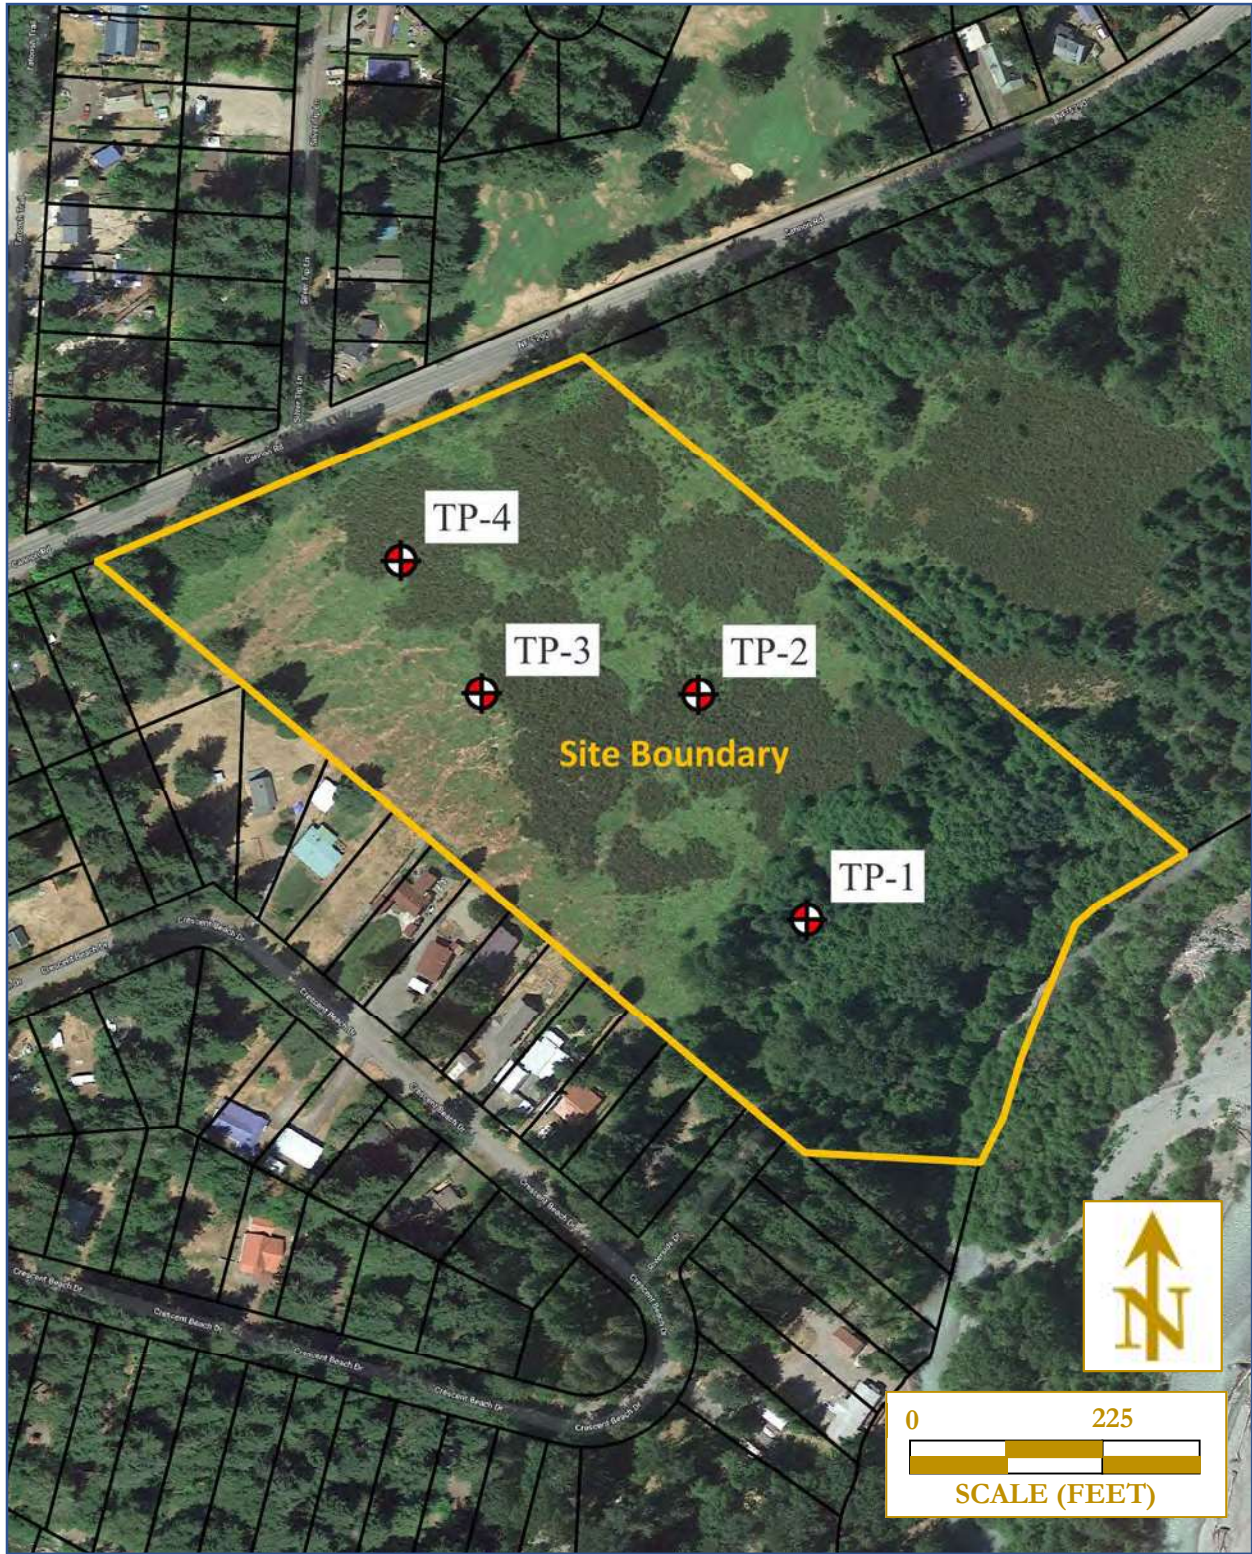
Figure 2

Site Map
Riverside Dr

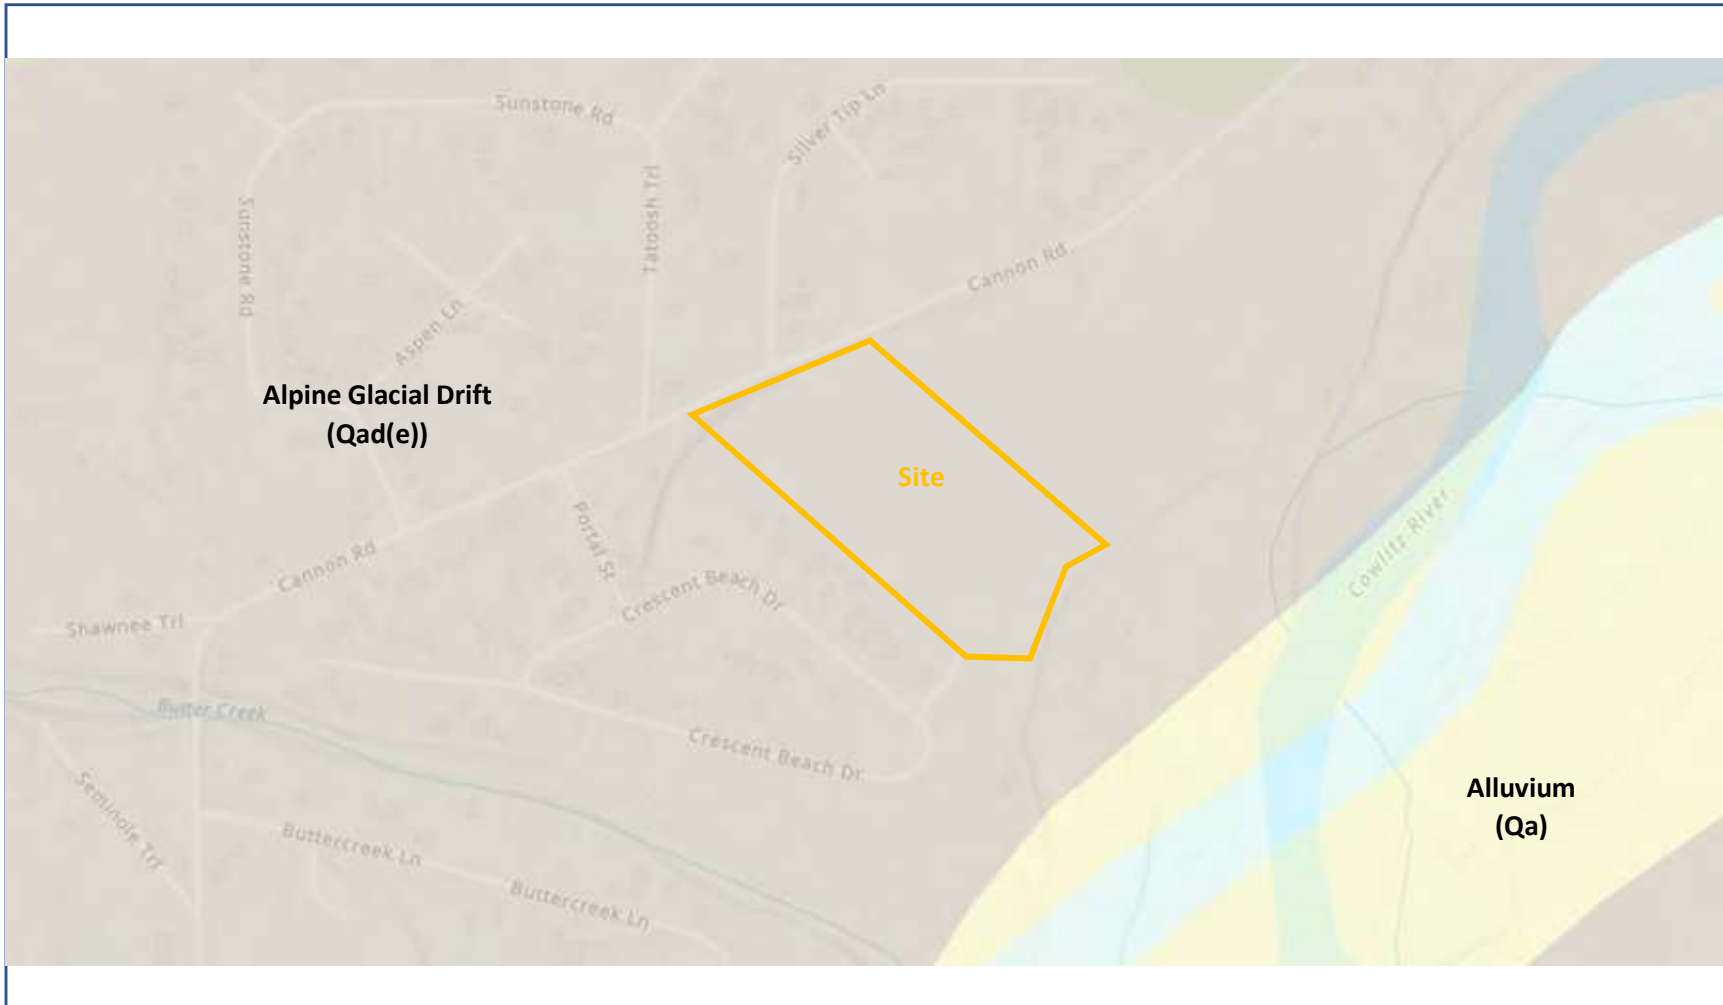
Figure 6

Geologic Map
Riverside Dr

QG reviewed available map publications to assess known geologic conditions and hazards present at the site location. The Washington Geologic Information Portal (WGIP), maintained by the Department of Natural Resources Division of Geology and Earth Resources, provides 1:100,000-scale geologic mapping of the region. Geology of the site location and vicinity consists of alpine glacial drift deposits (Qad(e)). The drift on site is described as being, “Quaternary till, outwash, and glaciolacustrine sediments; locally includes loess, talus, and lacustrine deposits.”

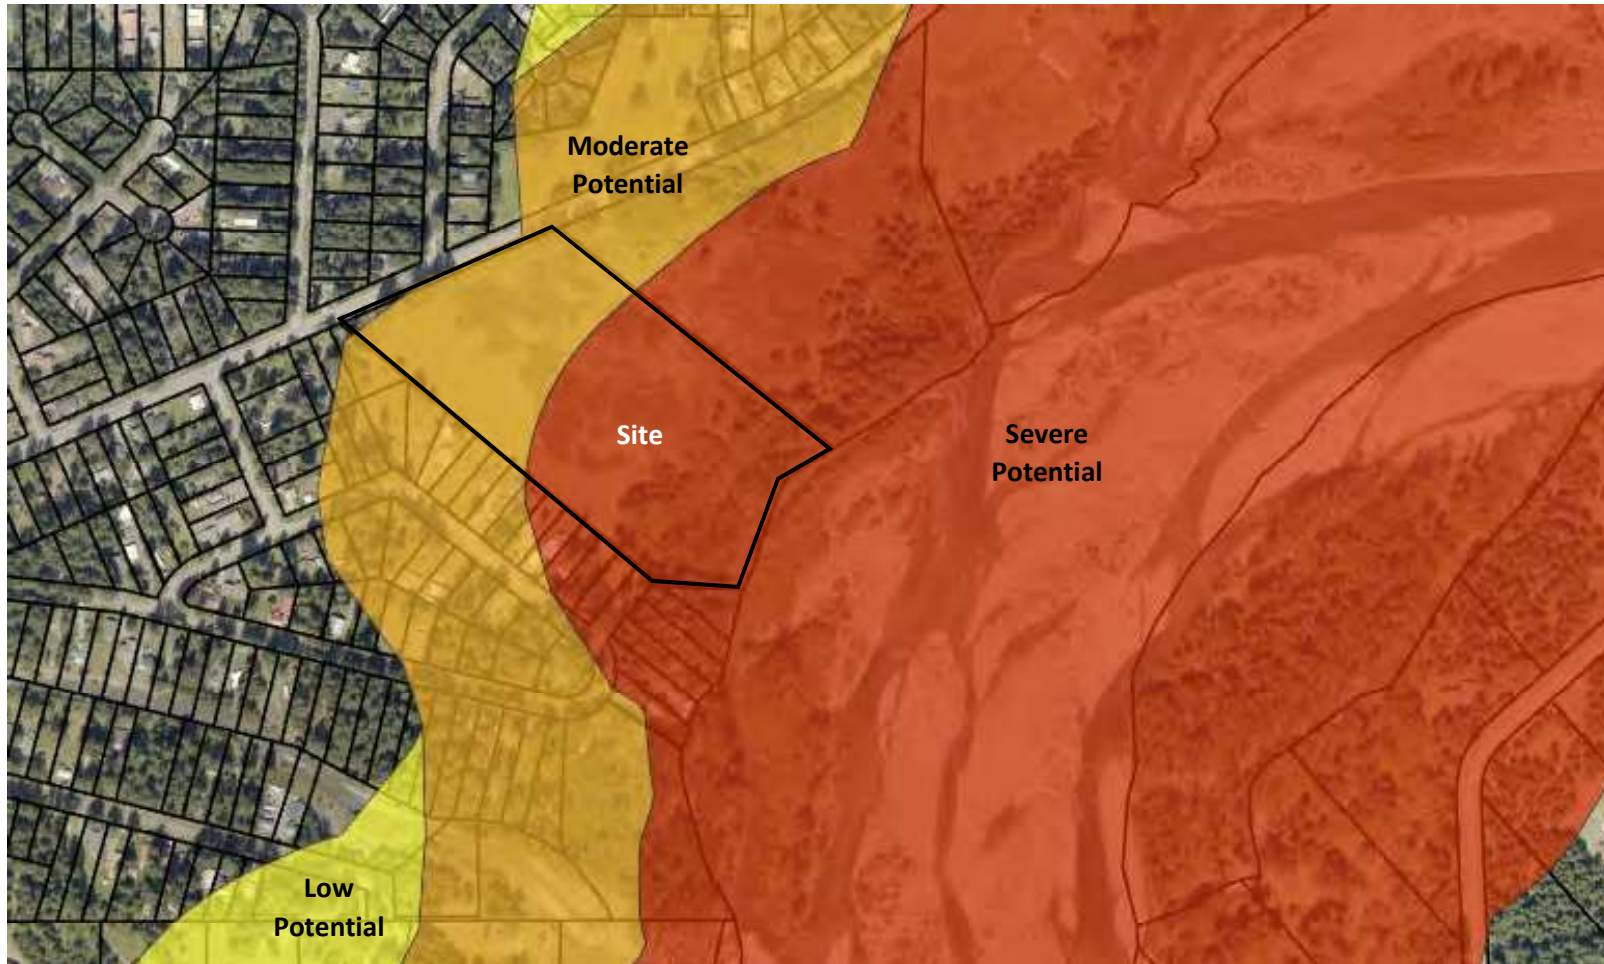
Figure 7

Lewis Co Shoreline Master Plan
Channel Migration Zones

The Lewis County Shoreline Master Program maps depict areas of anticipated CMZ hazards. Based on the mapped hazard potential, half of the site falls within the zone of Severe Risk. The other half of the site falls within the Moderate Risk area, and minorly peeks into the high hazard. However, based on our review of historical photos, maps dating back to 1904, other documented reports, and our observations on the ground, this risk seems less severe or moderate, and more likely low across the entire site, by strict definition. Based on historical maps and photographs the Cowlitz River has not encroached or migrated any closer to the parcel in questions in over 100 years, **and we interpret the site to be of a low risk category for channel migration.**

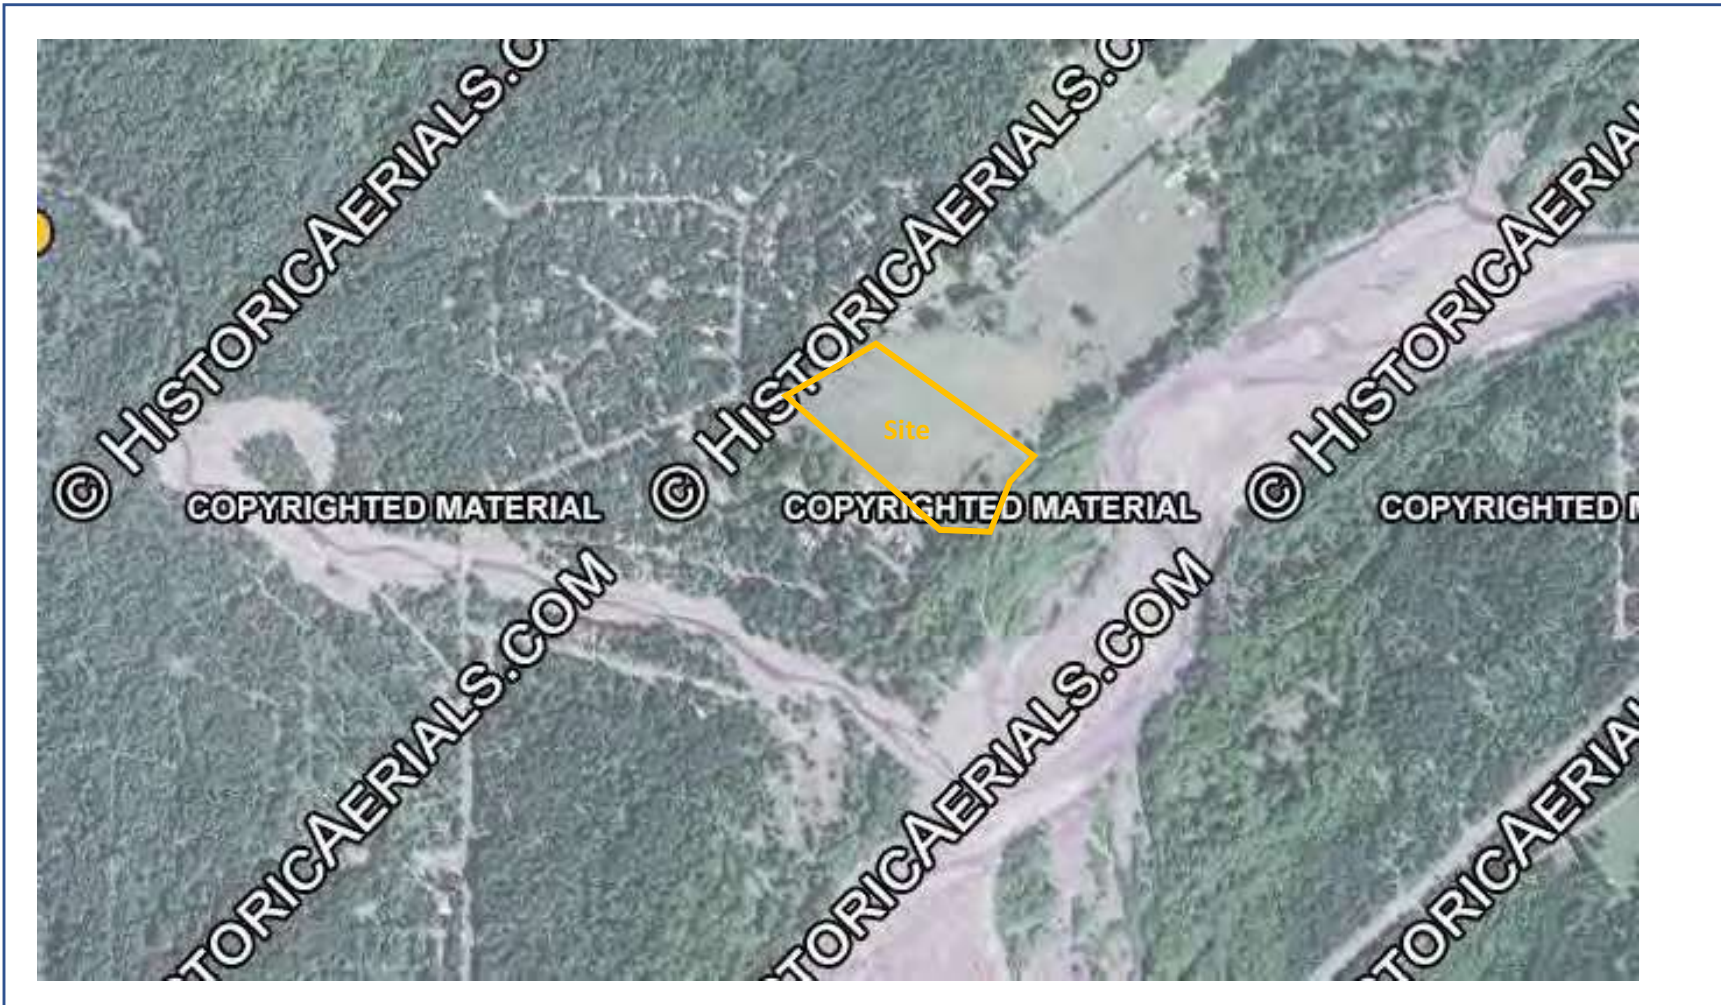
Figure 8

1983 Historic Aerial Imagery
Riverside Dr

Additionally, QG reviewed satellite imagery from the present and past. The earliest freely available aerial imagery dates back to 1983. Conditions of the Cowlitz River channel in the subject vicinity do not appear to have greatly changed, with some meandering of the channel braids up to the eastern edge of the site but maintaining a consistent area of influence outside the subject site. Trees and thick vegetation have been able to establish themselves entirely along the eastern edge of the site, without disturbance from channel migration over the last 40 years. In general, it appears that the Cowlitz River is a sinuous, moderate to high energy, braided stream system, within the subject vicinity.
