**Subject: Riverside Drive – Infiltration & Geo Hazard Assessments**  
TPN: 035067002003; 107 Riverside Dr, Packwood WA 98361  
Project Number QG23-174

# SOILS REPORT

RIVERSIDE DRIVE INFILTRATION & GEOLOGICAL HAZARDS  
TPN: 035067002003; 107 RIVERSIDE DR  
PACKWOOD, WA 98361

QG Project # QG23-174

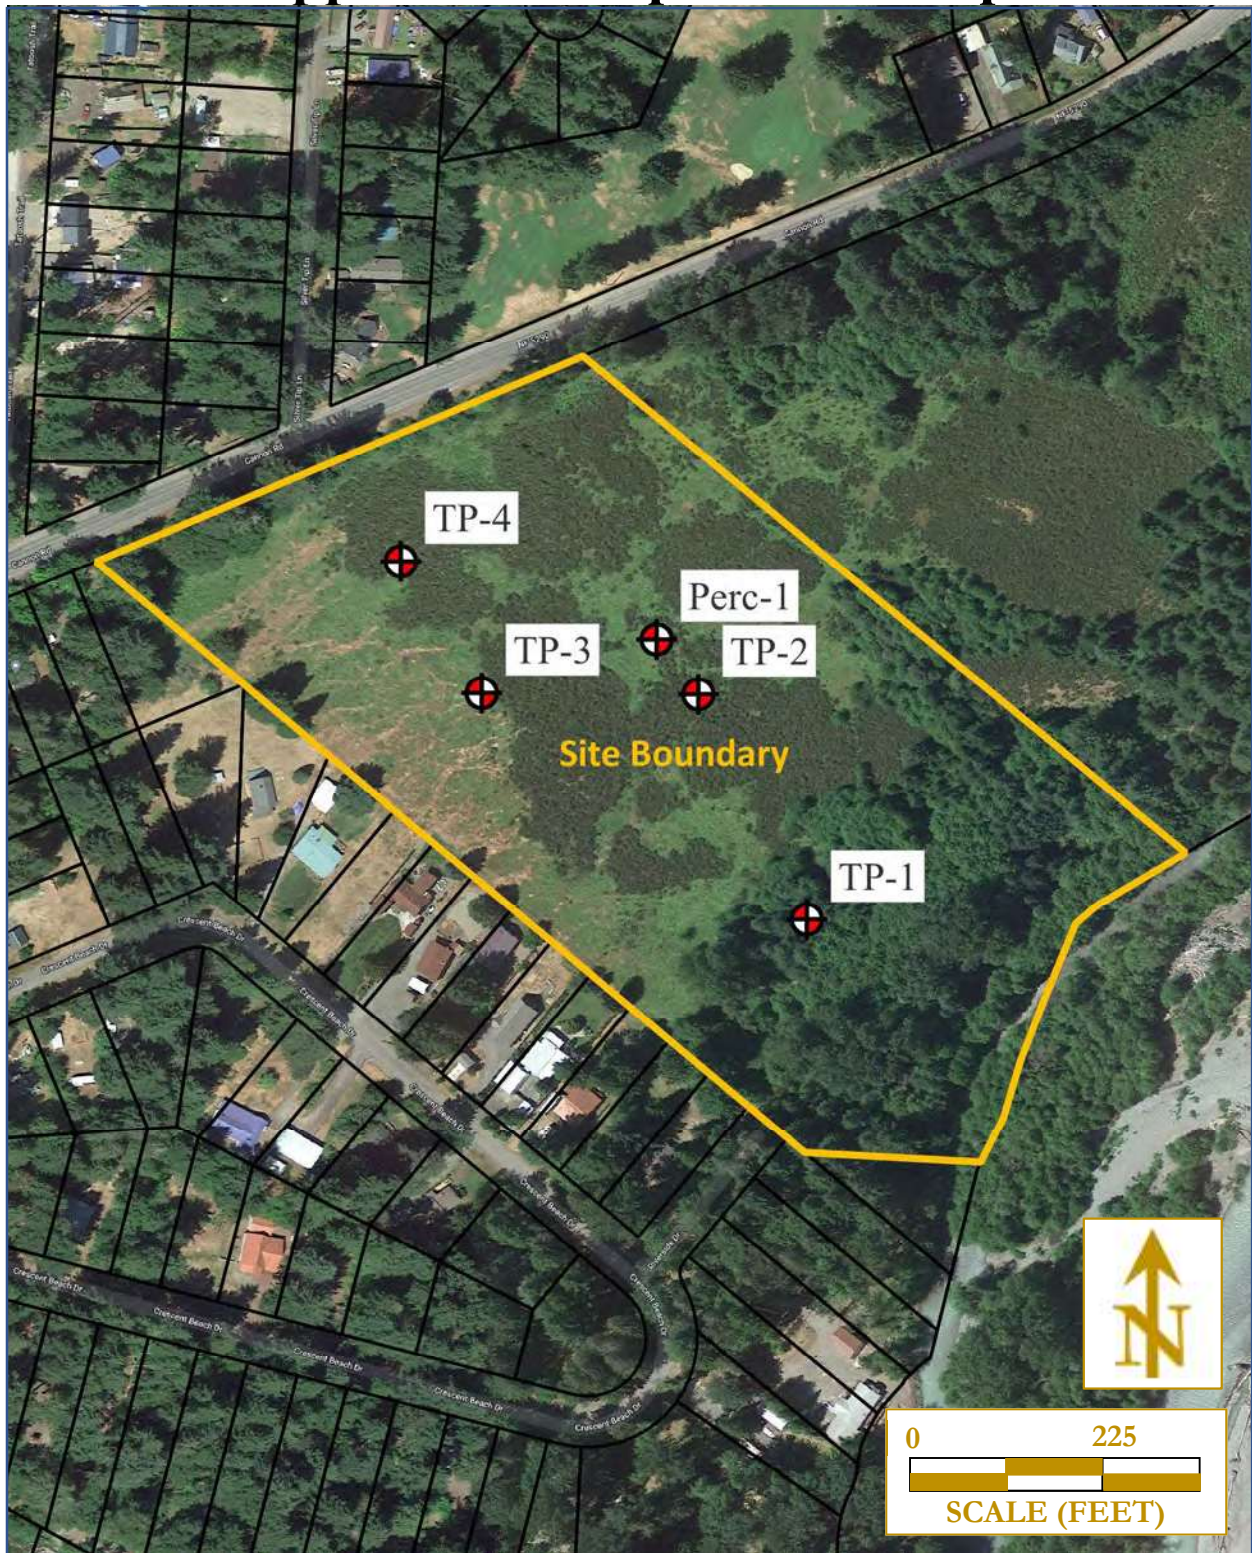
Site Map  
Riverside Dr

Site exploration activities were performed on 9/20/2023 and 10/26/2023. Exploration locations were marked in the field by a QG Project Geologist with respect to the provided map and cleared for public conductible utilities. Our exploration locations were selected by a QG Project Geologist prior to field work to provide safest access to relevant soil conditions. The geologist directed the advancement of 4 excavated test pits (TP). The test pits were advanced within the vicinity of the anticipated development footprint areas, to depths of 9.0 feet below present grade (BPG) in general accordance with the specified contract depth and groundwater conditions. Additionally, a QG staff geologist collected soil samples from a perc hole that was previously excavated on site.

Site soil conditions were consistent across the property in 4 test pits. Representative lab samples were taken from TP-1 and TP-2.

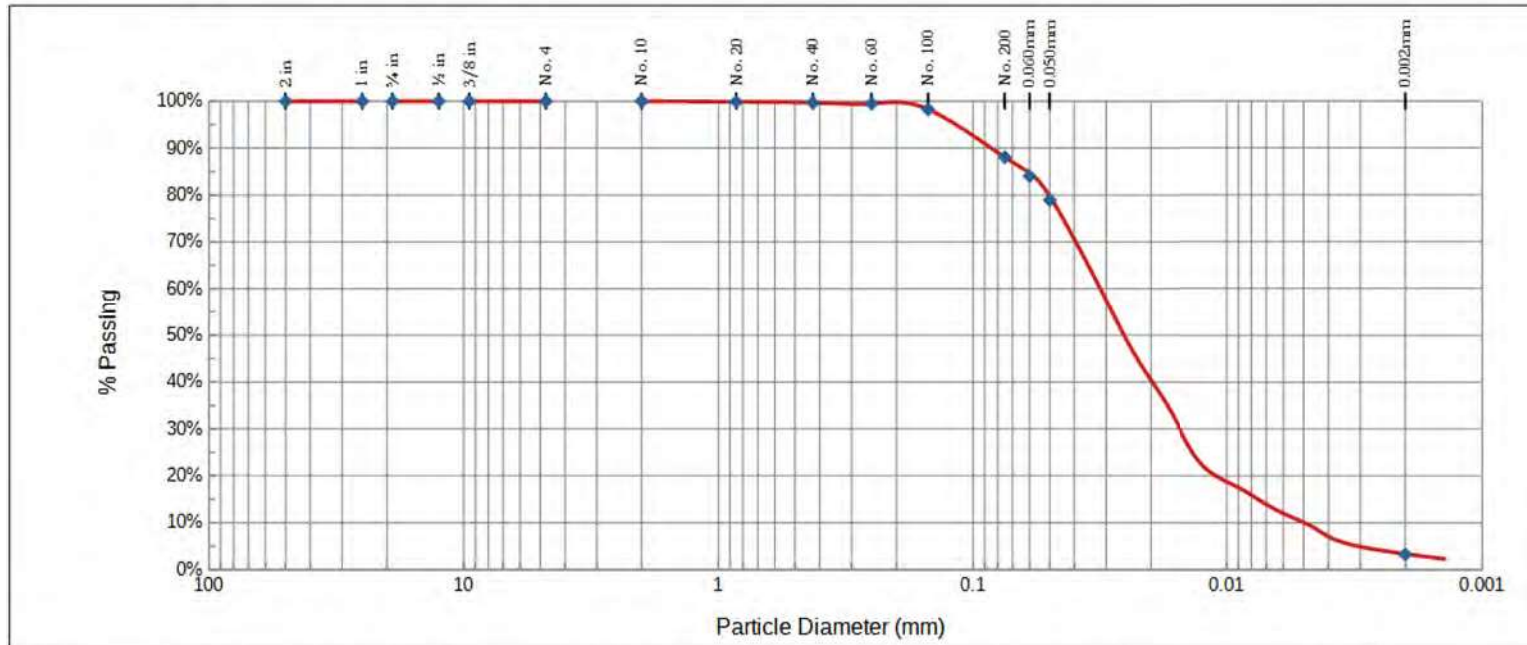
Project Name: Riverside Drive Geo  
Project Number: QG23-174  
Date Collected: 09/20/23  
Date Reported: 10/05/23  
Boring ID: Perc-1  
Boring Depth: 2ft

USCS Scale Sieve # Diameter, mm	Coarse Gravel		Fine Gravel			Coarse Sand		Medium Sand		Fine Sand			(% of Fines Passing #200 Sieve) Hydrometer Method			Sand Total	Gravel Total
	2"	1"	3/4"	3/8"	3/8"	4	10	20	40	60	100	200	0.060	0.050	0.002		
Retained	0.0%	0.0%	0.0%	0.0%	0.0%	0.0%	0.0%	0.1%	0.3%	0.5%	1.7%	12.0%				12.0%	0.0%
Passing	100.0%	100.0%	100.0%	100.0%	100.0%	100.0%	100.0%	99.9%	99.7%	99.5%	98.3%	88.0%	84.0%	79.0%	3.26%

During test pit excavations for general site investigation, QG additionally collected representative samples of native soil deposits among potential infiltration strata and depths. Representative soil samples were selected from the center of the site (TP-1, Perc-1) to characterize the local infiltration conditions.

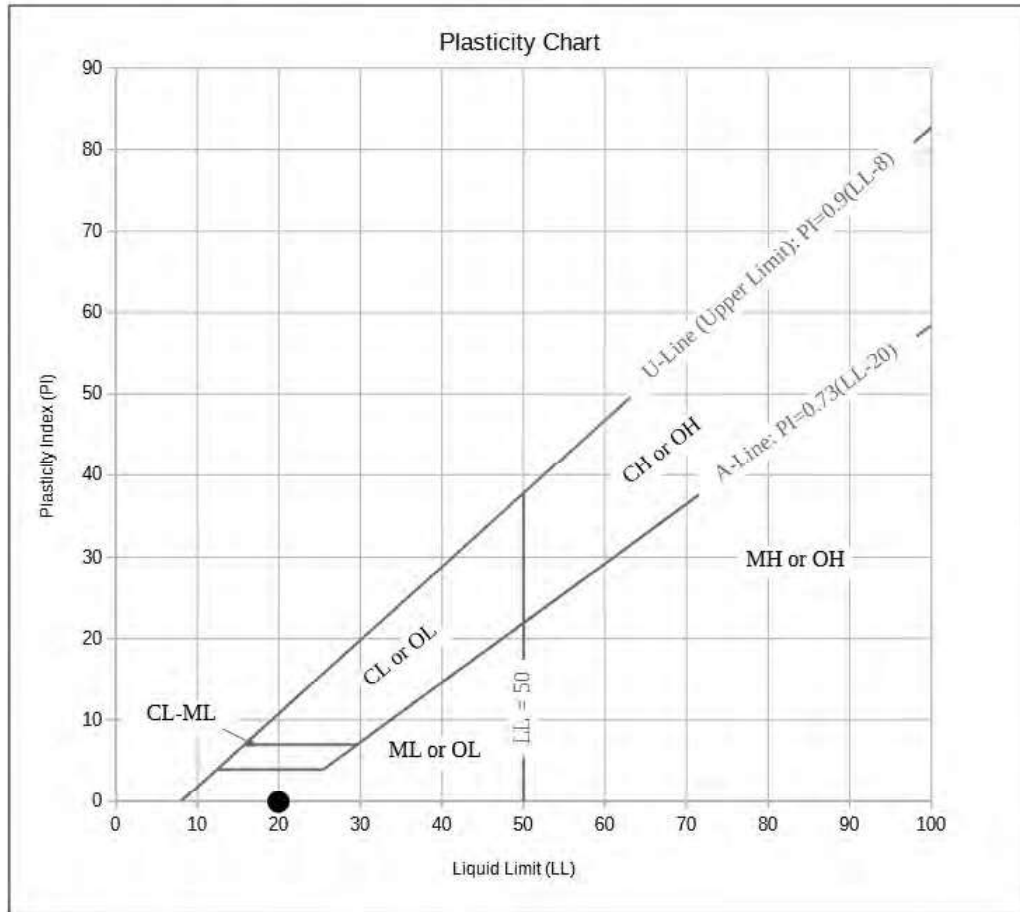
SAMPLE ID: Perc-1@2ft

Liquid Limit (LL): 20  
 Plastic Limit (PL): 20  
 Plasticity Index (PI): 0
