DATE: August 18, 2025  
TO: City of Centralia  
FROM: Amanda Weiss - Scientist II  
SUBJECT: Wetlands and Streams Reconnaissance  
PROJECT NUMBER: 216-3739-007  
PROJECT NAME: Seminary Hill

This memorandum is to document the findings from a critical area investigation in support of the State Environmental Policy Act (SEPA) environmental checklist for the Seminary Hill Pressure Zone Improvement project (project) (Attachment A, Figure 1). The project anticipates to only occur within developed areas except for within two parcels along its extent. Therefore, the investigation was limited to Lewis County parcels #001365001002 and #021323005000. Areas outside the parcels up to 300 feet were assessed through a visual inspection and review of publicly available resources. The project spans through City of Centralia and Lewis County boundaries. It is located in Section 09, Township 14 North, and Range 02 West.

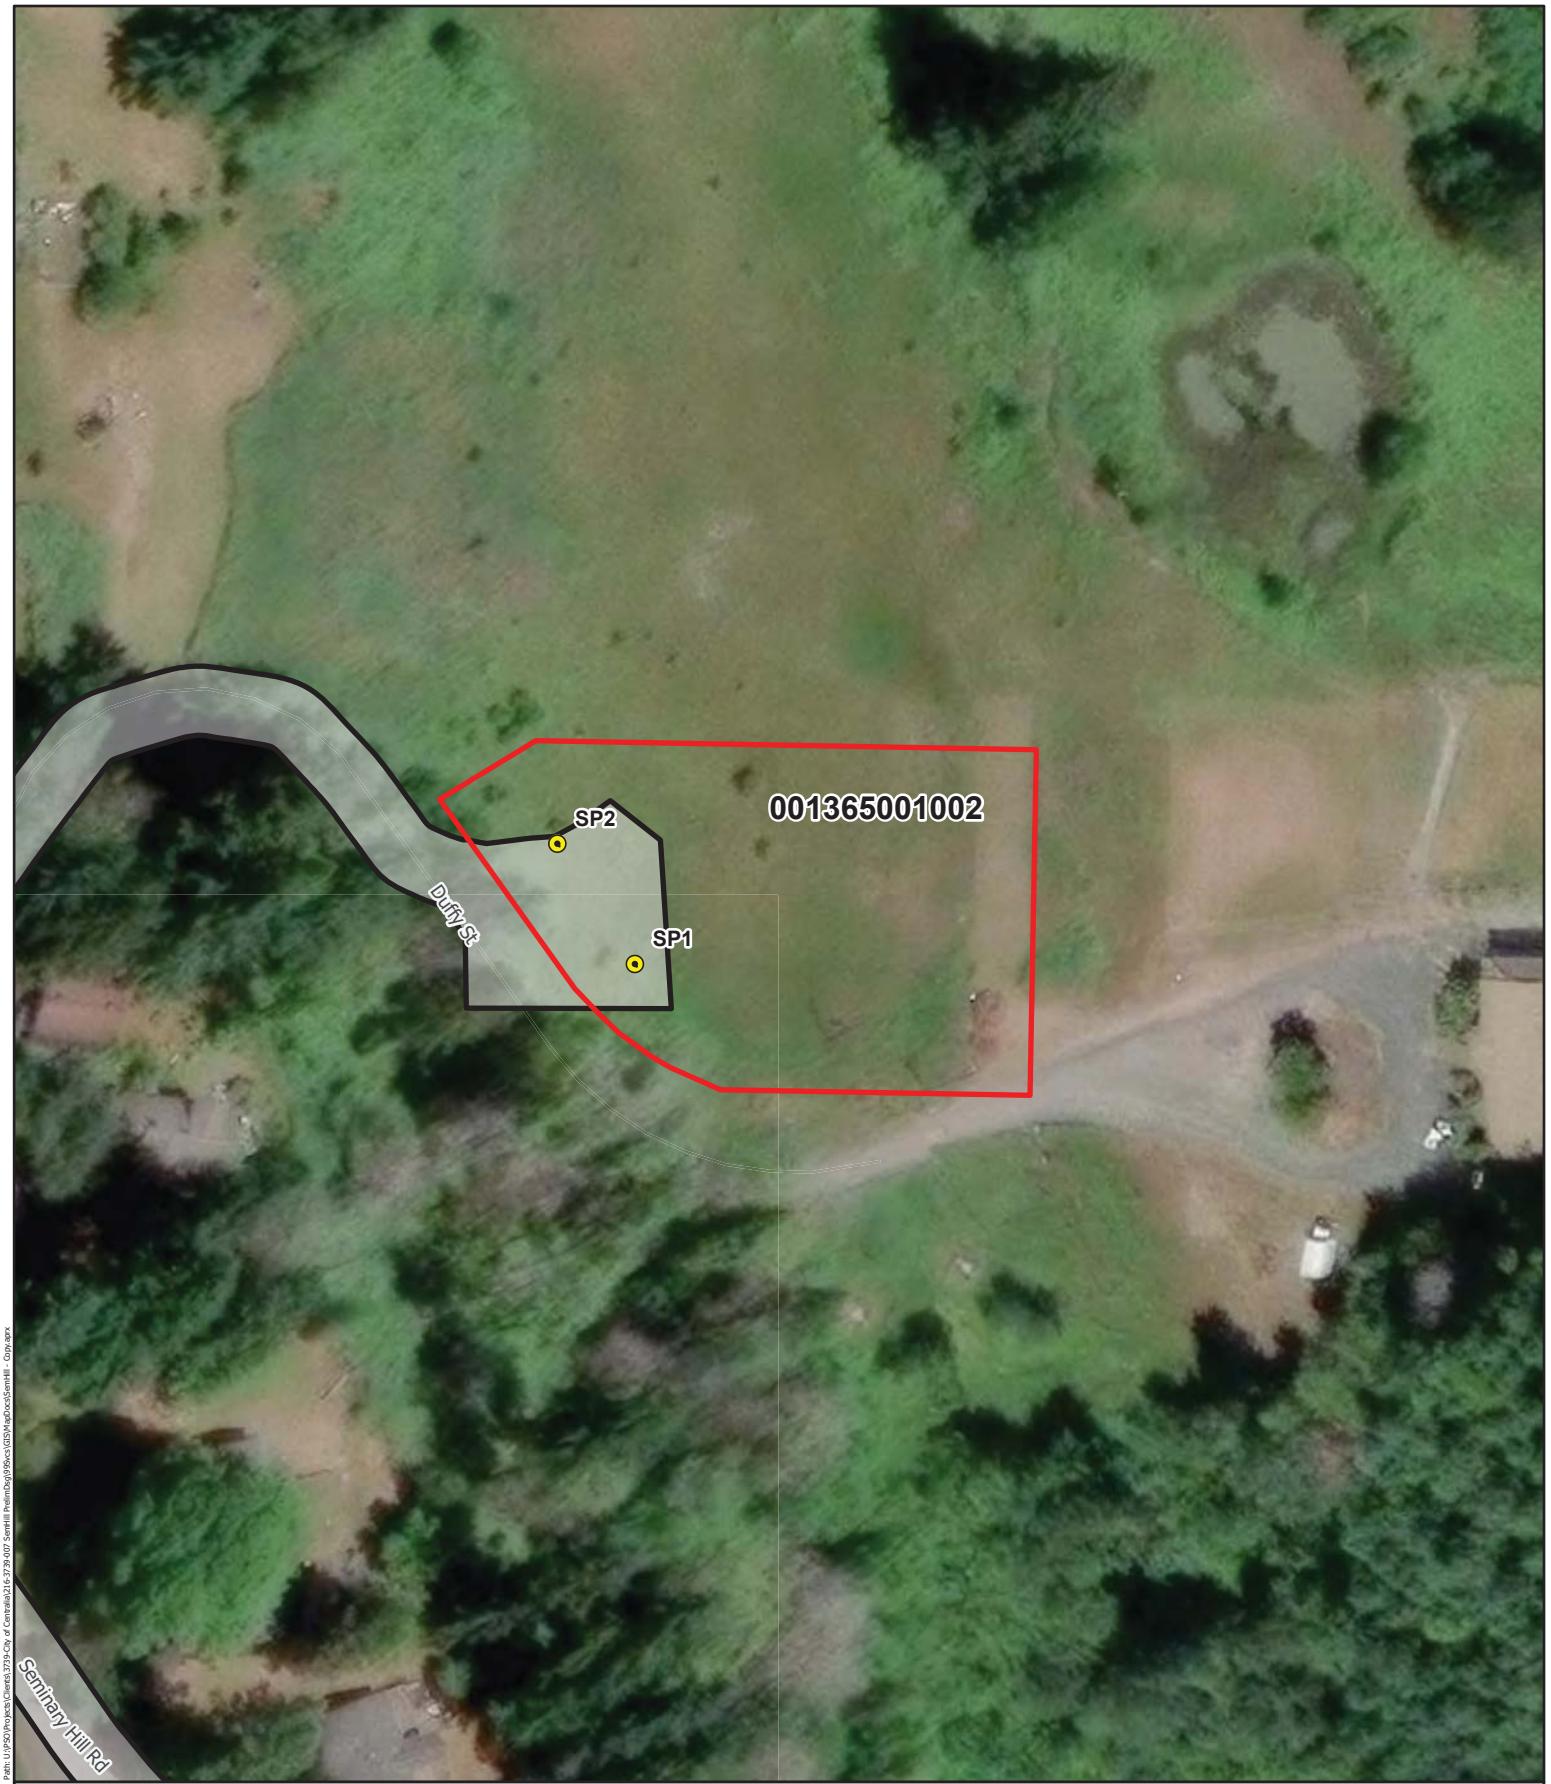
Figure 2 - Investigated Parcels  
Seminary Hill

Project parcel #001265001002 is located on Duffy Street in Centralia, Washington (Attachment A, Figure 2). The site is undeveloped and abuts an abandoned golf course. Adjacent to the parcel is the former golf course clubhouse that is currently used as a single-family residence. Topography of the site is eastern facing slopes. The site appears to have been previously altered due to the presence of flat, shelf-like features within the slope faces. Data for this parcel was collected on Sample Point 1 and 2 in Attachment B.

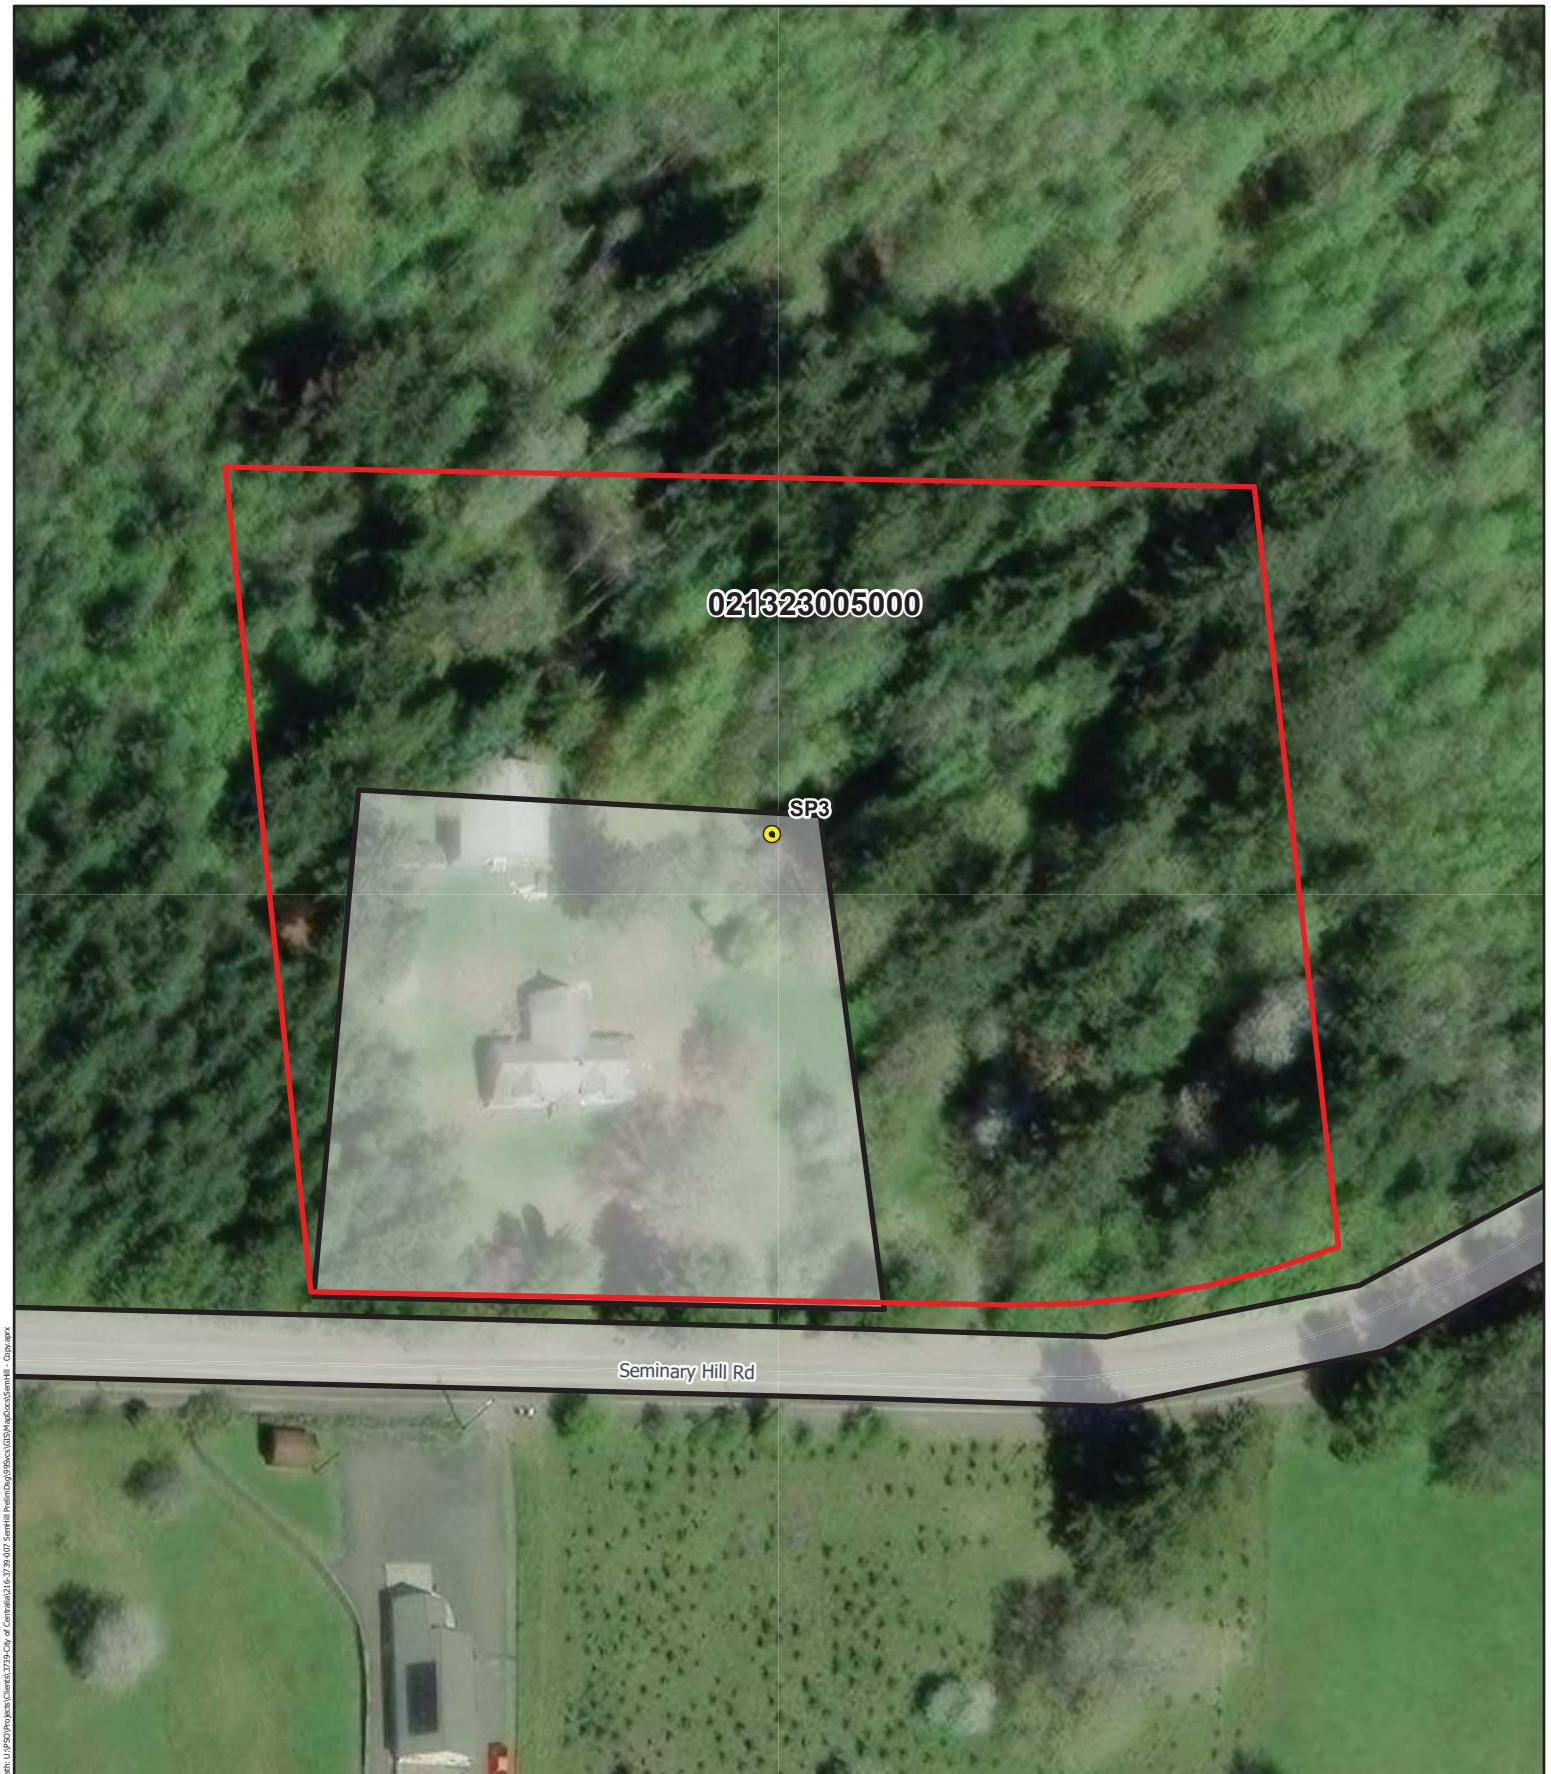
Figure 3 - Investigated Parcels  
Seminary Hill

Project parcel #021323005000 is located at 2353 Seminary Hill Road, Lewis County, Washington (Attachment A, Figure 3). Formerly, the parcel contained a single-family residence. Currently, remnants of the residence remain including the house's foundation, barn/shed, orchard, and other landscaped areas. The parcel is surrounded by undeveloped forest and other single-family residences. Data for this parcel was collected on Sample Point 3 in Attachment B.

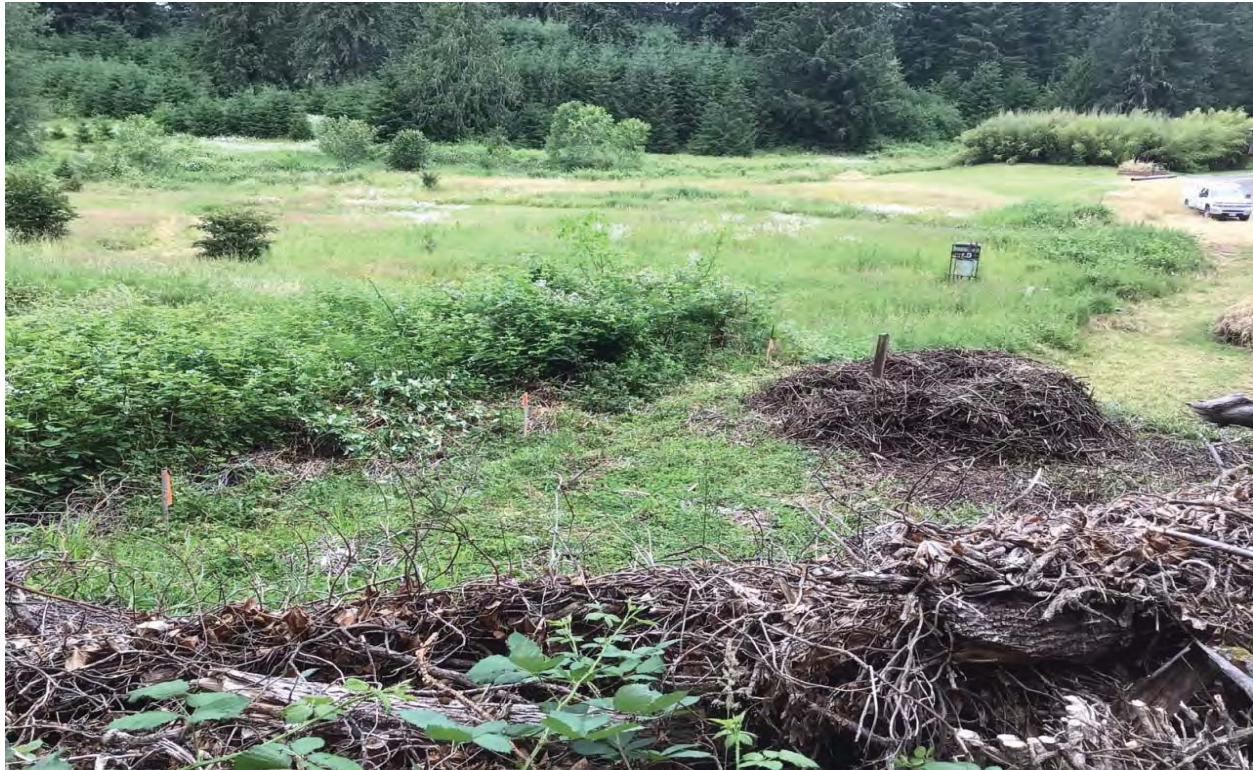
Photo 1. Overview of Project Parcel #001265001002

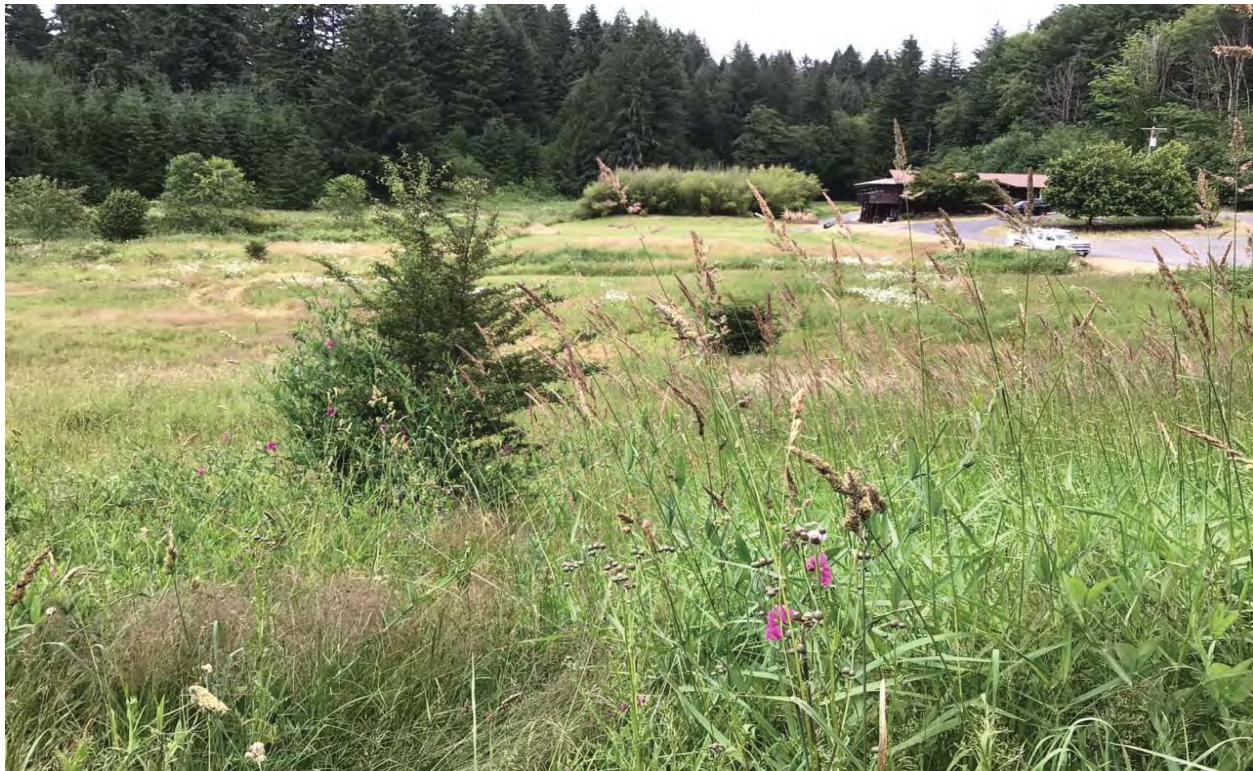
Project parcel #001265001002 vegetation community is dominated with a mixture of lawn grasses with some shrubs sparsely throughout. Lawn grasses include, but are not limited to, Kentucky blue grass (*Poa pratensis*), colonial bentgrass (*Agristis capillaris*), and orchard grass (*Dactylis glomerata*). Shrub species observed on-site include Himalayan blackberry (*Rubus armeniacus*) and beaked hazelnut (*Corylus cornuta*). Other species observed include Canadian thistle (*Circium arvense*), common vetch (*Vicia sativa*), creeping buttercup (*Ranunculus repens*), and English plantain (*Plantago lanceolata*).

Photo 2. Typical habitat conditions at Project Parcel #001265001002

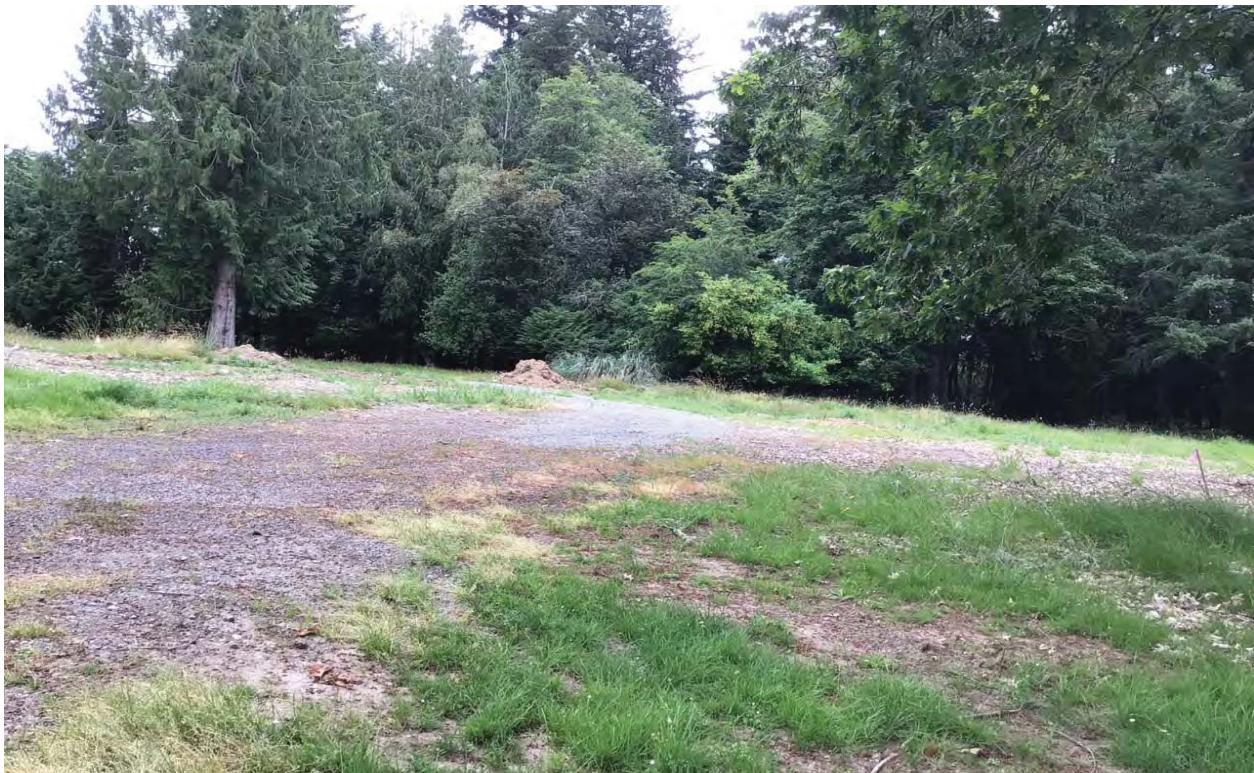
Project parcel #021323005000 vegetation community is predominantly forested with landscaped areas immediately adjacent to the former house. Landscaped areas include ornamental non-native shrubs and trees and lawn grasses. The orchard contains common fruit trees including apple, plum, apricot, cherry, and pear. Native forests were observed along the perimeter of the developed portion of the parcel. Native forest species include western red-cedar (*Thuja plicata*), Douglas fir (*Pseudotsuga menziesii*), and big-leaf maple (*Acer macrophyllum*), with salal (*Gaultheria shallon*) and sword fern (*Polystichum munitum*) in the understory.

Photo 3. Project Parcel #021323005000

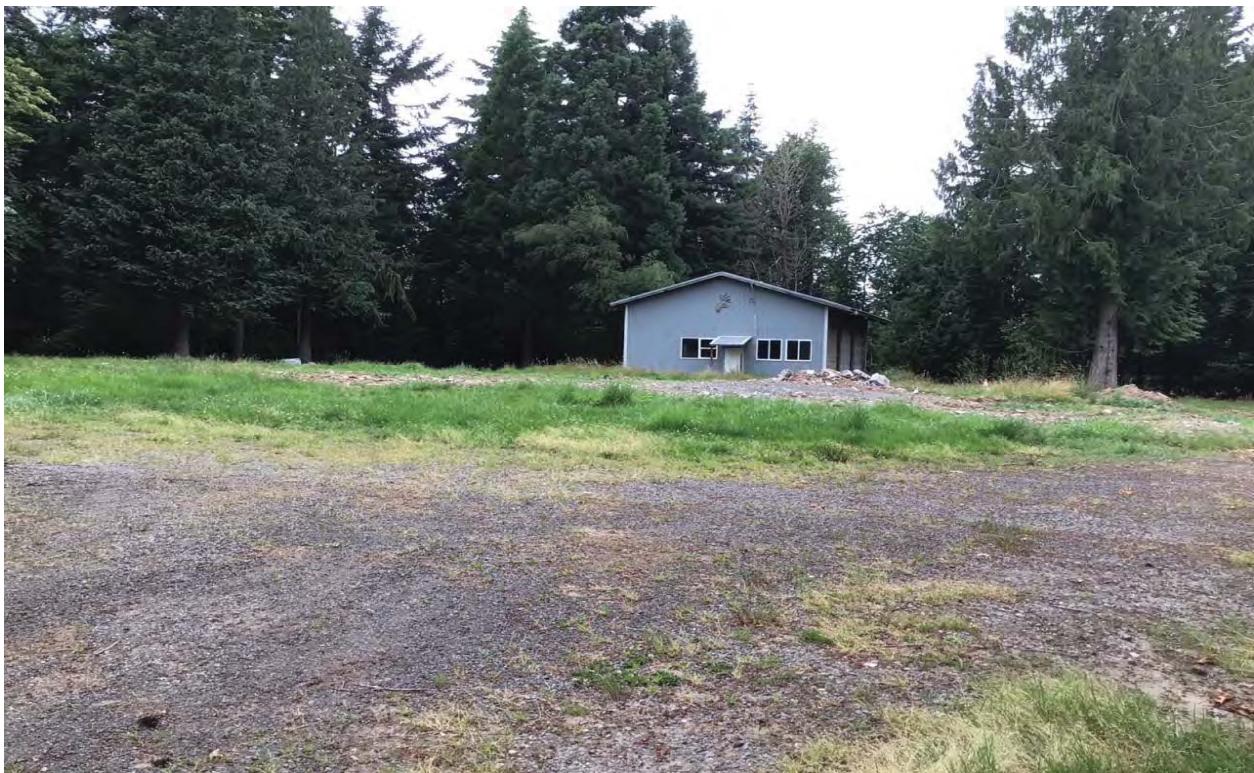
Photo 4. Abandoned house and driveway at Project Parcel #021323005000.

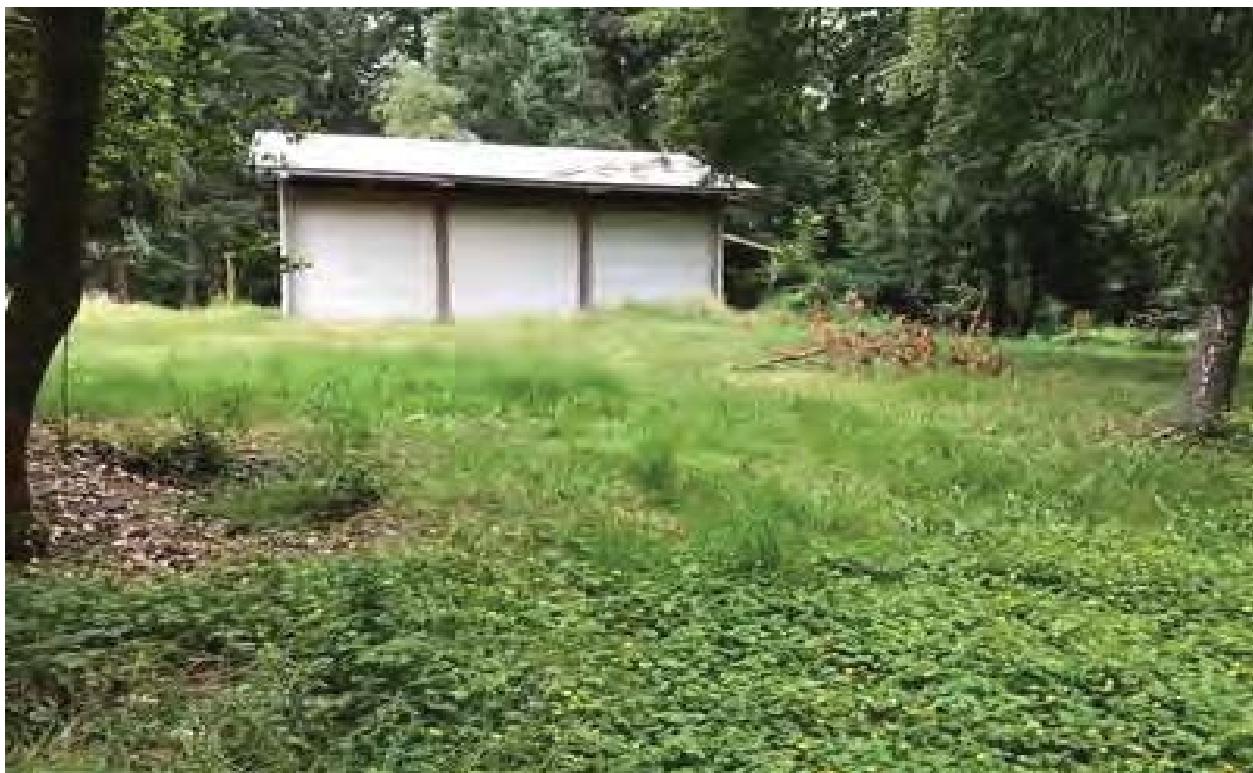
Soils were observed at one location on-site and contain very dark brown (7.5YR 2.5/3) silt loam (Munsell® Color 2015).

No hydrology or hydrology indicators were observed.

Photo 5. Habitat conditions at sample point #3 on Project Parcel #021323005000.
