RE: TCI Group Site Address: 149 Mattson Road, Centralia Tax Parcel Number: 023883000000  
Wetland Report Date: January 9, 2026  
Subject: 3<sup>rd</sup> Party Letter of Review

# Critical Area Report

Prepared For: TCI Group

Site Address: 149 Mattson Road, Centralia

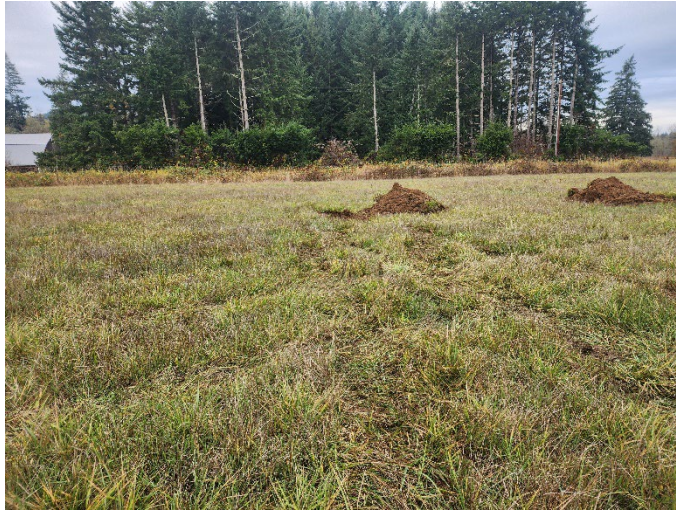
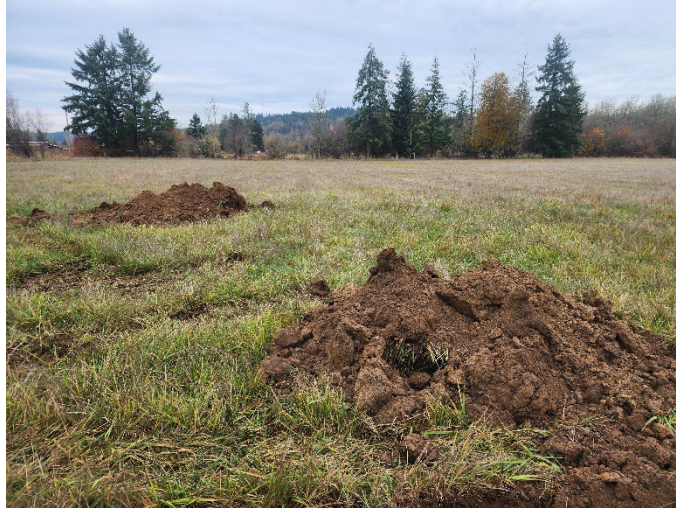
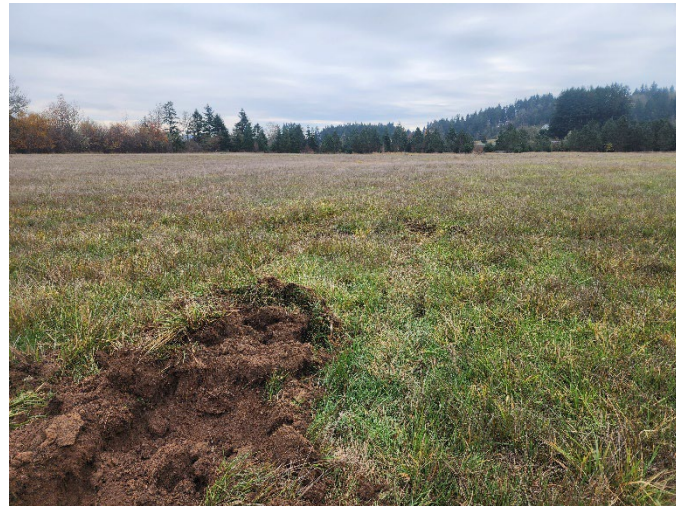
The vegetation on the site is primarily field grass with dandelion species. In the spring the site was observed to have Ox-Eye daises and Queen Anne Lace patches as well. On the north side of Eagle Creek the vegetation has young Douglas Fir Trees, Pine Trees, Nootka Rose and field grass.

Mattson Road Area Building Sites

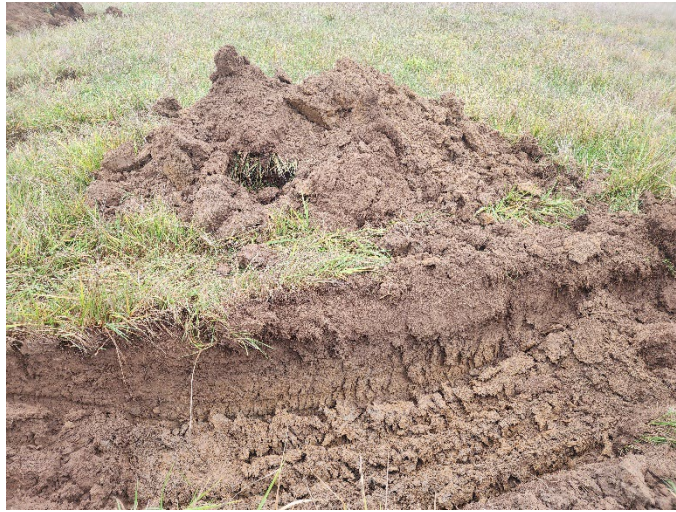
The soil on the site did meet the criteria for being hydric as mottling was found in the profile at about 16 inches throughout the middle of the site. The soils closer to Mattson Road were a little deeper in areas to a depth of 20 inches. The soils observed on the Cooks Hill Road side had mottling at about 16 inches as well. The profile of the soil matched the mapped series and did meet hydric soil criteria.

Soil Profile

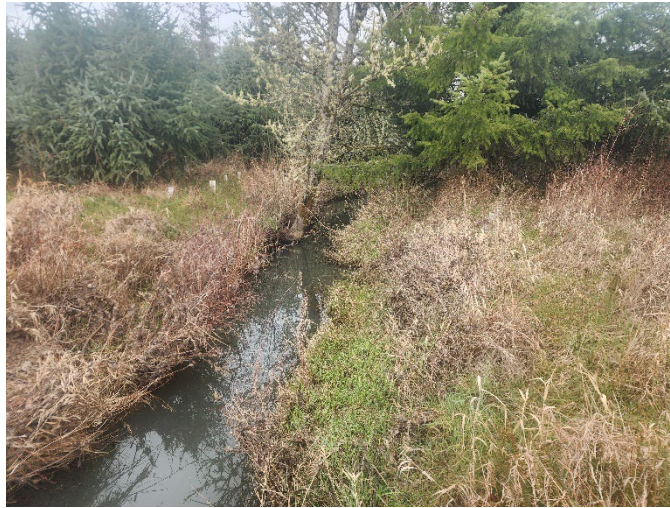
Eagle Creek
