Geotechnical Engineering Services Report

Mineral Lake Property Due Diligence
Mineral Lake, Washington

for
YMCA Seattle

March 16, 2021

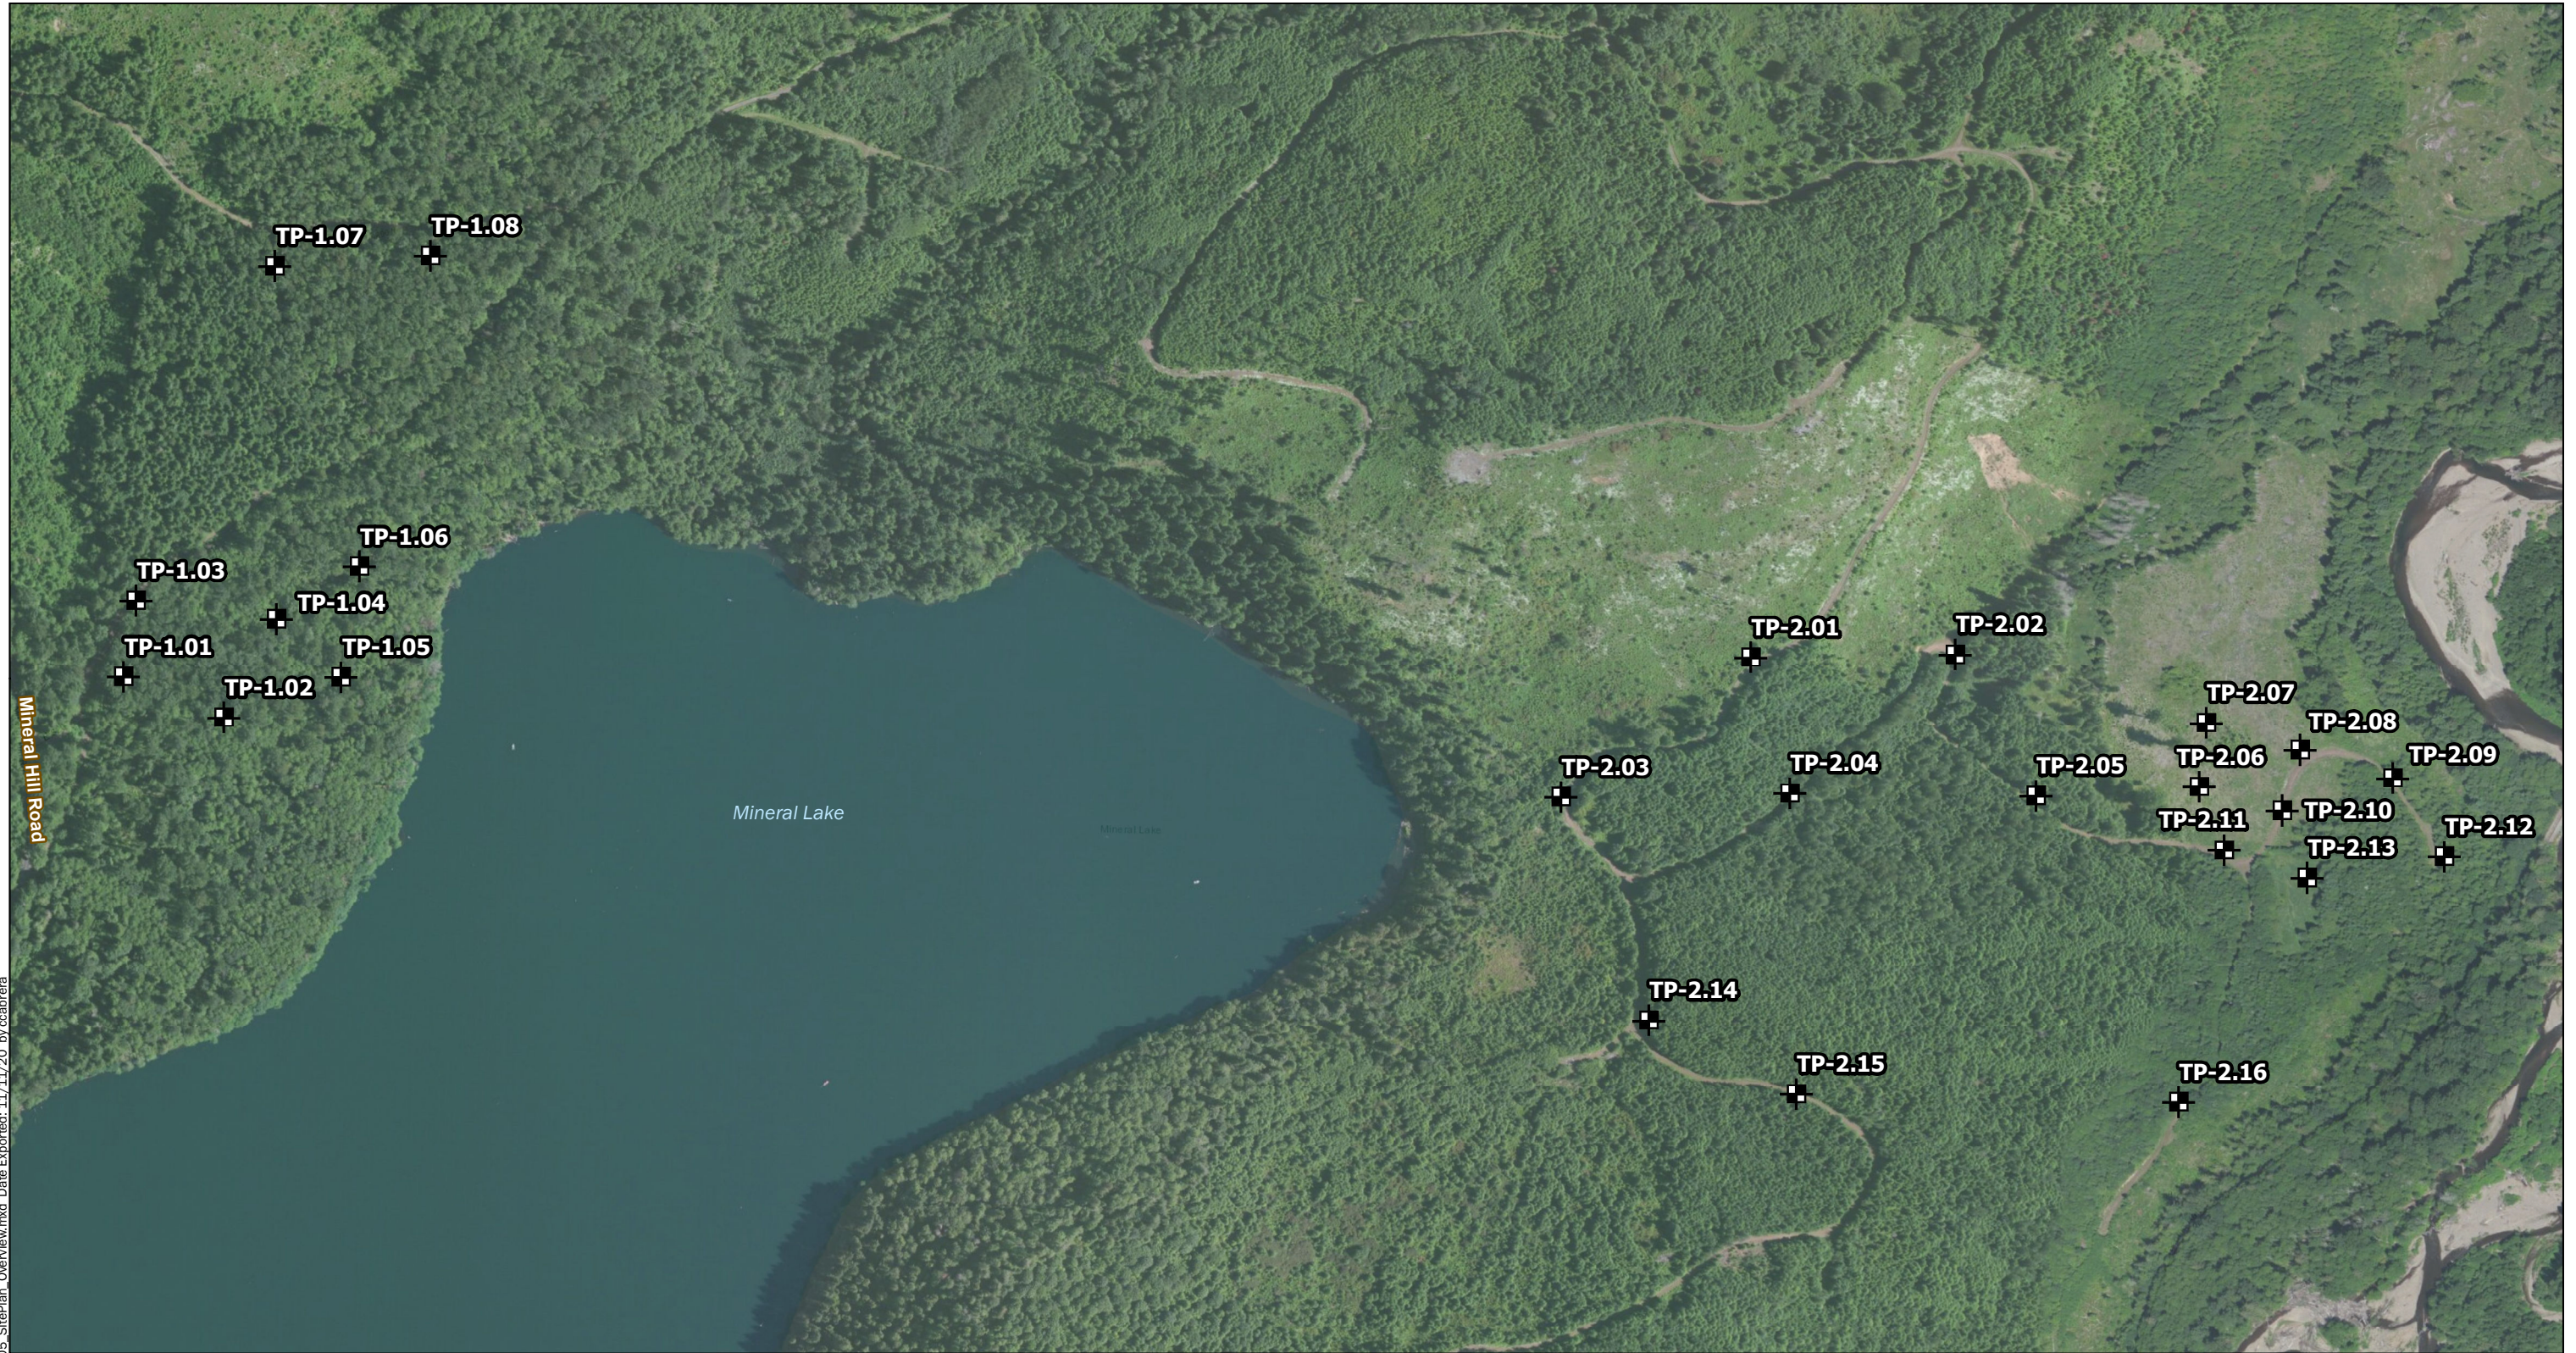
| | Figure 5 |

Legend
 [Symbol] Test Pit Location (GeoEngineers, 2020)

| Site Plan - Test Pit Overview | |

Soil and groundwater conditions at the site were explored by observing 24 test pit excavations on March 26 and March 27, 2020. Locations of the test pits were determined via an electronic tablet with global positioning system (GPS) software and are shown on the Site Plan - Test Pit Overview, Figure 5, as well as detailed views on Figure 6 and Figure 7. The locations and elevations of the explorations should be considered approximate.

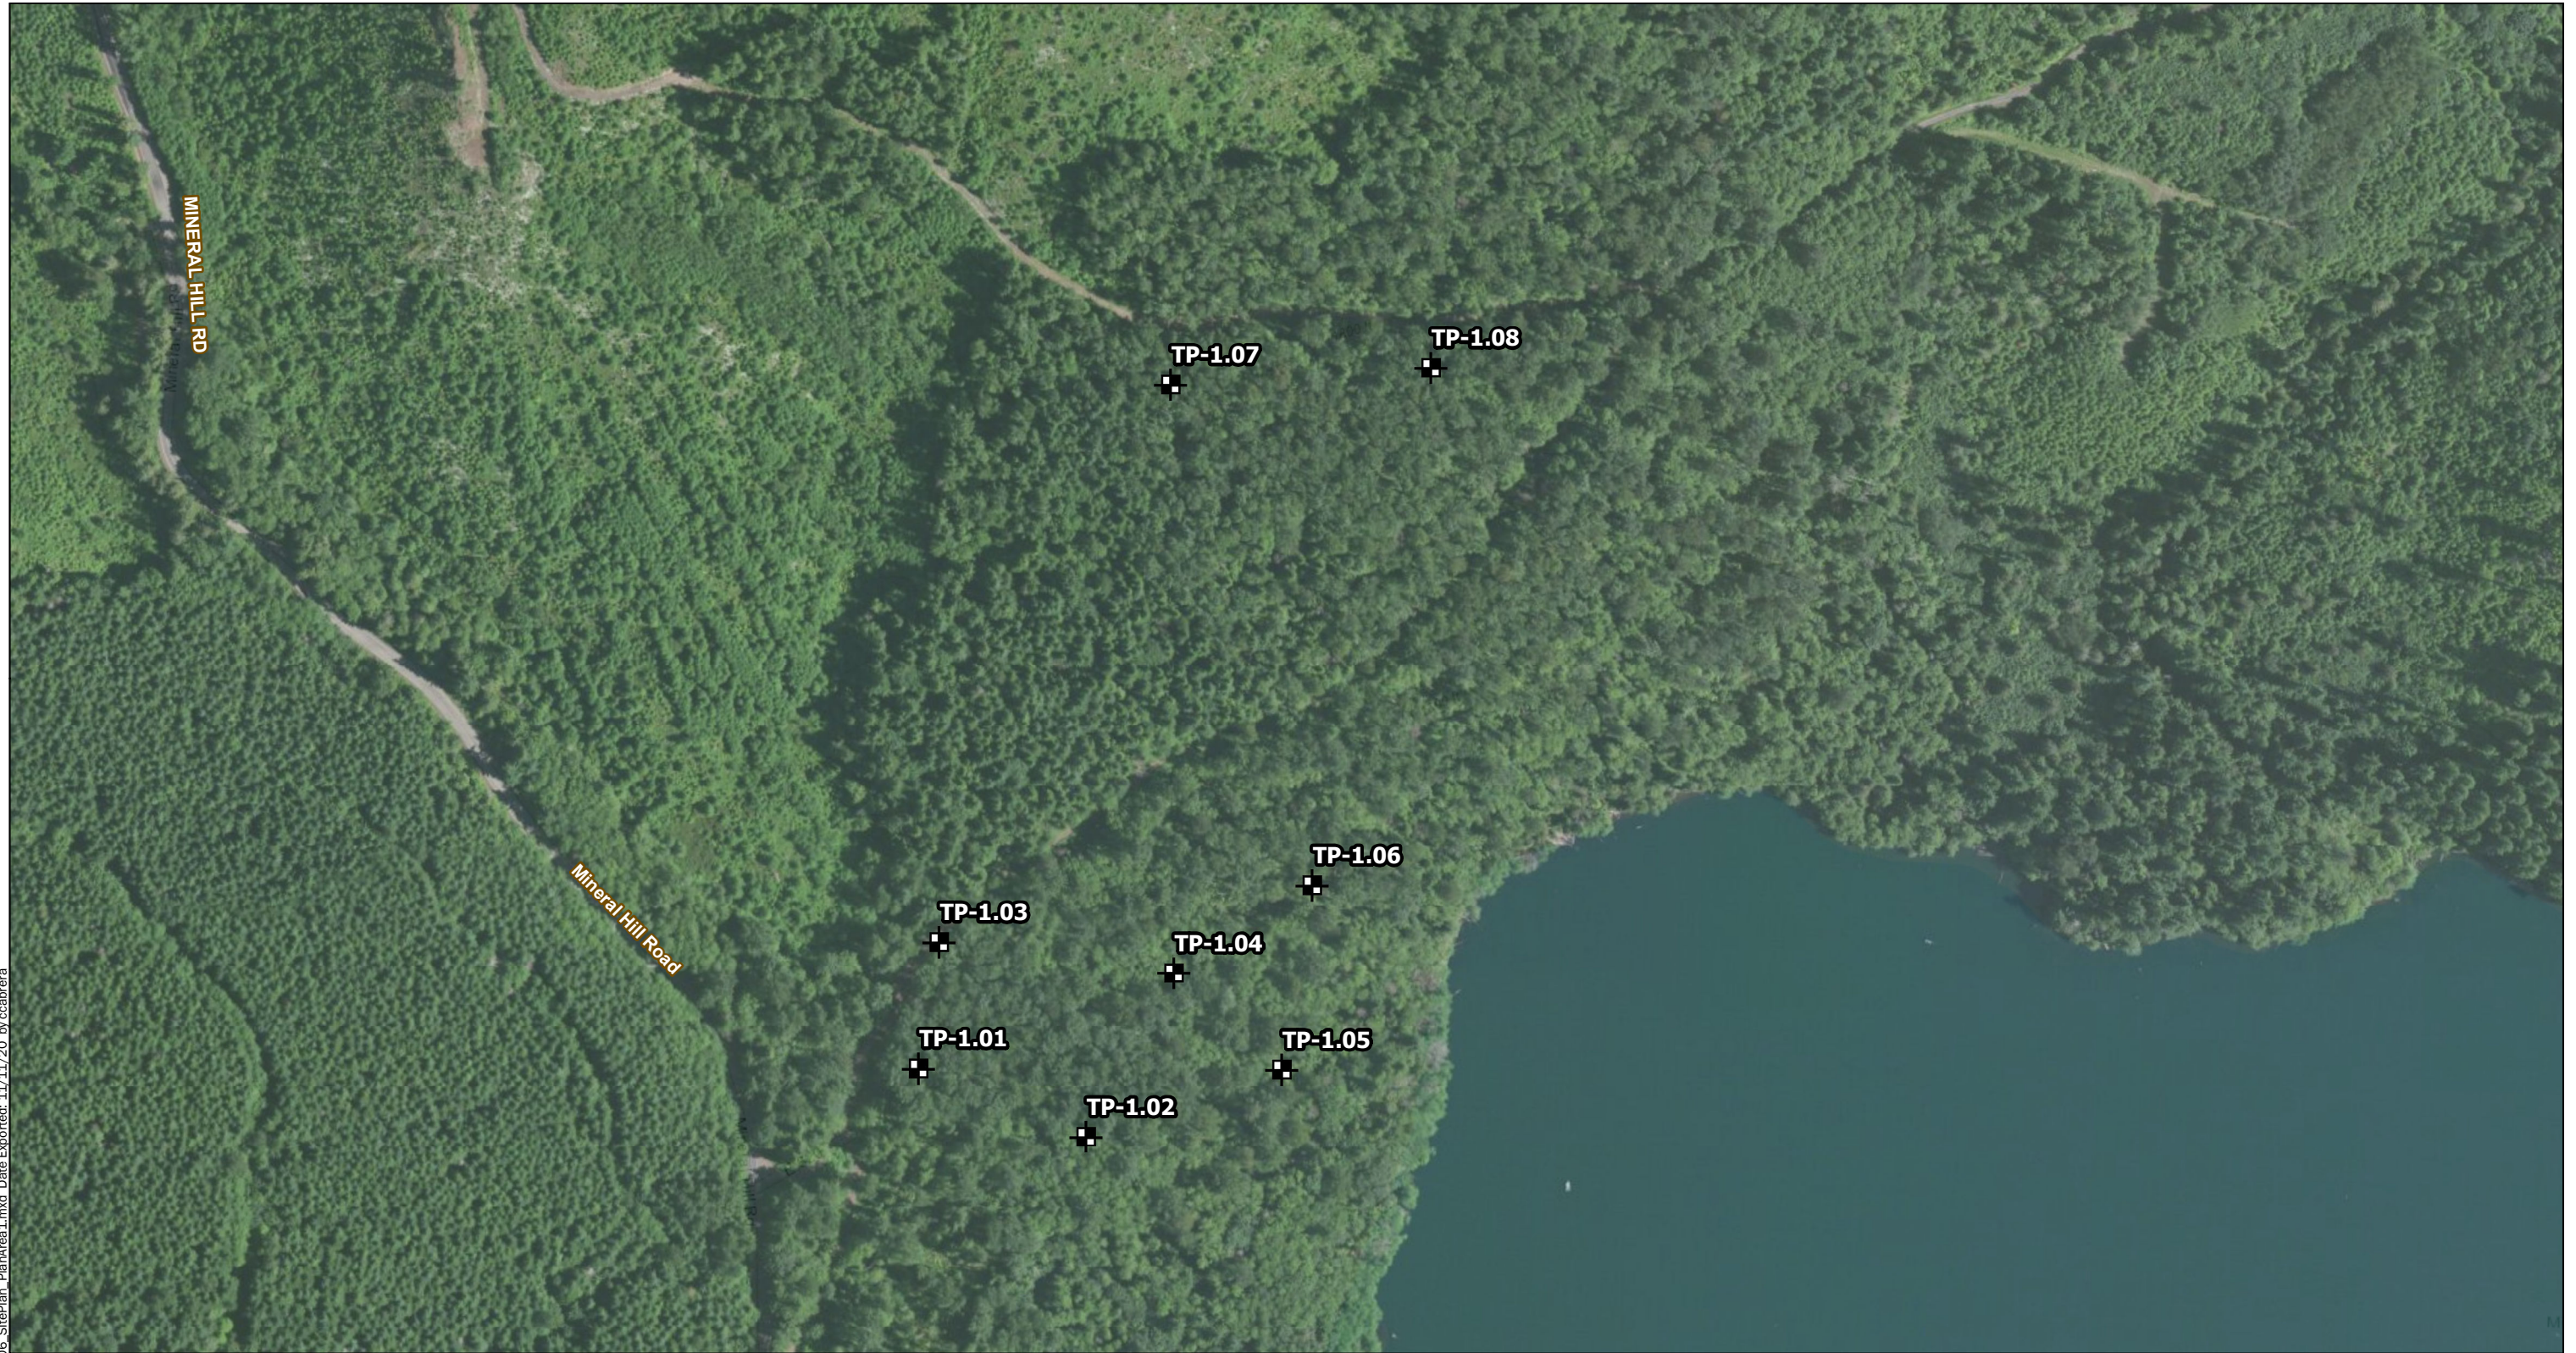
| | Figure 6 |

- Test Pit Location (GeoEngineers, 2020)

| Site Plan - Test Pit Area 1 | |

Eight test pits (TP-1.01 through TP-1.08) were located in Test Pit Area 1 in the western project area, immediately northwest of Mineral Lake and near the property entrance off Mineral Hill Road. Test Pit Area 1 is shown in detail on Site Plan - Test Pit Area 1, Figure 6. Ground surface elevation at Area 1 test pit locations varied between about Elevation 1,464 feet (TP-1.05, nearest Mineral Lake) to Elevation 1,783 feet (TP-1.07, approximately 1,000 feet laterally upslope from Mineral Lake).
