## **2. DESCRIPTION**

## 2.3 SYSTEM FACILITIES

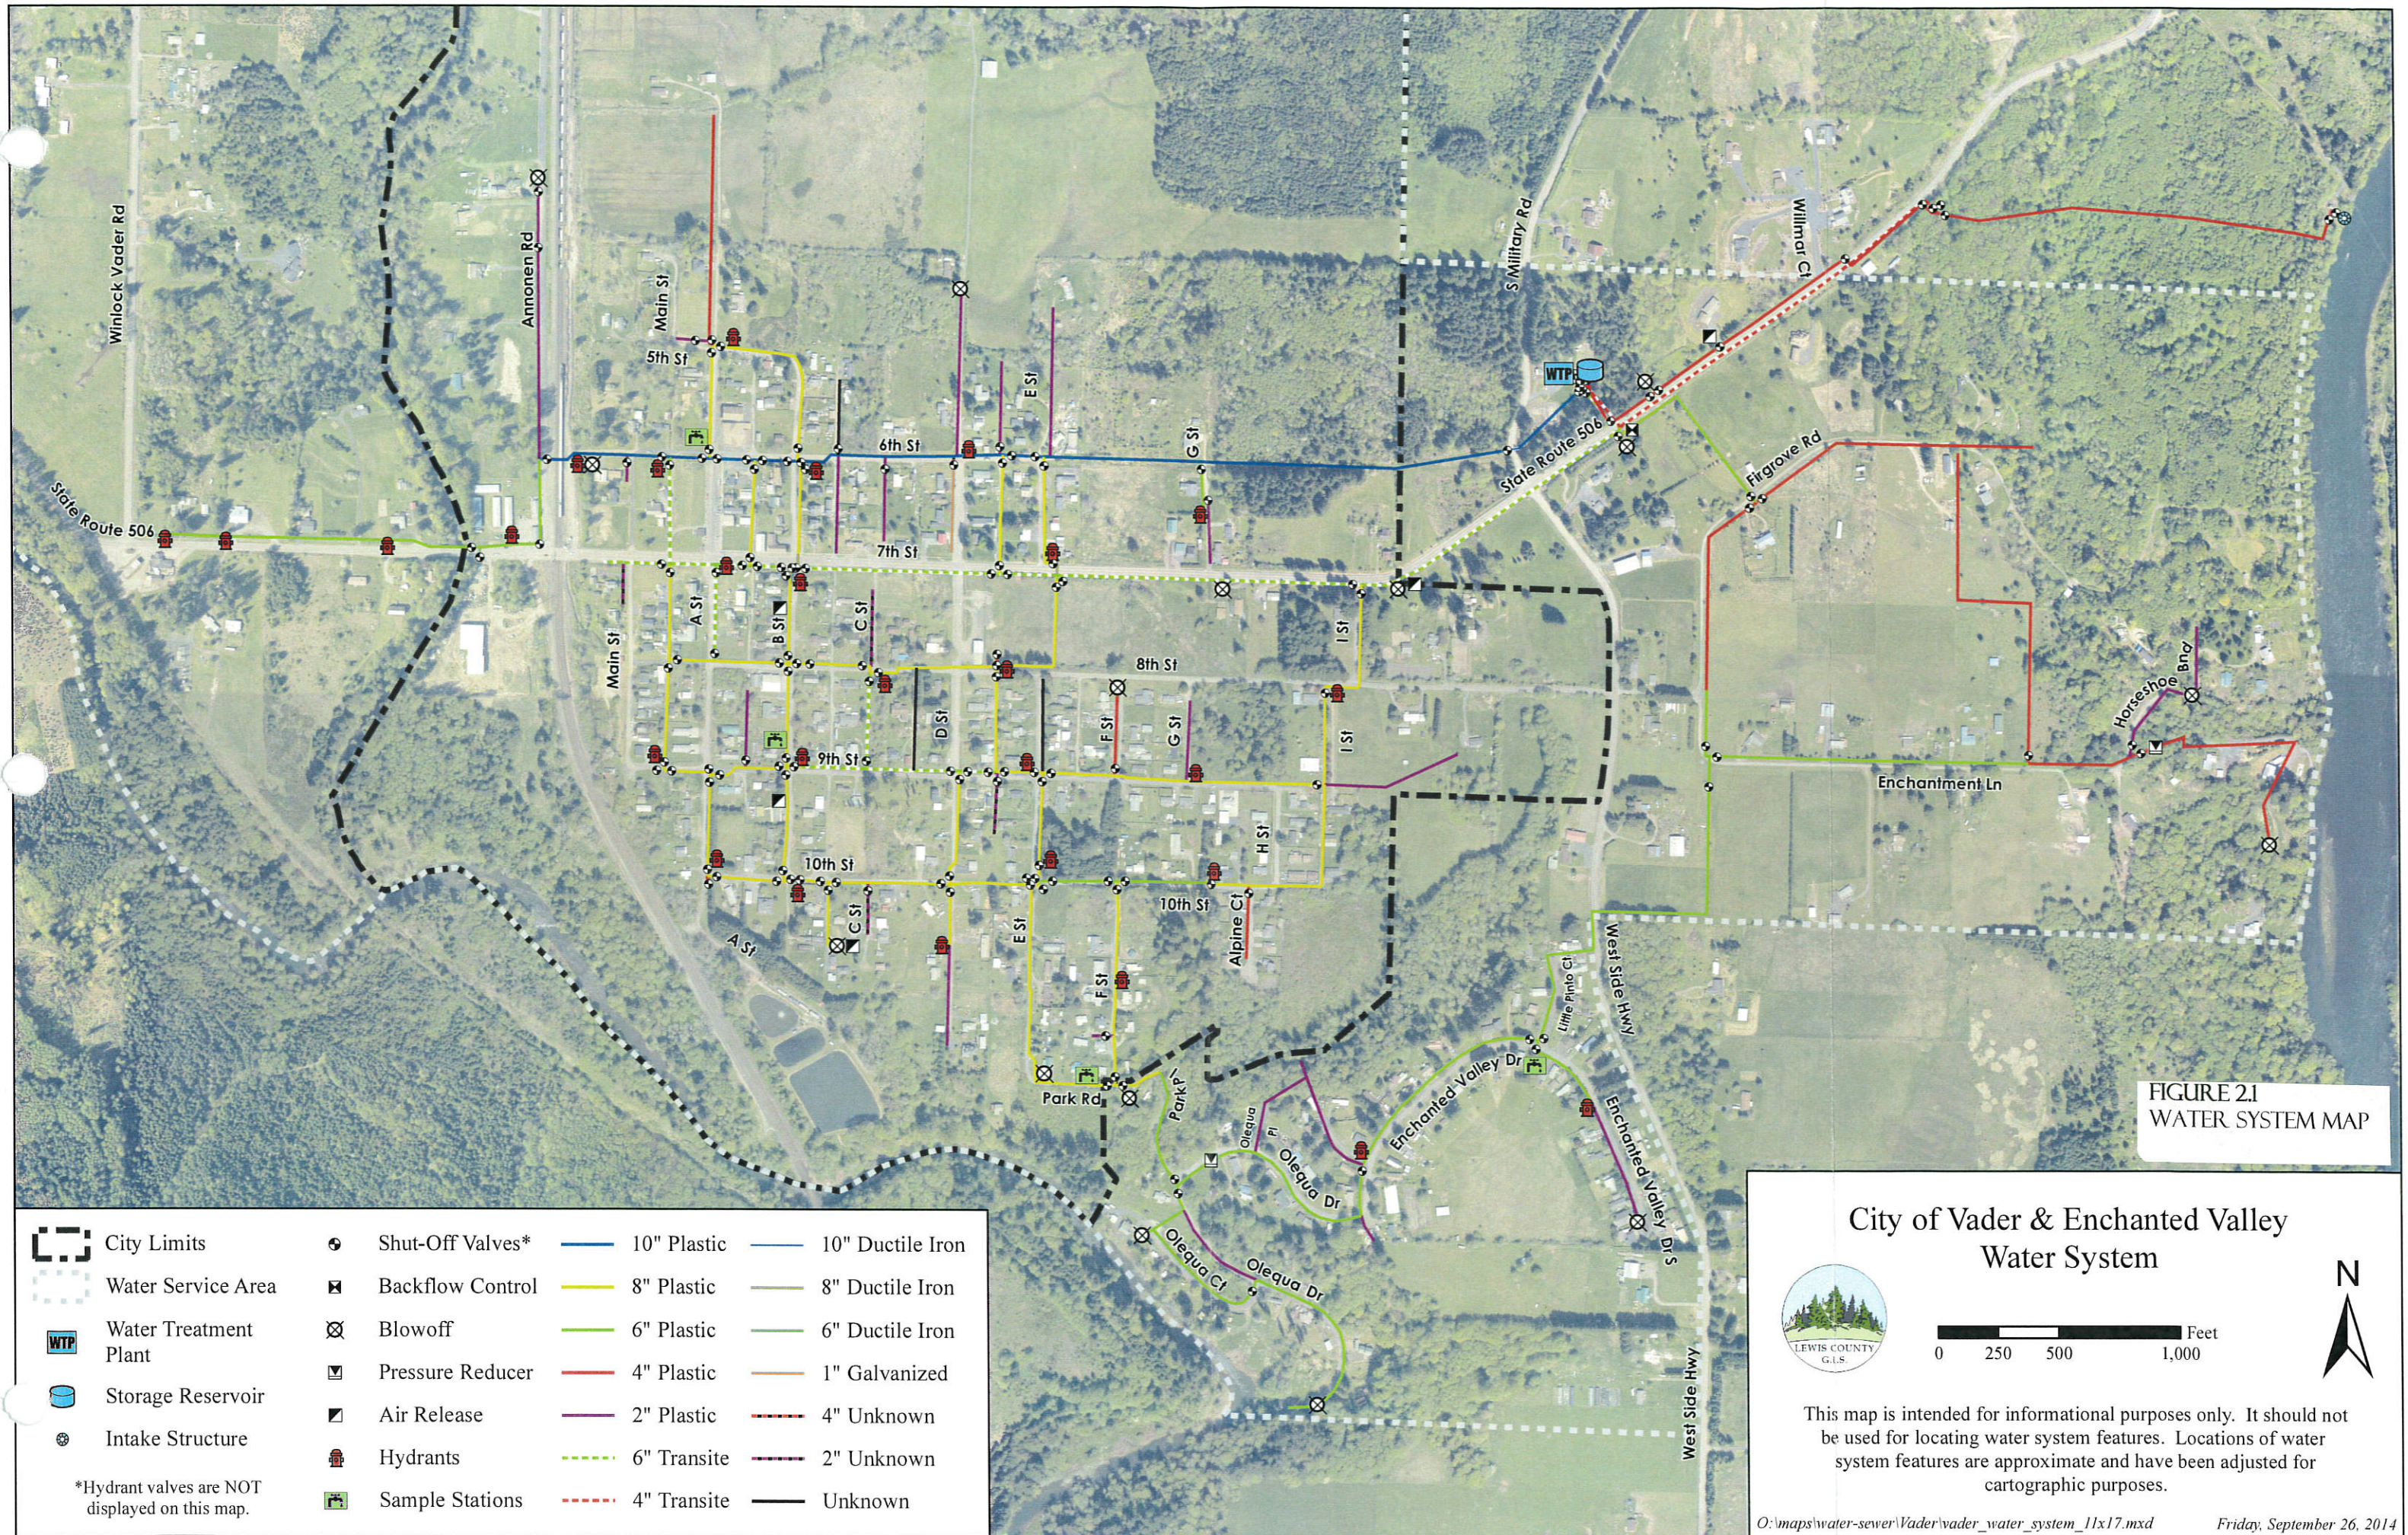
Descriptions of the water system facilities owned and managed by Lewis County are provided in this section. A water system map is provided as Figure 2.1.
